Lake Kate Sheppard:

An exemplar mahingā kai site?

GEO 402
Urban Development
Ada Zhang
Steve Carrick
June 2014

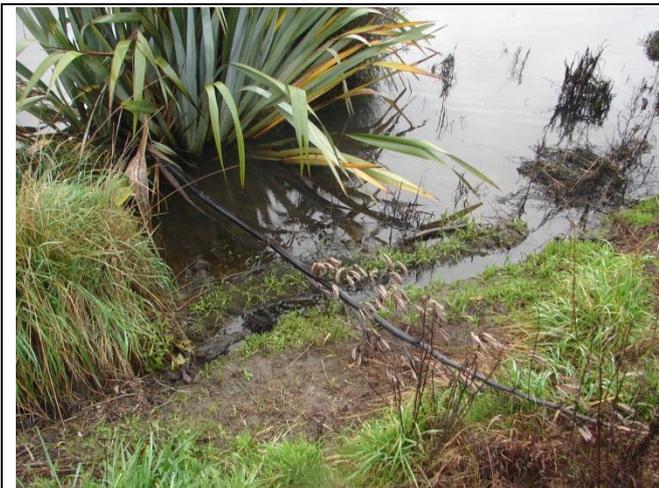
It had been predicted that the lower ecological corridor would become the main habitat for inanga spawning with suitable vegetation and fish entrance (Taylor, 1996). Along with the riparian flora gradually growing to maturation, the minute habitat was considered much more suitable for inanga egg growth in April 2004 (Taylor, 2004). Inanga eggs were mostly found in the north of the wooden jetty on the lake with high egg densities (Taylor & Chapman, 2007). However, post-earthquake, there were no inanga eggs found in the damaged habitat. Furthermore, the location of inanga spawning that were largely buried by soil were marked in 2007. The riparian vegetation which was regarded as the most suitable for inanga disappeared in 2011. They were probably killed by soil as well (Taylor & Blair, 2011). Currently, it is found that the original bank level has buried by silt as displayed in Figure 5 and 6.

Fig 5. Eastern Bank of Lake Kate Sheppard

- **Short term recommendations**
 - Remove silt and reshape bank from jetty to south end of lake
 - Replant this section, both in water and on the banks
 - Plant trees on island with “wet feet” to encourage breeding zone
 - Involve local community groups/schools to facilitate replanting
 - Assess and monitor water quality
 - Toxicology assessments of mahingā kai species
- **Longer term recommendations**
 - Mitigate/manage silt issues
 - Excess water to flow back into Travis wetlands and/or detention basin
 - Shape bank of lake to provide depth and shallow edge
 - Replant lake edge & surrounds
 - Install storm water zone detention/treatment basin
 - Make outdoor classroom information panels interactive
 - Barrier fence along Anzac Drive to capture rubbish

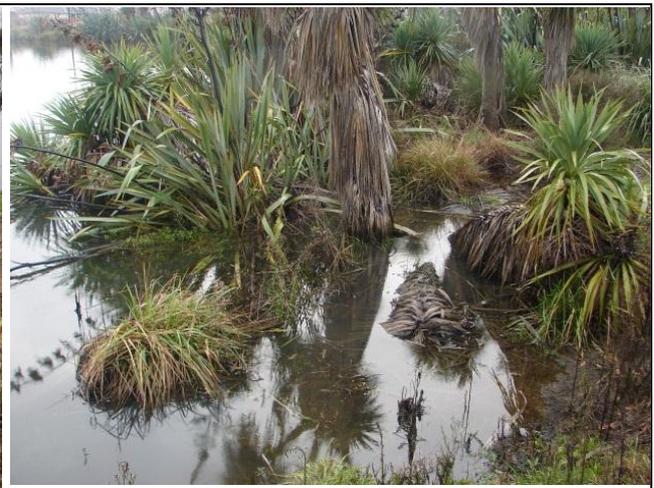
Fig 6. Western Bank of Lake Kate Sheppard

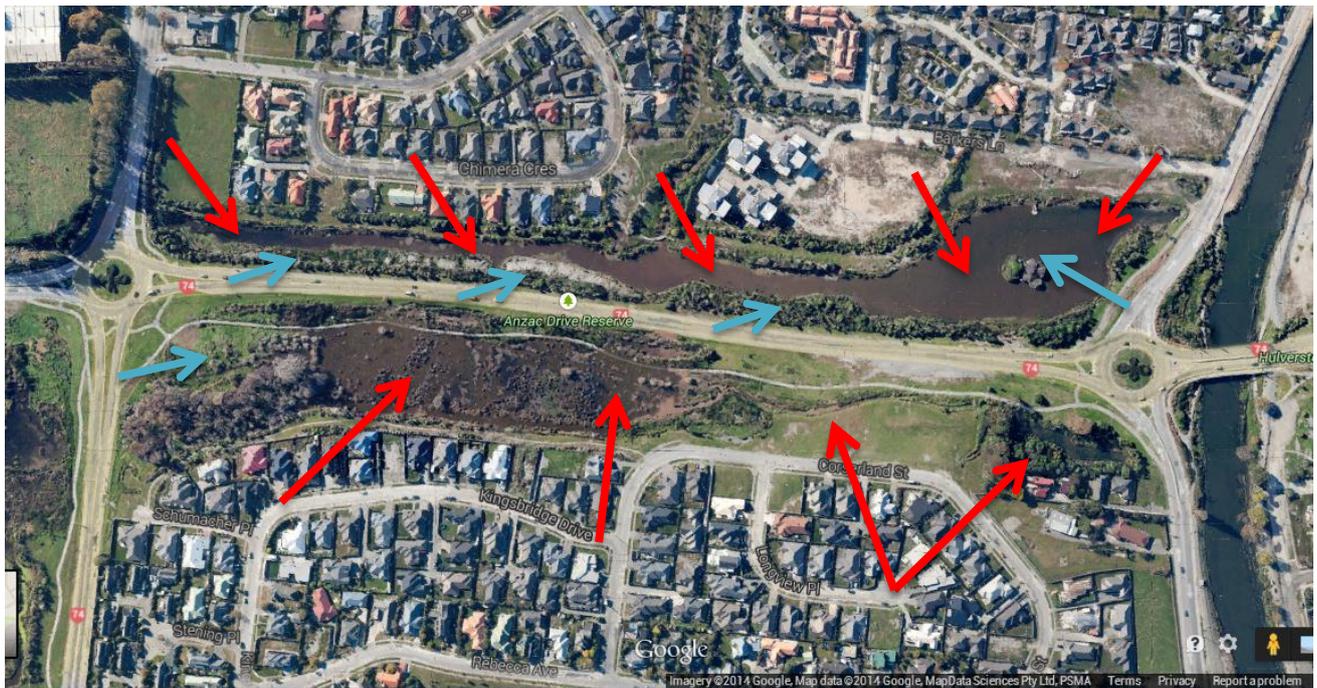
untreated. It directly flows into streams, rivers, and finally estuaries and the sea. As mentioned earlier, the land level in Lake Kate Sheppard has settled since the earthquake. This causes stormwater runoff from the surrounding area to readily flow into the lake and is shown in Figure 7. The red arrows represent the stormwater runoff from residential area and the blue arrow represents the stormwater runoff from Anzac Drive and surrounding roadways.

Fig 7. Probable stormwater runoff flow direction.

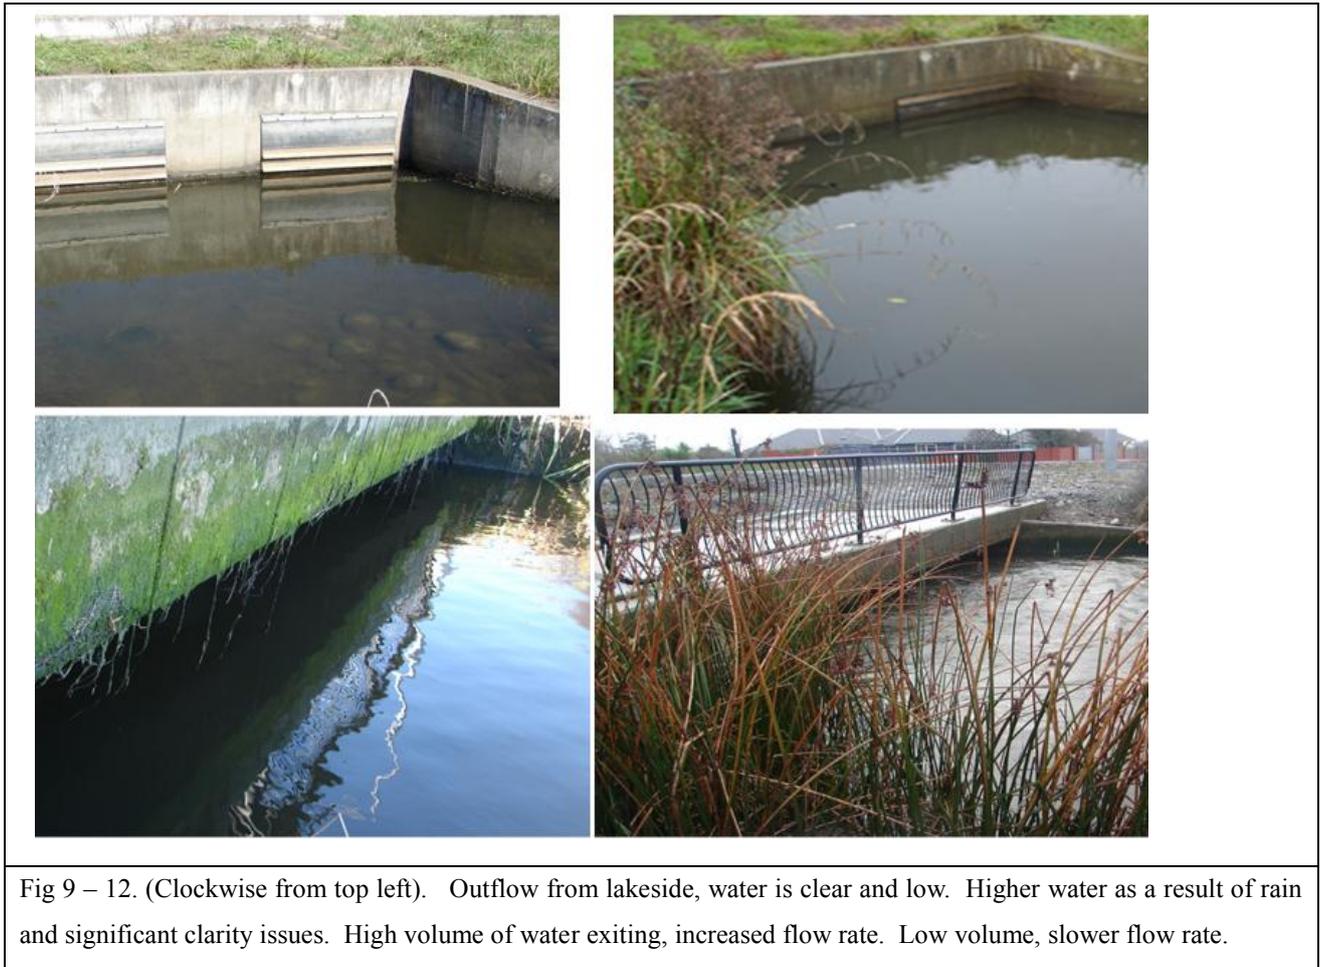
Lake Kate Sheppard was visited by the project team on 22 Mar 14 and 14 May 14. The first visit was on a warm sunny day after a prolonged dry spell with the second visit after a high rain event. Whilst lacking quantitative data for these events, the qualitative data showed significant comparisons which raised some concerns. The outflow of the lake to the river at the southern end of Lake Kate Sheppard is shown in Figure 9 – 12 from two perspectives, from the lake side and the river side and it is obvious to see the difference between a sunny and rainy day and the effect it has

upon the lake. The differences include water flow rate, water flow velocity, turbidity/clarity, water quantity (water level). After the rain the water level increased sharply and this in turn increased turbidity levels. The quantity of stormwater discharged from any given rainfall events can depend on several factors such as storm size (duration and intensity), ground cover type and the degree of imperviousness, soil type (saturability) and Topography.

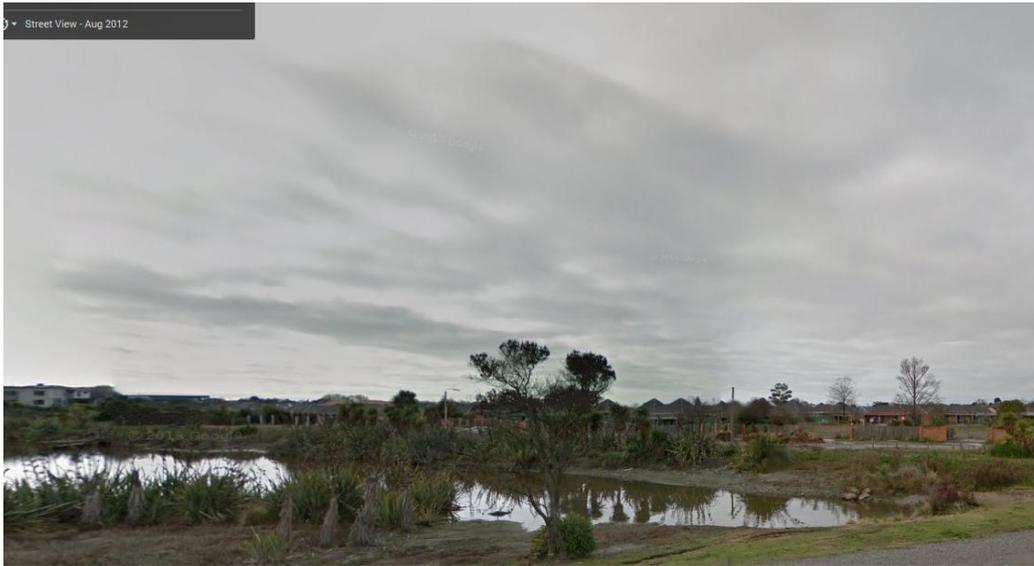
Further evidence of the dramatic change in water levels is shown in Figure 13 from Aug 20112 where the water level significantly lower than in Mar 14. The vast difference in water levels inhibits the sustainability and resilience of shoreline plants surrounding the lake. A mild fluctuation in the lake water level could be catered for but not such dramatic changes as shown in Figures 9 – 13.

Fig 13. View of lake from south west corner shown lake level in Aug 2012. (Google.maps)

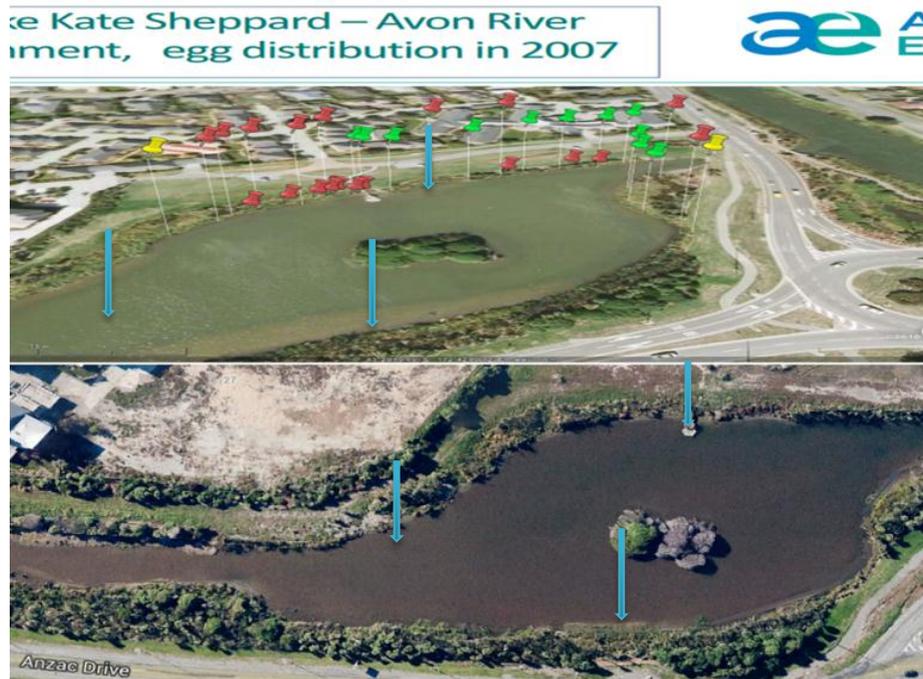
A further qualitative assessment by comparing aerial views of the lake from a pre-earthquake and post-earthquake perspective shows that the water quality and the physical makeup of the lake appear to have changed and this is shown in Figure 14. The water colour is different, green (pre-quake) and brown (post-quake) in the same area of the lake. The top picture shows the ledge in the inanga spawning habitat in 2007 and the lower picture shows the ledge has gone since the earthquake. The blue arrows indicate the shallow ledge along the bank on both sides of the lake. The reasons for the absence of the ledge in the later picture could be due to increased turbidity so that it cannot be seen, that the liquefaction silt has risen from the bottom of the lake and buried the shallow or that the land slump issues mentioned previously have affected the shelf and it has dropped into the lake bed. The reason for the change in colour is a complex issue and this could be related to a variety of issues such as water temperature, water flow, quantity, contaminants, phosphate and nitrogen levels and potential algae bloom issues.

Fig 14 Pre and post-earthquake aerial view of Lake Kate Sheppard showing different water colour and a shelf/ledge around the lake in the top view which is missing the bottom view.

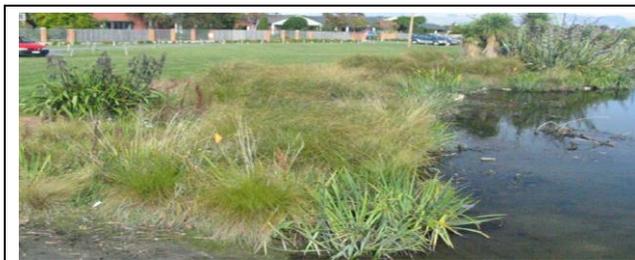
The seismic events of 2010 and 2011 also had major effects on the structure of the banks and the shoreline plantings. The liquefaction not only placed significant amounts of silt through the plants but also damaged large areas of plants. A comparison of the shoreline for pre and post seismic events can be seen in Figures 15 and 16. Remedial action needs to be completed to replace/restore the shoreline planting to provide a suitable habitat for inanga to lay their eggs. This needs to cater for a mean water level and the plants chosen require some resilience for the fluctuating water level from high water events, tidal surges and flooding as well as low water events. Planting should also incorporate plants to reduce the impact of Canadian geese and the residue that they create as this can be prolific and further reduce water quality.

Fig 15. Shoreline pre earthquake

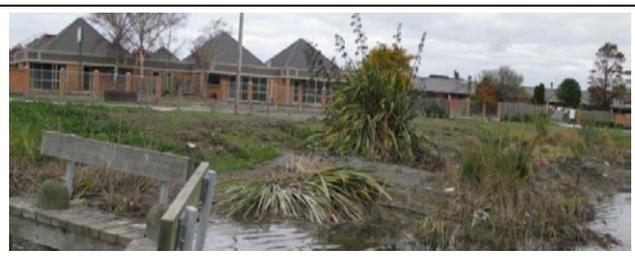
Fig 16. Shoreline post earthquake

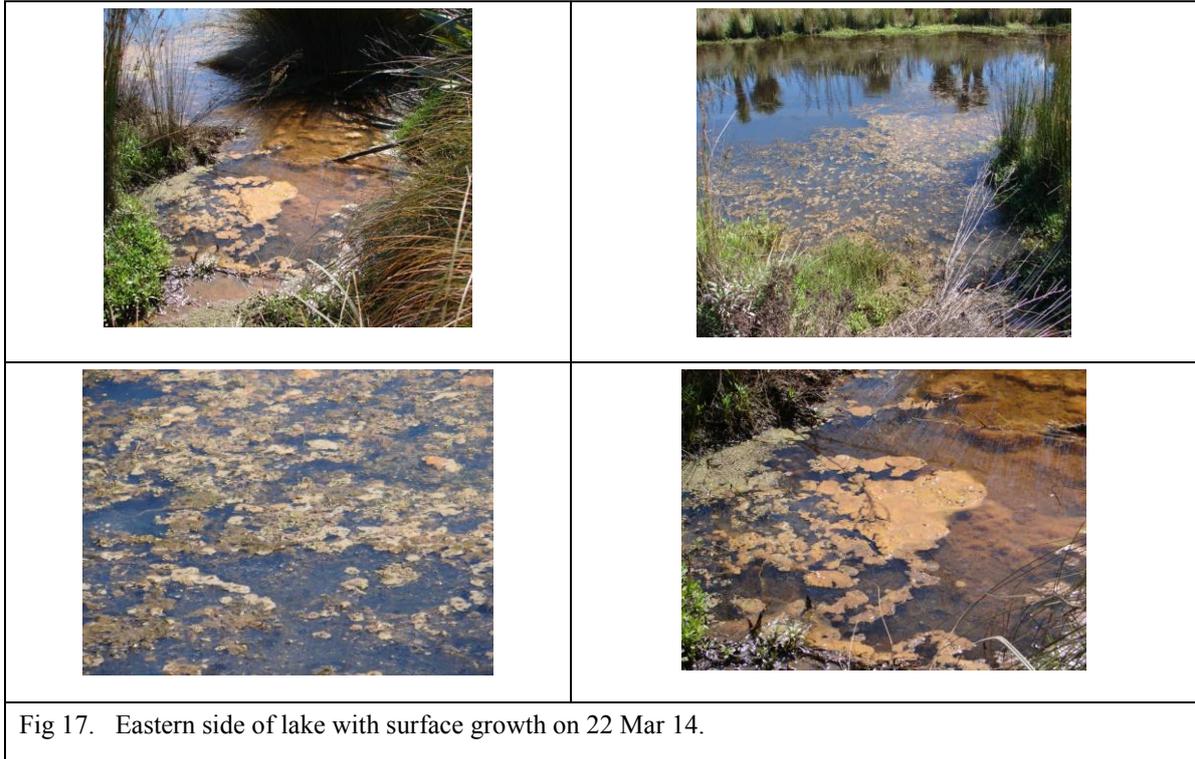
An observation on the eastern side of the lake shows that the lack of flow within the lake in Mar

2014 created a buildup of surface matter which may not be conducive to healthy water (Figure 17).

Fig 17. Eastern side of lake with surface growth on 22 Mar 14.

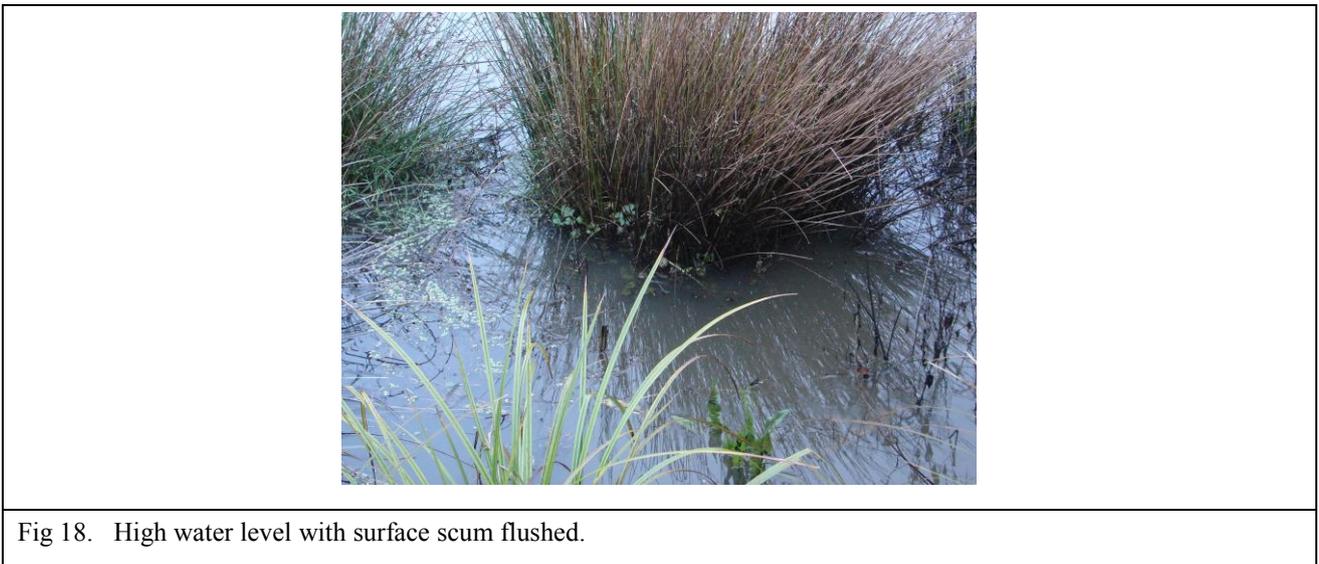
A comparison of this location between Mar and May 2014 can be seen where there is no surface matter in Figure 18 and the brown sludge has gone. The surface matter has been flushed as a result of heavy rain. This requires to be monitored to rule out algae bloom and any potential negative elements.

Fig 18. High water level with surface scum flushed.
