Impacts of Earthquake-Induced Landslides

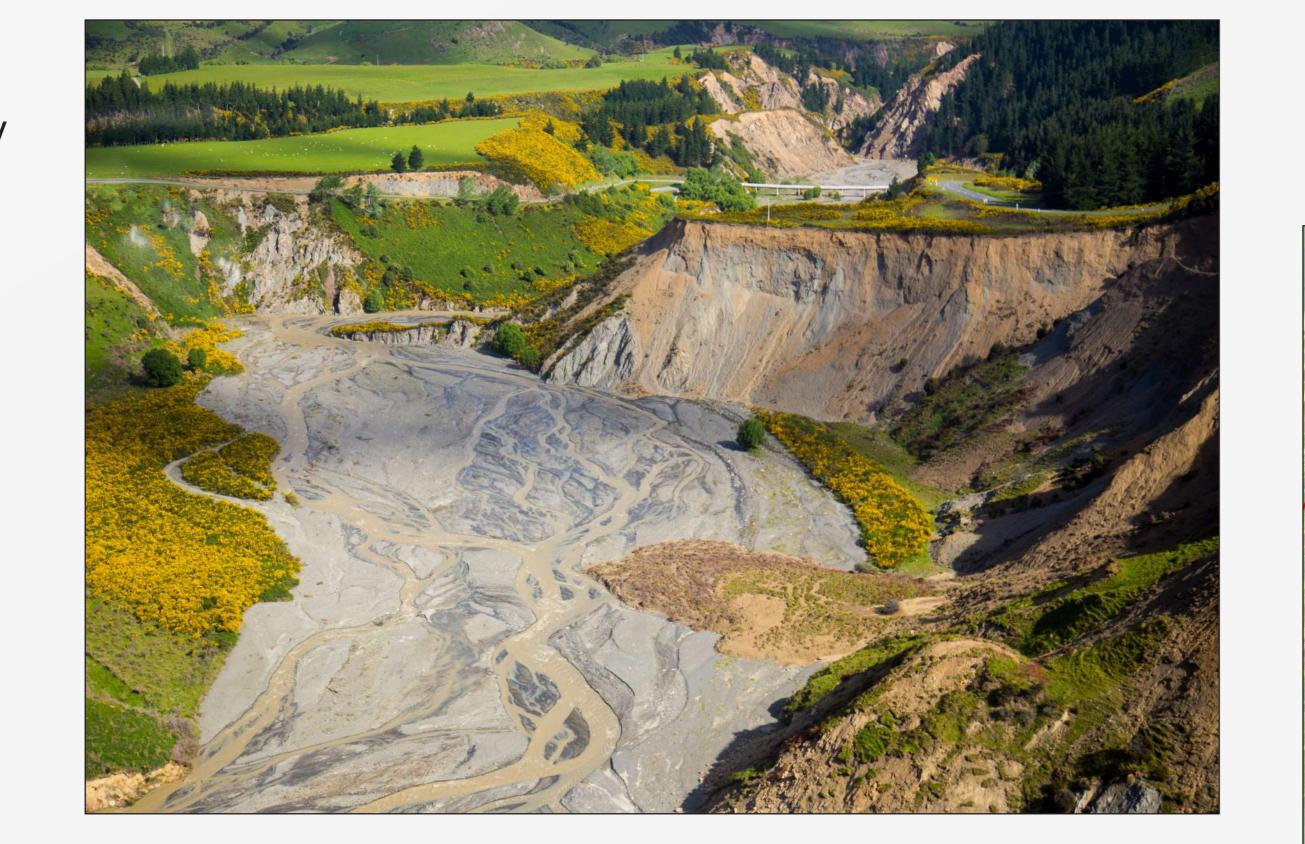
- Debris flow runout into the Conway River just north of the Inland Road bridge at Cloudy Range Rd
- Influx of landslide debris in Canterbury rivers will affect sediment transport and floodplain

deposition for many years

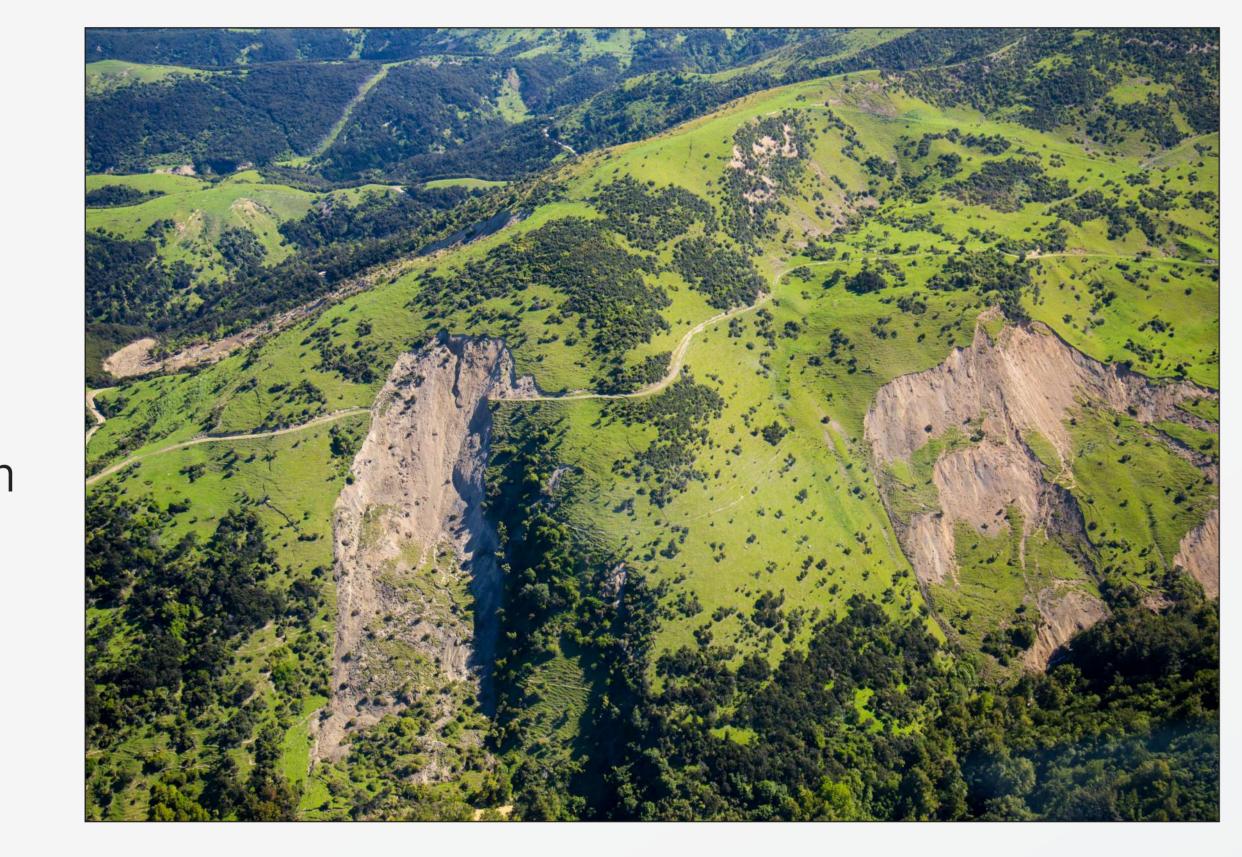
- Landslides on a 4WD track in the Black Hills near the Gelt River
- The track needs to be cleared and assessed for stability before
- resuming access

Loss of grazing land associated with even minor landslides

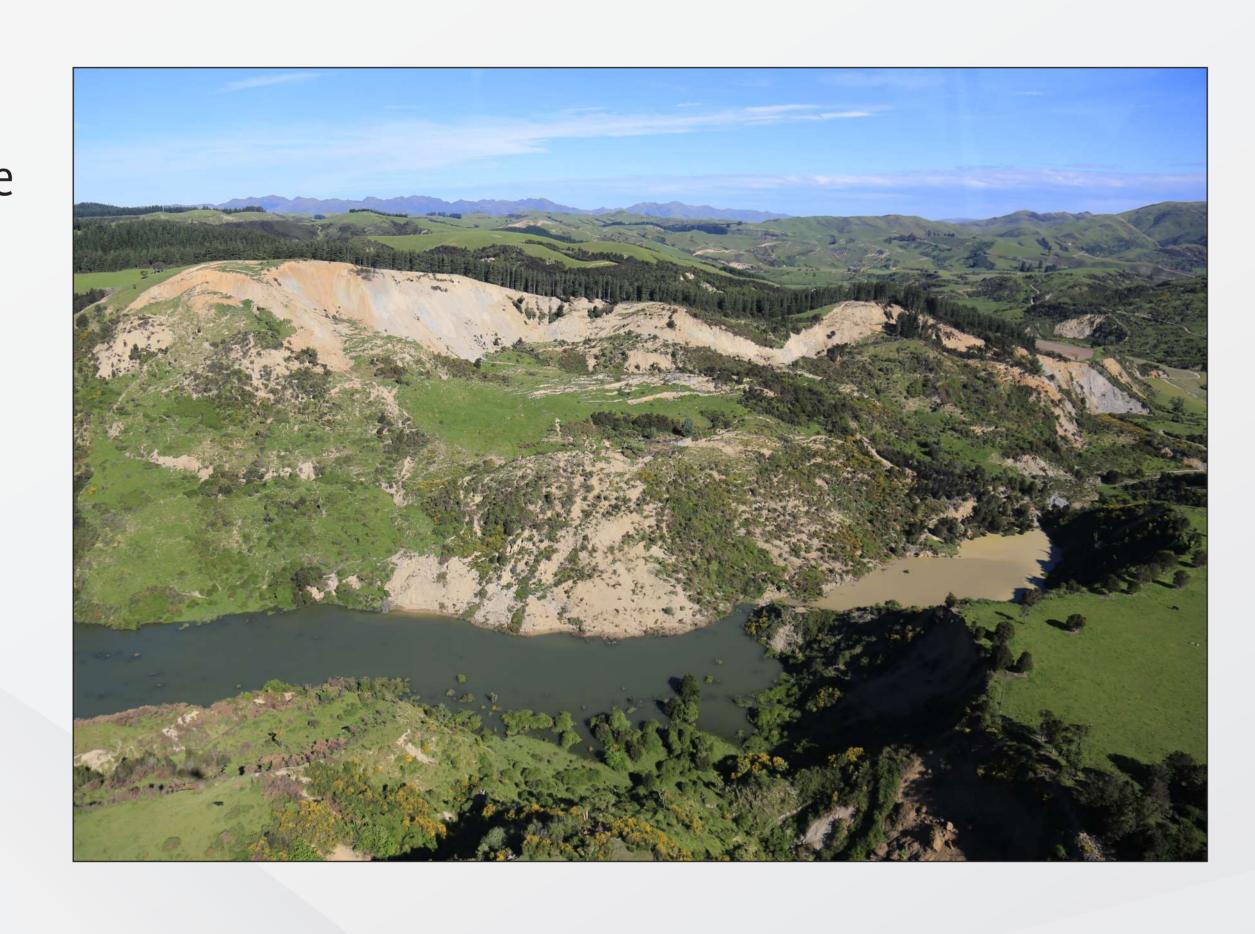
- Large (~3 million m³) landslide on the Stanton River
- River is dammed in two places
- Erosion is visible at the lower right of the upper dam
- Some land flooded upstream of upper dam, encroaching on a hut

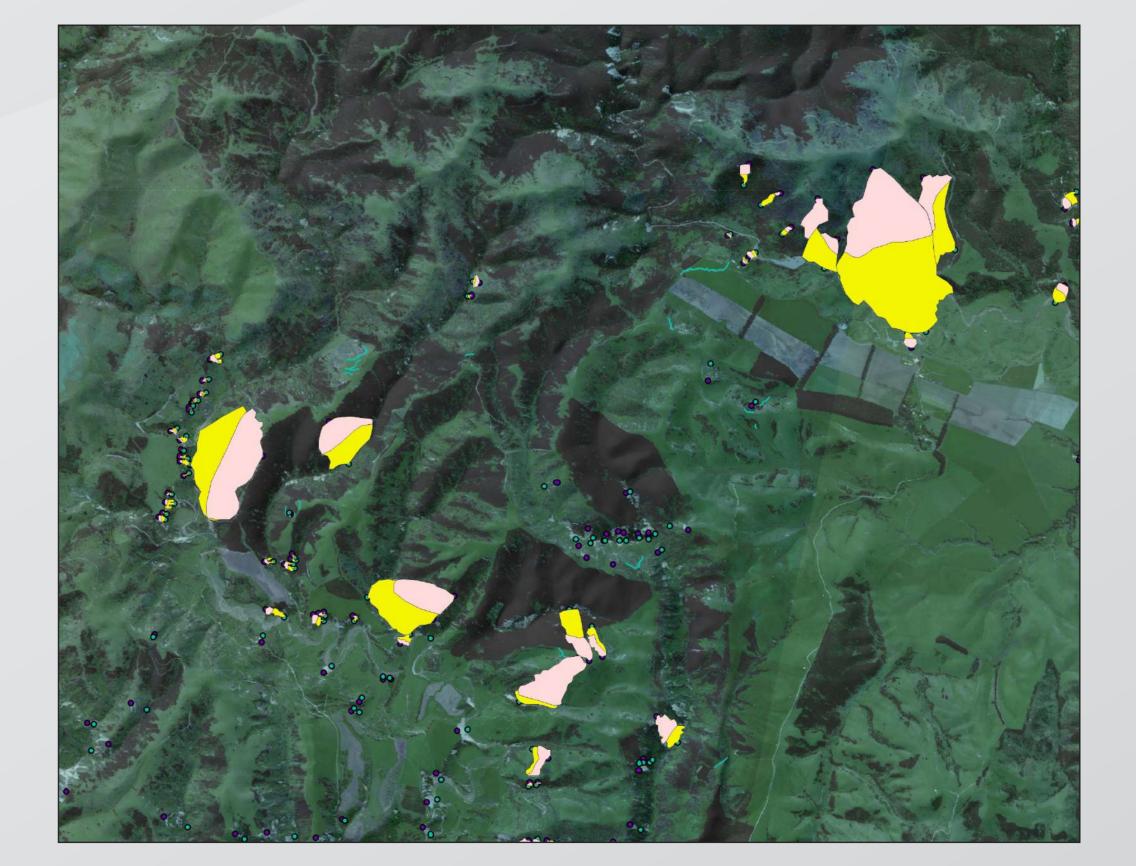
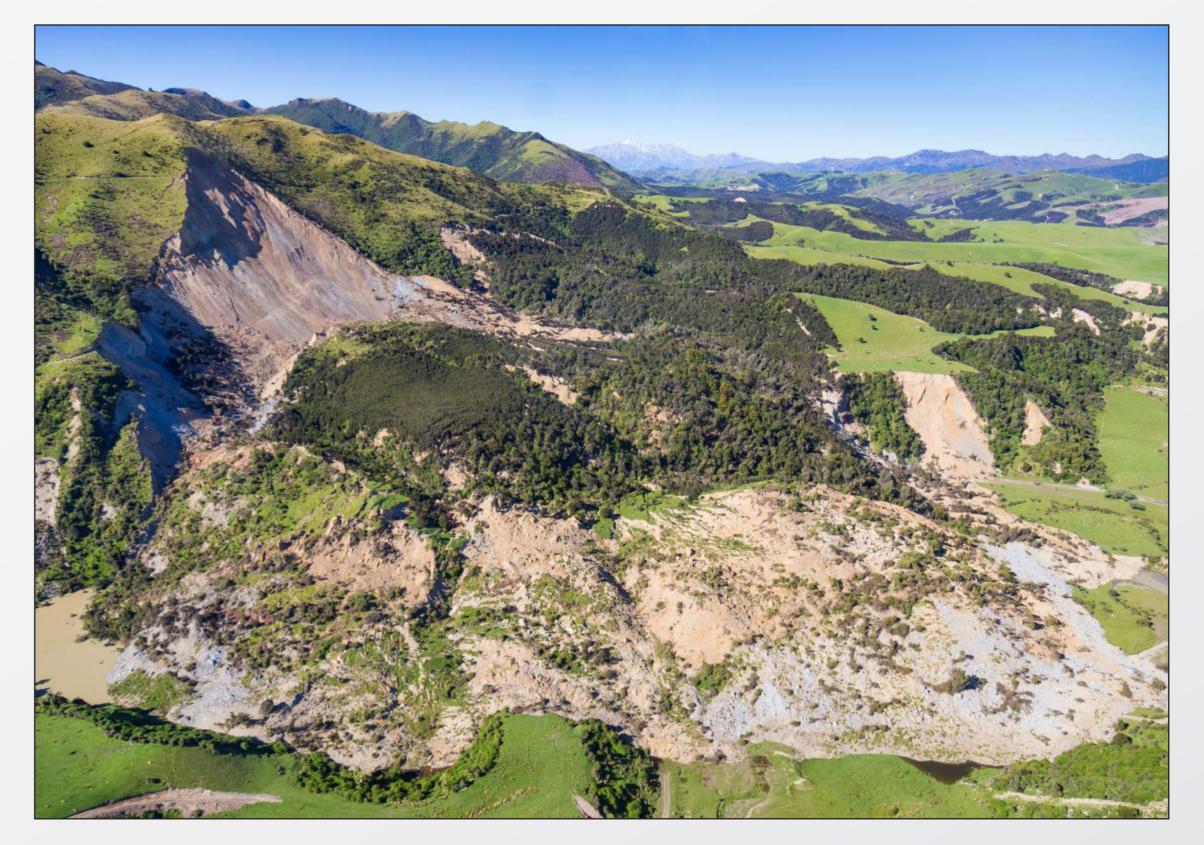
Summary

Landslide mapping based on satellite, LIDAR and air photo imagery up to 18th February 2017. Individual landslides mapped by a group of a dozen researchers. Compiled into a large database available for use by the public, government and researchers.

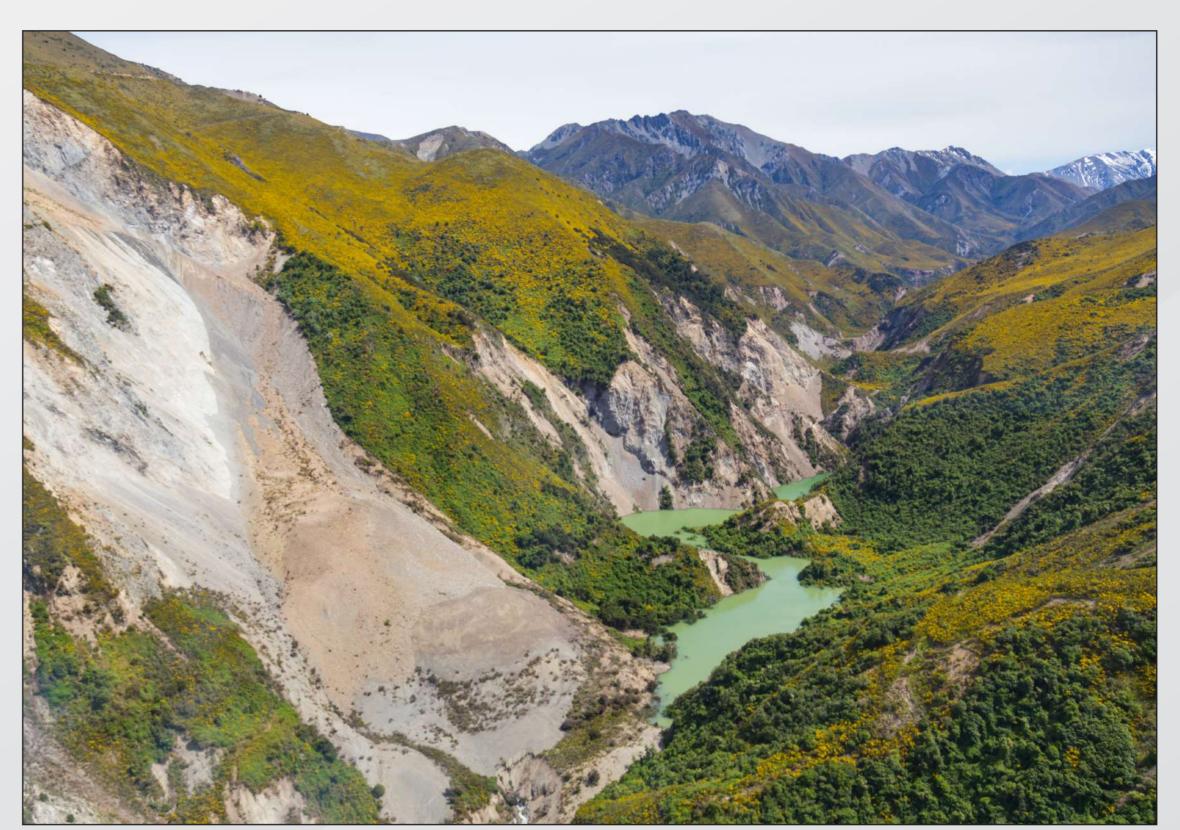
Large (~4 million m³) landslide damming the Leader River northeast of Waiau

Rapid failure of dams poses a hazard to downstream communities
Overtopping began 31st January
Dam breached on 14th February

Downstream aggradation of sediment and loss of farm infrastructure

Lake Rebecca level has dropped 3 m
