Improving the Resistance of Structures to Earthquakes

Hopkins Lecture - 16 August 2000

ABSTRACT

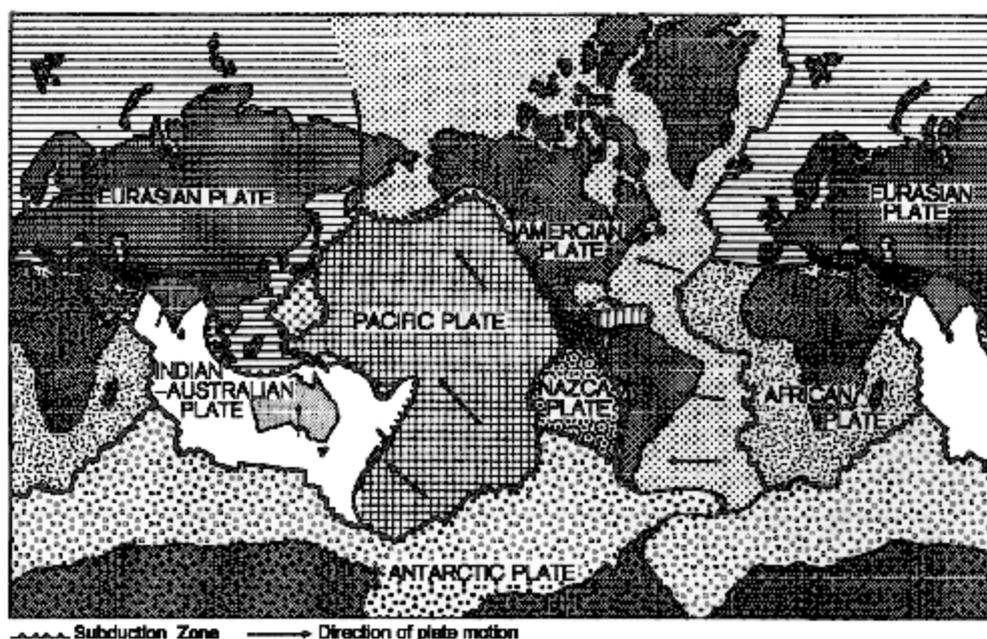
Fig. 1 Coastal Plate Boundaries of the Earth [1]

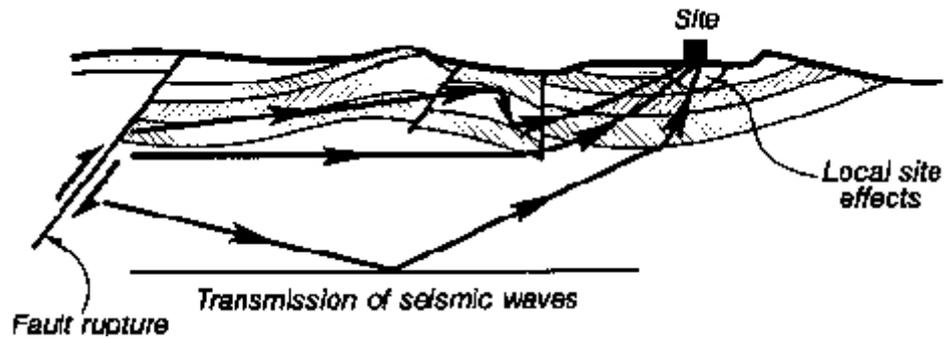
Fig. 2 Transmission of Seismic Waves from the Focus of an Earthquake to a Site

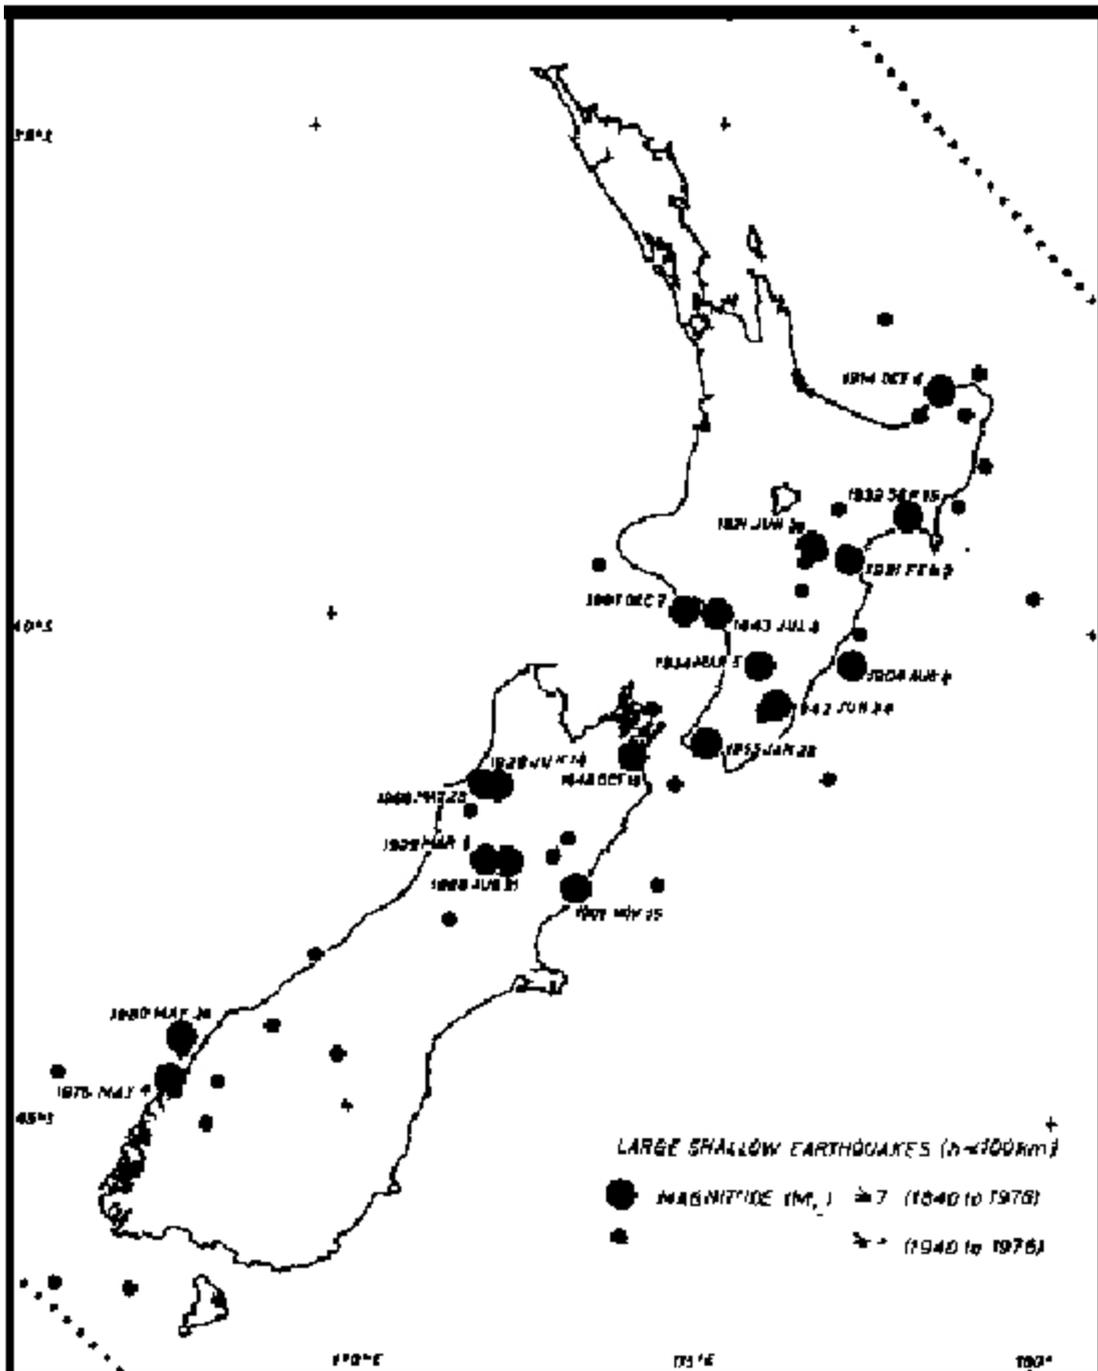
Fig. 3 Large Shallow Earthquakes Which Have Occurred in New Zealand During 1840-1976 [2]

New Zealand was subjected to a number of major earthquakes in the early years of European settlement, as is evident from Fig. 3 and Table 2. Fig. 5 shows some typical damage to buildings in Wellington as a result of the 1848 Marlborough earthquake which had a Richter magnitude of 7.1. These early warnings that special building precautions were needed for earthquake resistance went largely unheeded by settlers who had come from non-earthquake countries and had brought traditional European building procedures with them.

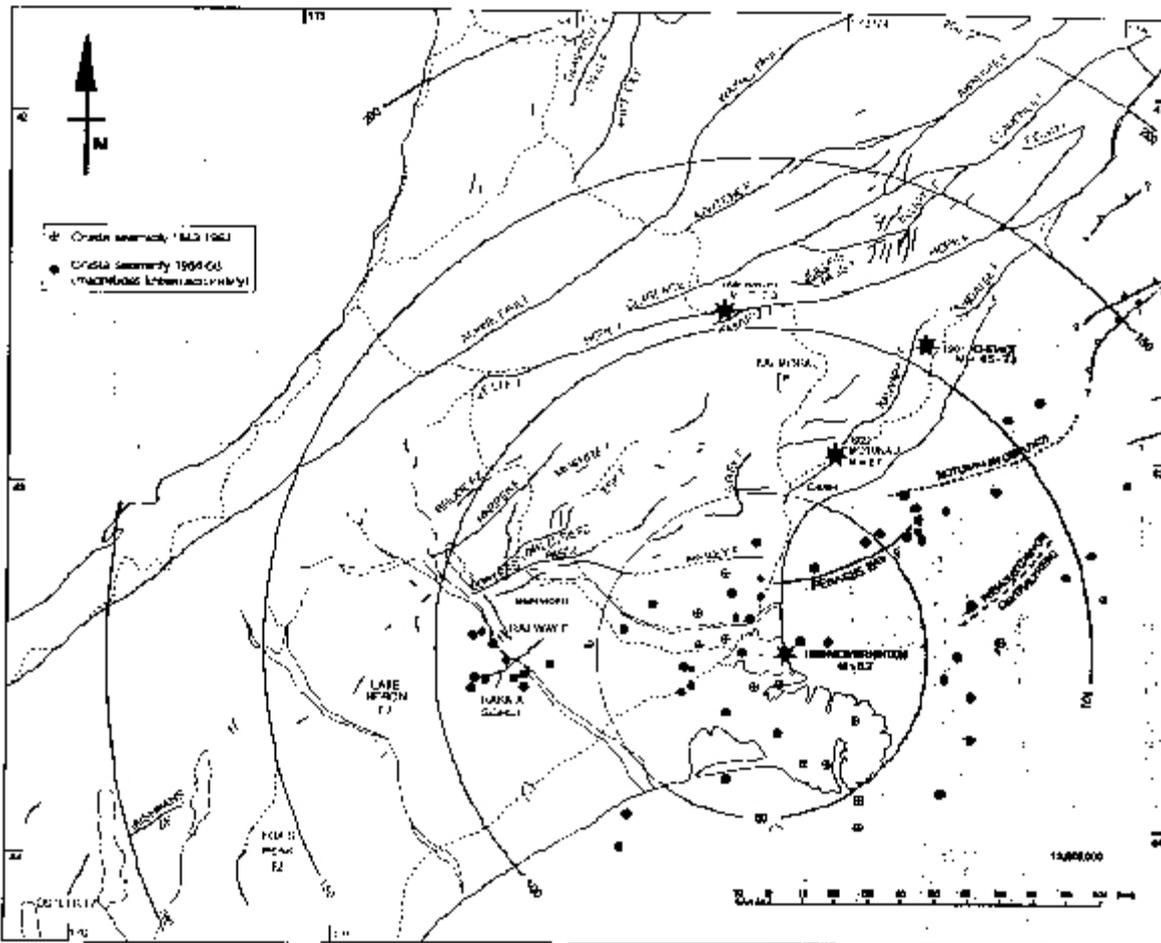
Fig. 4 Active Faults Within 200 kms of Christchurch[5]

Known active faults in Canterbury are shown in Fig. 4. The Christchurch Engineering Lifelines Group in 1997[5] after a study of the information on the seismicity of Christchurch, mainly by Elder et al[6], concluded that a major earthquake with a felt intensity of VIII to IX (causing considerable damage to ordinary buildings) could be expected for Christchurch with a return period of about 150 years. Such shaking would most likely be caused by a moderately-large to large earthquake in the Canterbury foothills or North Canterbury. A very large earthquake on the Alpine fault would also be likely to produce these shaking intensities or greater.

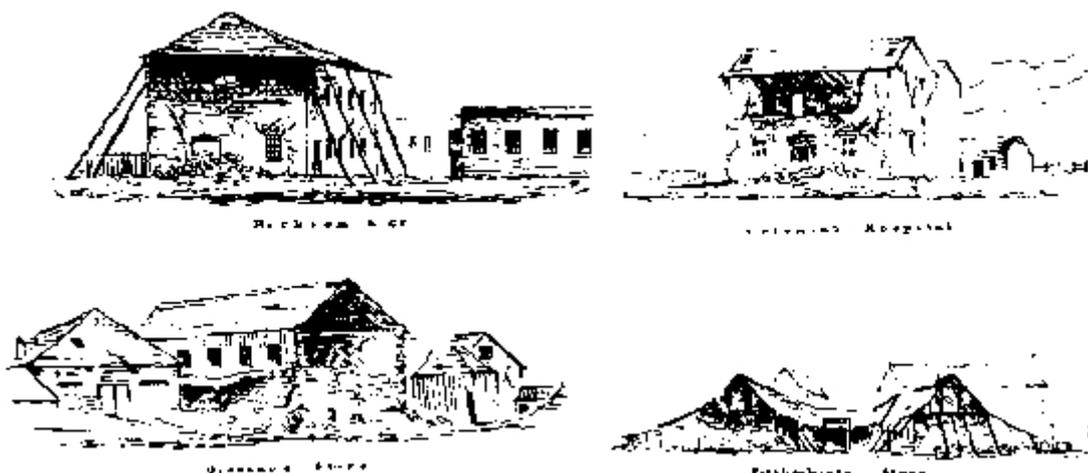
Fig. 5 Sketches of Some Damaged Buildings in Wellington as a Result of the 1848 Marlborough Earthquake (Alexander Turnbull Library, Wellington)

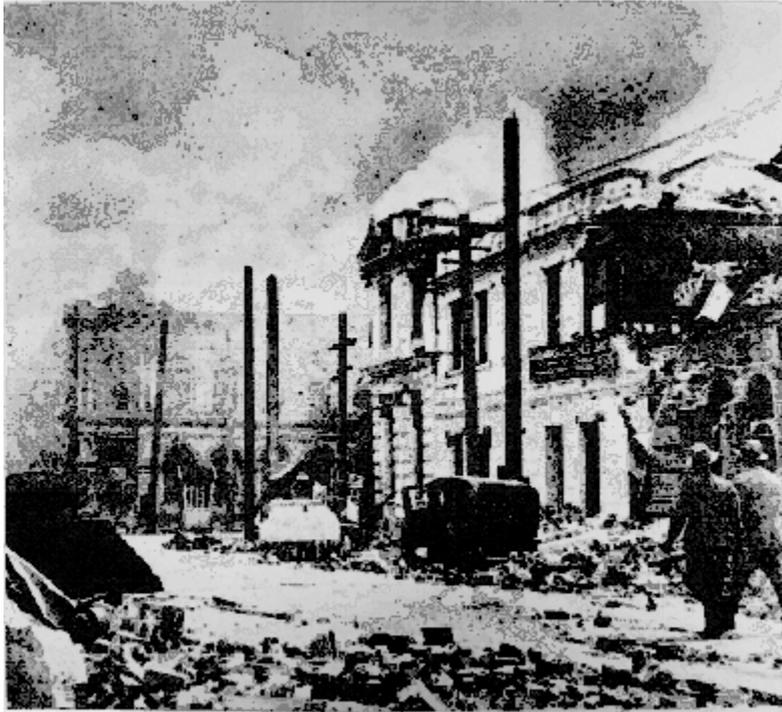
Fig. 6 Damage at Napier as a Result of the 1931 Hawke's Bay Earthquake (Alexander Turnbull Library, Wellington)

The 1931 Hawke's Bay earthquake caused extensive damage to buildings. Fire followed the earthquake rapidly, completing the devastation caused by the earthquake. Figs 6 and 7 show close-up views of some of the business centres of Napier after the earthquake and fire and give an impression of the resulting devastation. Whereas load bearing masonry structures performed badly in the Hawke's Bay earthquake, buildings with reinforced concrete frames on the whole suffered very little structural damage and withstood the earthquake with remarkable success. In New Zealand this led to a shift in emphasis of building type from load bearing brick to framed buildings.

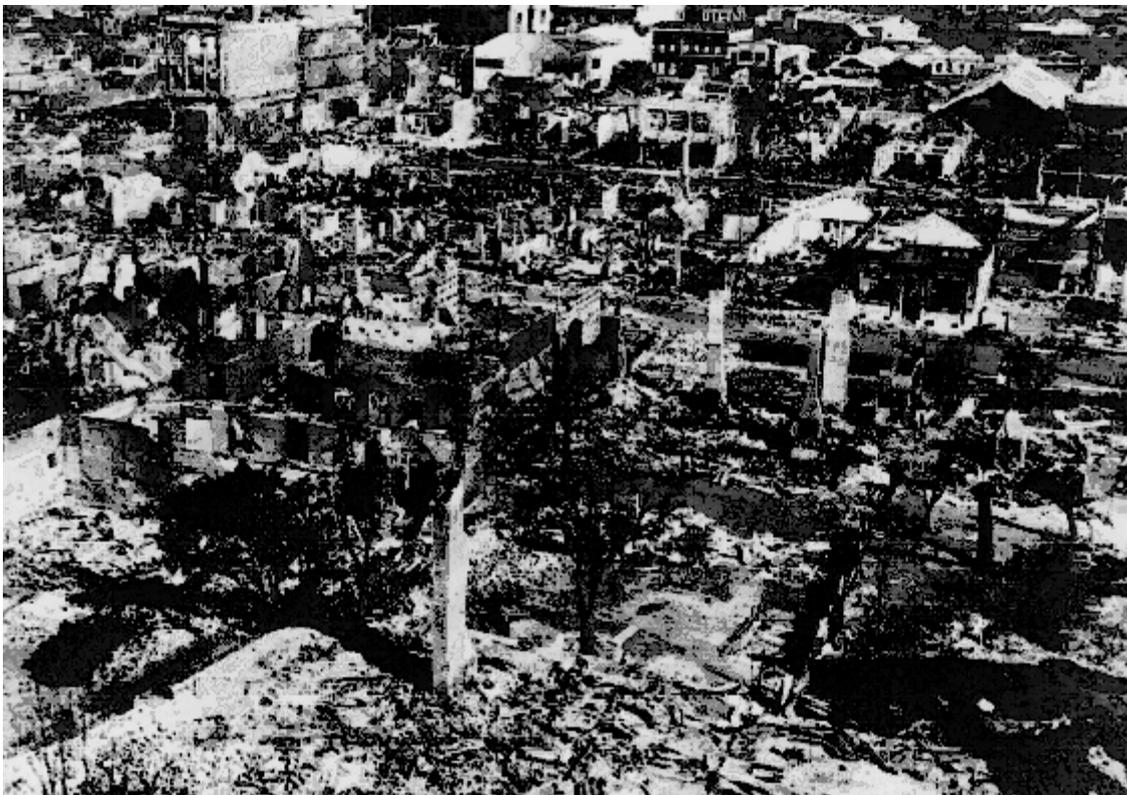
Fig. 7 Damage at Napier as a Result of the 1931 Hawke's Bay Earthquake (Alexander Turnbull Library, Wellington)

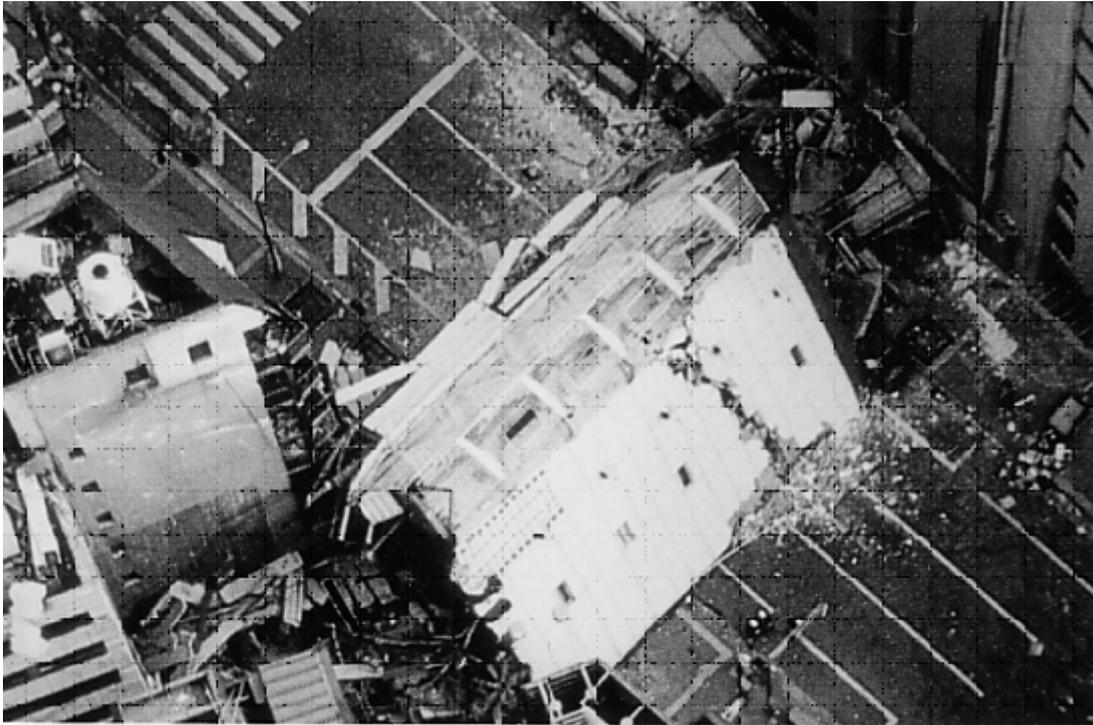
Fig. 8 Overturned Building Lying Across a Street (Kobe, 1995)

Tilting of buildings, and even overturning (see Fig. 8), occurred in some cases in the most devastated areas of the city. The columns of the overturned buildings parted from their foundations.

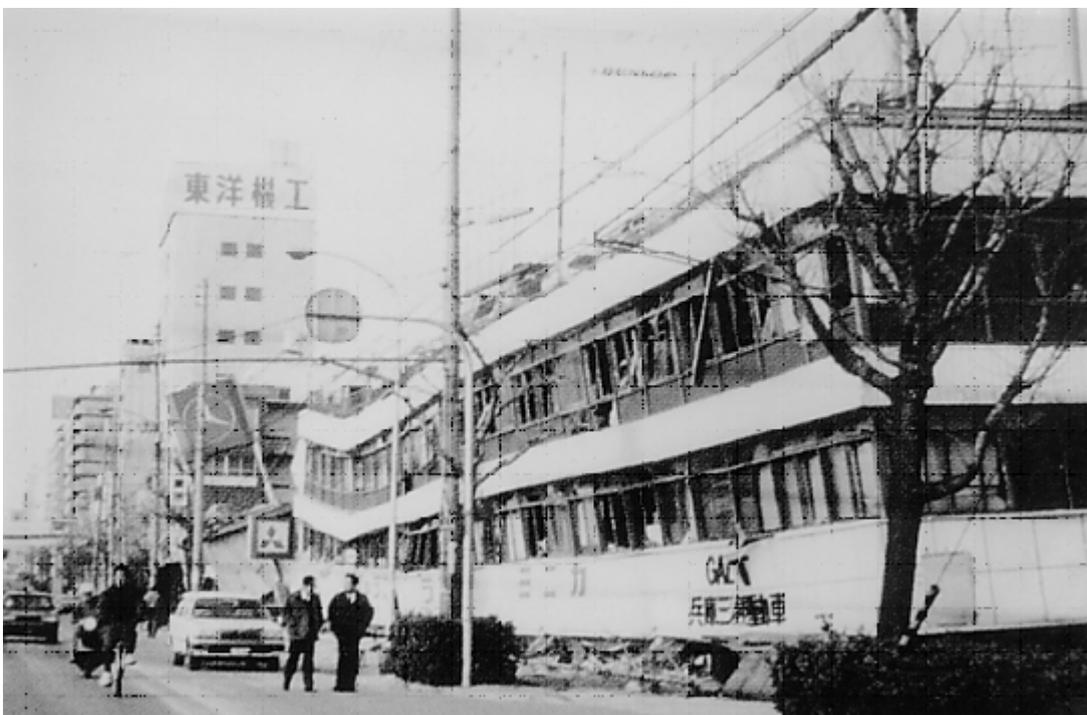
Fig. 9 Soft Storey Collapse of the First Storey of a Departmental Store (Kobe, 1995)

The predominant mode of collapse of pre-1981 buildings was of the soft storey type due to failure of the columns of one storey. Many soft storey collapses were due to failure of the first storey columns (for example, see Fig. 9). These failures occurred due to strong beam-weak column behaviour of moment resisting frames,

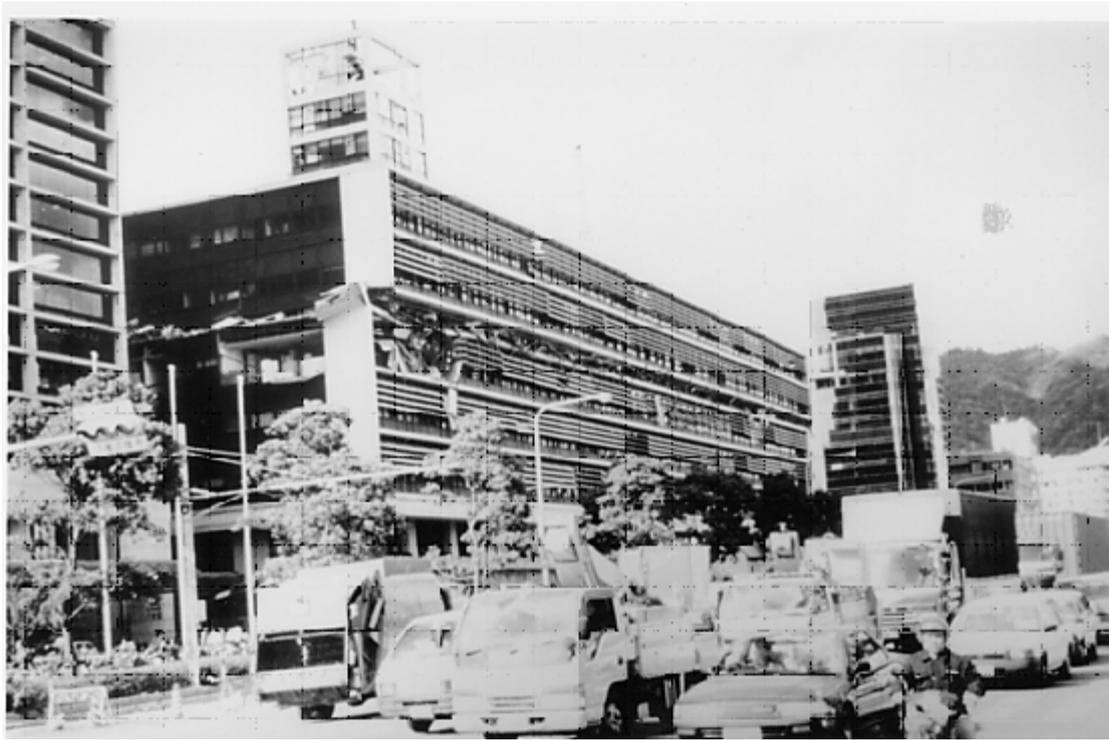
Fig. 10 Soft Storey Collapse of an Intermediate Storey of a Municipal Building, (Kobe, 1995)

However, many soft storey collapses also occurred due to the failure of columns in an intermediate storey up the height of the building (see Fig. 10). A particularly tragic example was the Municipal Hospital in the west of Kobe which had a soft storey failure in the 5th storey and 49 people were killed in that storey.

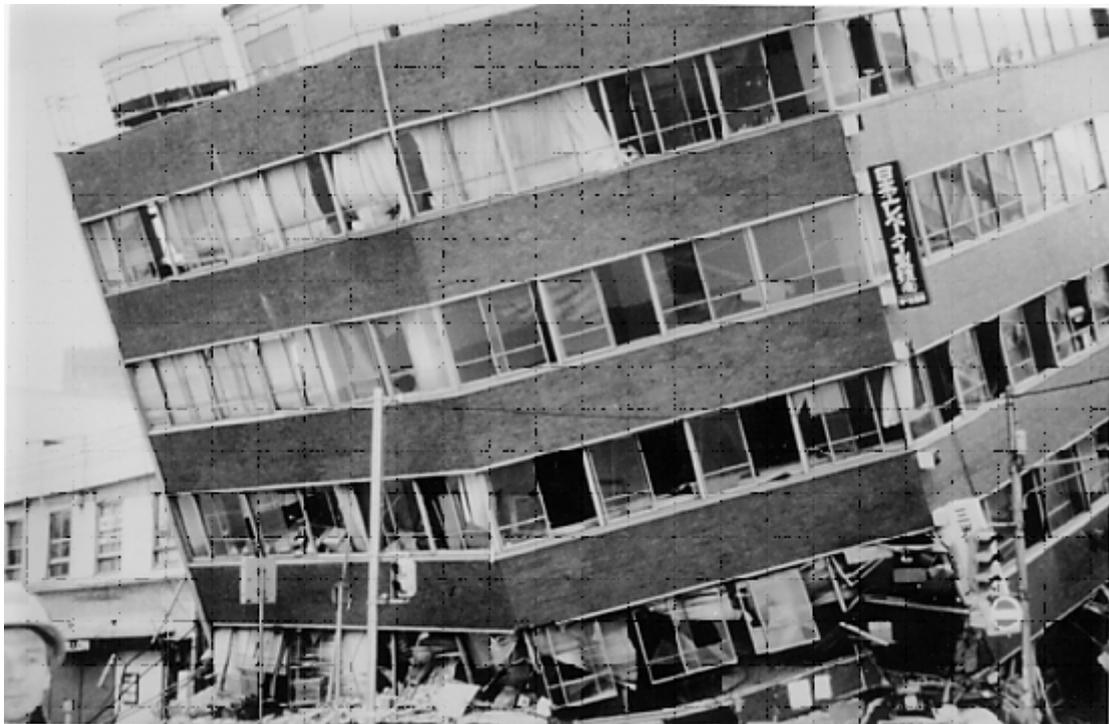
Fig. 11 Collapse of a Building With an Unsymmetrical Structural Configuration (Kobe, 1995)

Other general types of failure observed were due to torsion (twisting) of structures on street corners which were unsymmetrical in structural plan, such as due to walls only along two adjacent sides of the building (see Fig. 11) and pounding of adjacent structures of different stiffnesses.

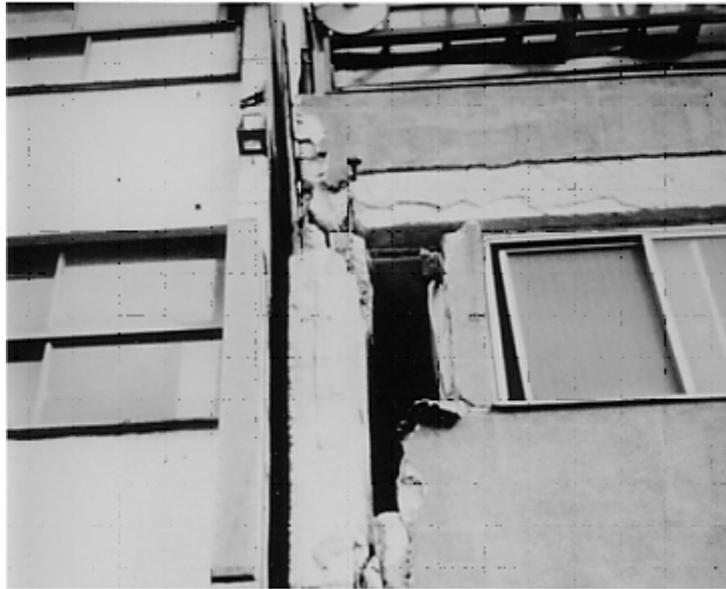
Fig. 12 Failure of Reinforced Concrete Beam-Column Connection Regions (Kobe, 1995)

For reinforced concrete structures the particular problems for structural elements and connections were due to poor detailing of reinforcement leading to shear failures, brittle compression failures of concrete, buckling of compressed longitudinal reinforcement, and anchorage failure in columns and beam-column connections (see Fig. 12).

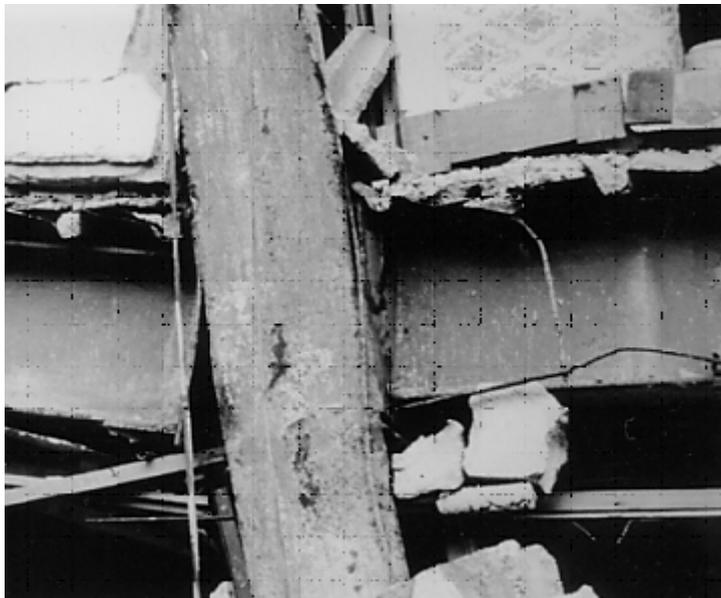
Fig. 13 Failure of a Structural Steel Beam-Column Connection Region (Kobe, 1995)

For structural steel the particular problems for elements and connections were due to inadequate welding leading to fracture of the welds, fracture of brittle steel members, buckling of compression members, and inadequate provision of a load path through beam-column connections (see Fig. 13).

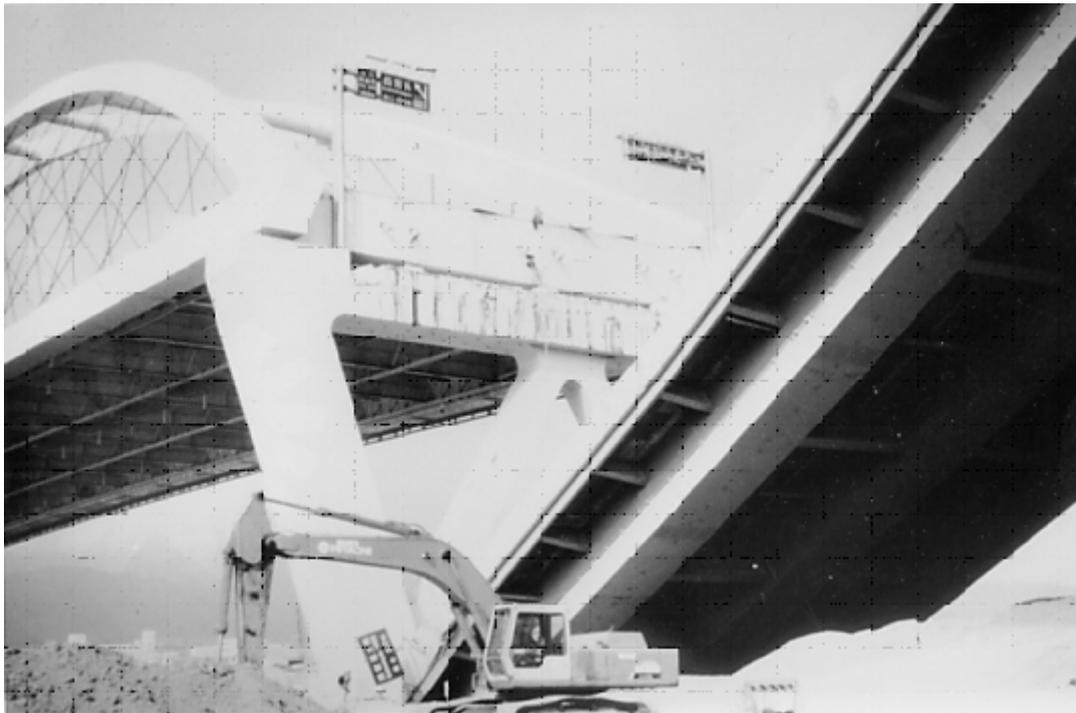
Fig. 14 Loss of Approach Span of the Nishinomiya-ko Bridge (Kobe, 1995)

Major revisions were made to the Japanese highway bridge design code in 1980. Elevated bridge structures designed to the 1980 bridge code generally performed well during the Kobe earthquake. Many elevated bridge structures designed prior to the 1980 code performed badly. For example, major damage occurred to bridge bearings, seismic restrainers and road joints. Some spans fell due to liquefaction causing lateral spreading of piers located adjacent to waterways (see Fig. 14). Bridge piers were often heavily damaged and collapsed in a number of regions of the city (see Fig. 15). Tilting of some piers occurred due to movement of the foundation.

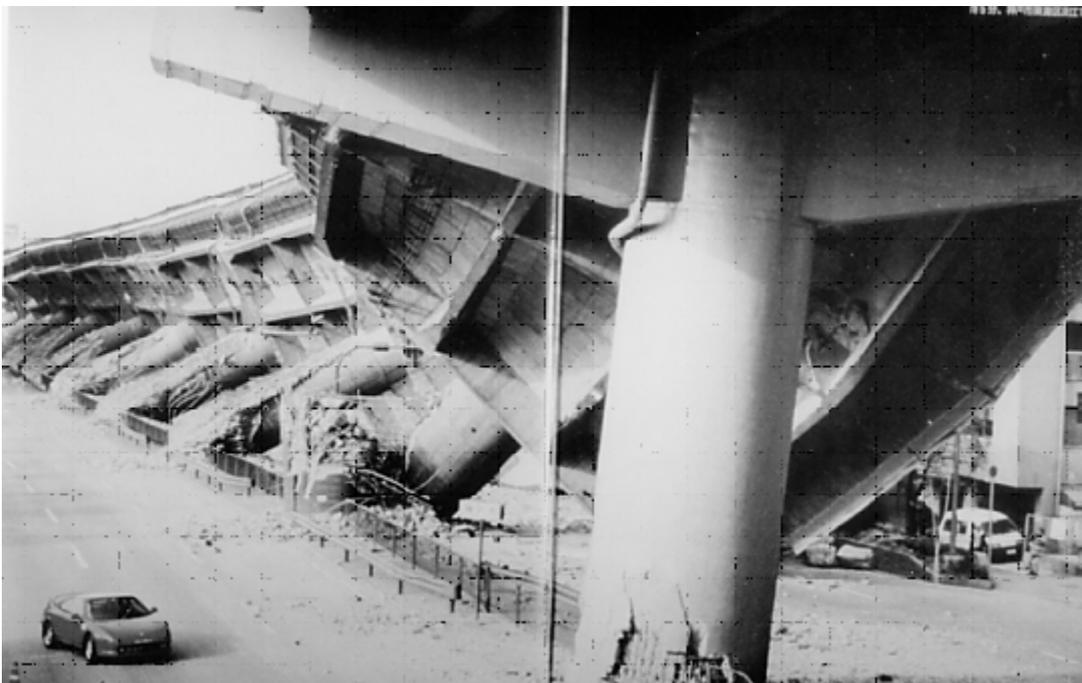
Fig. 15 Failure of Columns of the Hanshin Expressway Near Ashiya (Kobe, 1995)

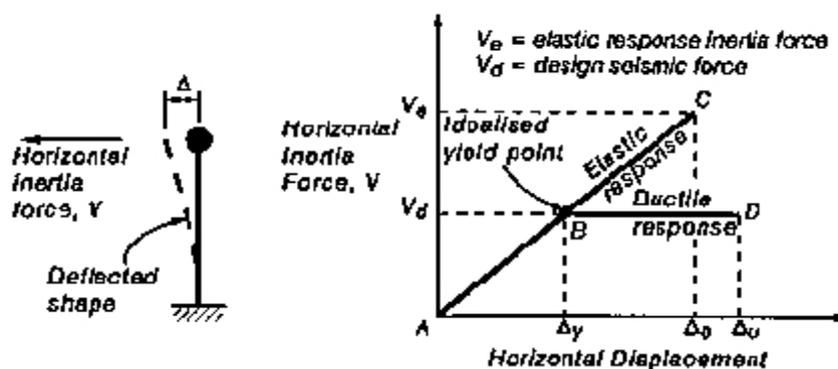
Fig. 16 Elastic and Ductile Response of a Simple Structure Responding to an Acceleration Pulse of a Severe Earthquake

Before the mid 1970s the seismic design procedures for structures in New Zealand, as in other countries of the world, were still their infancy. It was not realized that because the seismic forces used in design were generally much smaller than the seismic forces induced in an elastically responding structure during a severe earthquake, the structure needed to possess adequate ductility to survive the earthquake. Ductility here is defined as the ability to maintain force carrying capacity while being displaced into the post-elastic range. For example, Fig. 16 shows the elastic and ductile response of a simple structure. If the structure is able to resist the horizontal inertia force V_e corresponding to elastic response it will not need to enter the post-elastic range. However, this force V_e in New Zealand can be as high as $1.0g$. For many years a much smaller force V_d has been used in design (for example, $0.1g$ was recommended in the 1935 Standard Model Building By-Law). In order to survive the earthquake without collapse, when a design force V_d which is less than V_e is used, the structure must be able to yield in the post-elastic range in a ductile manner to horizontal displacement Δ_u .

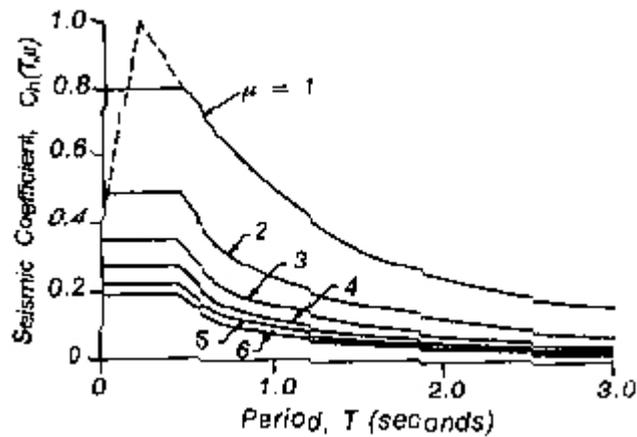
Fig. 17 Seismic Hazard Acceleration Response Spectra for Intermediate Soil Sites [9]

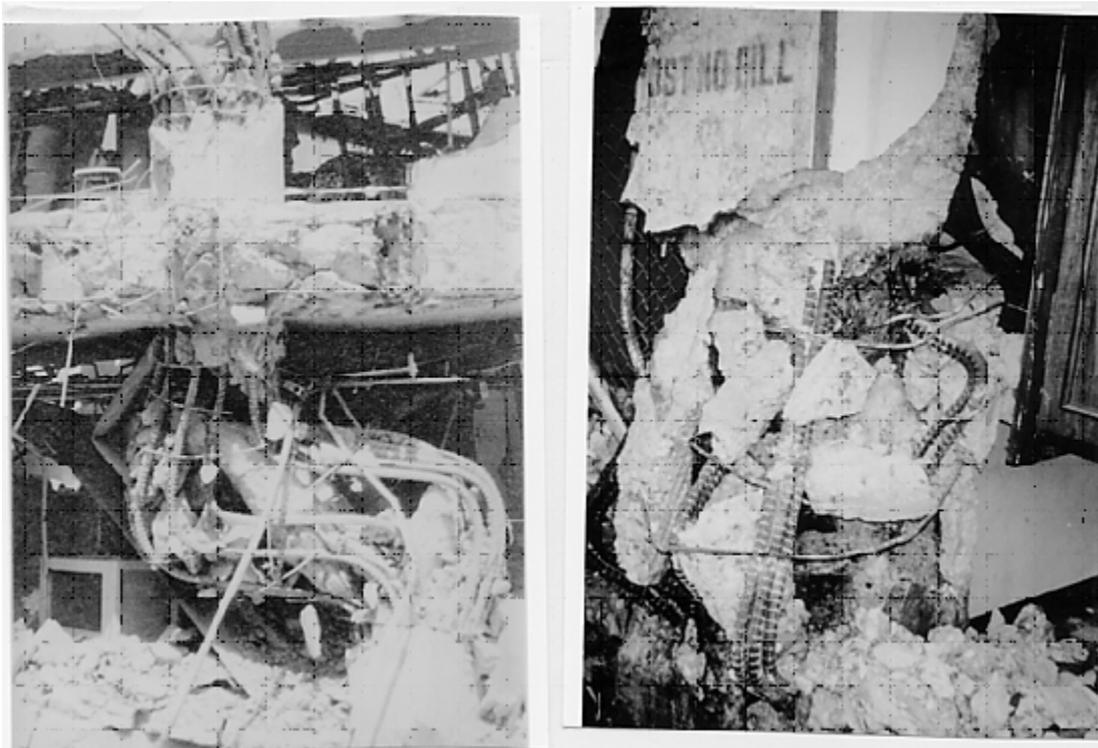
Fig. 19 Examples of Brittle Behaviour of Reinforced Concrete Columns Due to Inadequate Transverse Reinforcement

A major step forward since the 1960s has also been the development of methods for detailing reinforced concrete elements and assemblages of members for adequate ductility [13,14,15,16,17,18]. Poor detailing which leads to brittle failures is to be avoided. Examples of poor detailing are inadequate anchorage of longitudinal reinforcement, inadequate anchorage of transverse reinforcement, and inadequate quantities of transverse reinforcement. Inadequate anchorage of longitudinal reinforcement will result in the yield strength of the reinforcement not being developed during the cyclic loading caused by earthquakes. Lap splices may fail if placed in potential plastic hinge regions. Transverse reinforcement will not be effective if not properly anchored and/or of insufficient quantity. End hooks should preferably be bent through at least 135° . 90° end hooks are definitely inadequate for perimeter hoops, since spalling of cover concrete will result in loss of anchorage. 90° end hooks could be tolerated in limited ductility design when used for interior legs of hoops or ties which pass through the core concrete and are bent around intermediate column bars. Anchorage failure and/or inadequate quantities of transverse reinforcement will result in a reduction in the flexural ductility of members due to lack of concrete confinement and a lack of restraint against buckling of longitudinal bars and/or shear failure due to lack of adequate shear reinforcement (see Fig. 19).

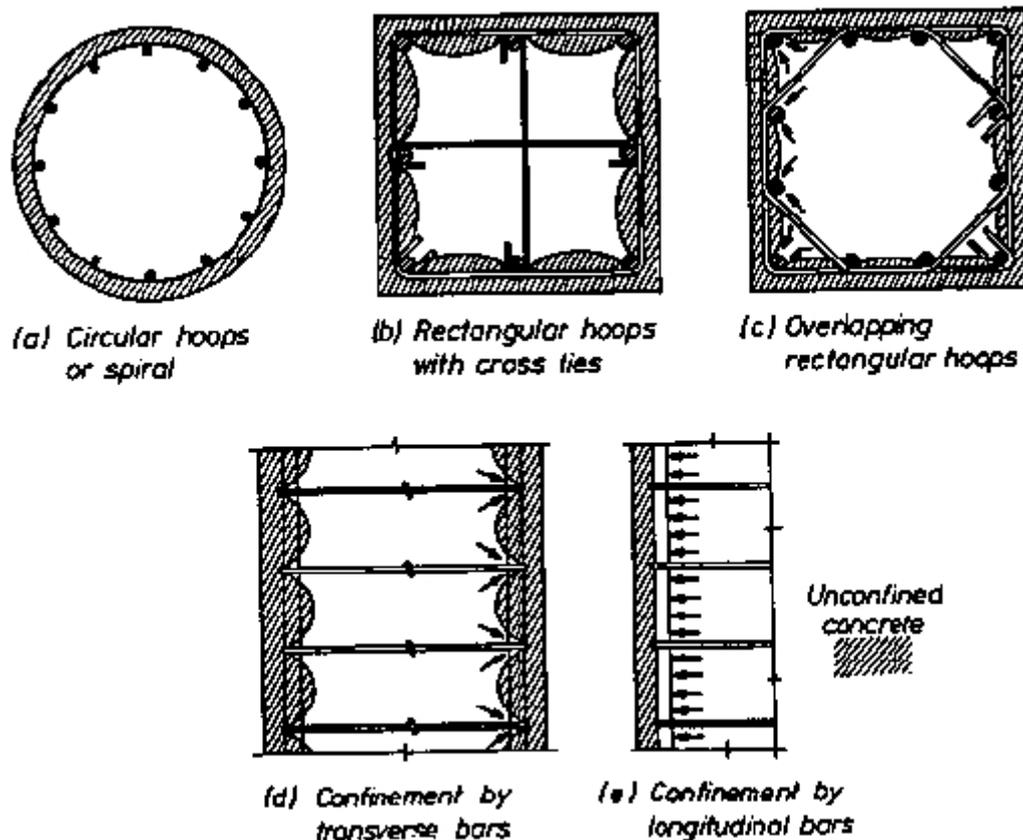
Fig. 20 Arrangements of Reinforcement Which Confine the Concrete and Prevent Premature Buckling of Longitudinal Reinforcement of Columns

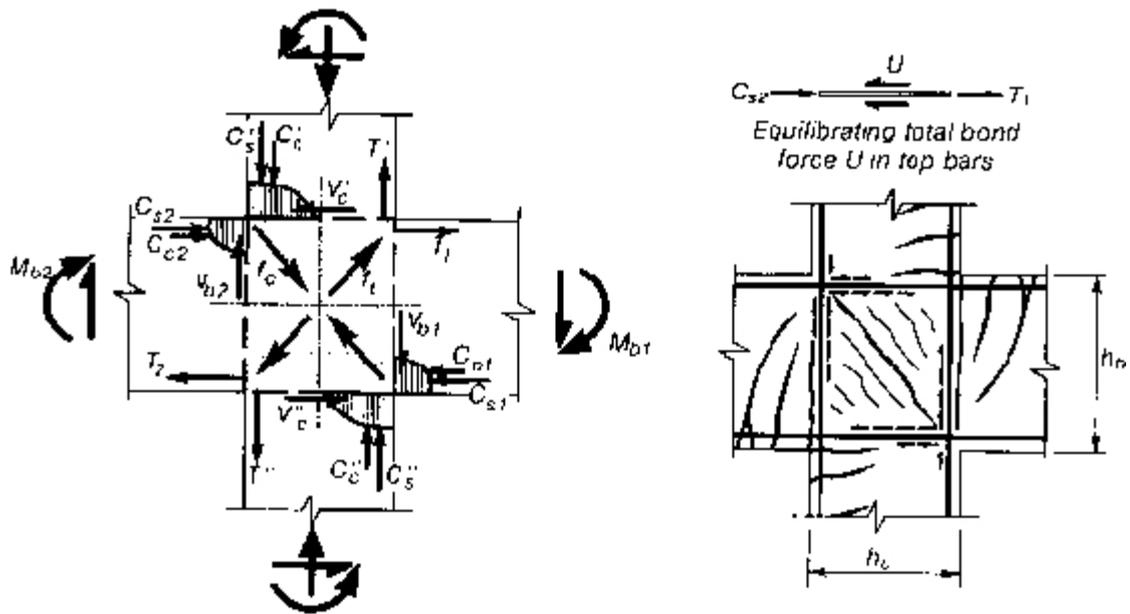
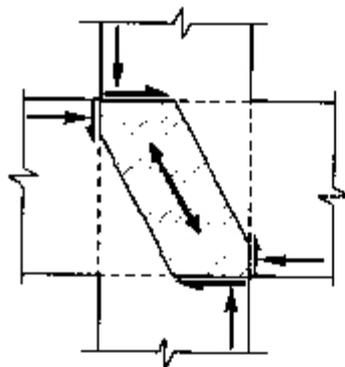
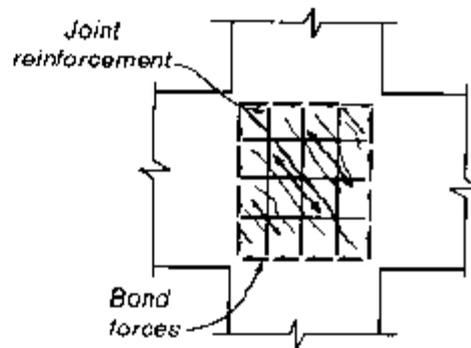
(a) Forces from beams and columns acting on the joint

(b) Crack pattern and bond forces after diagonal tension cracking initiates in joint core

(c) Concrete diagonal strut mechanism, equilibrating concrete compression forces in beams and columns and some bond forces in the compression zones

(d) Truss mechanism of concrete diagonal compression field and horizontal and vertical reinforcement needed for equilibrium after diagonal tension cracking

Fig. 21 Forces Acting on an Interior Beam-Column Joint During an Earthquake and the Resulting Cracking and Mechanisms of Force Transfer

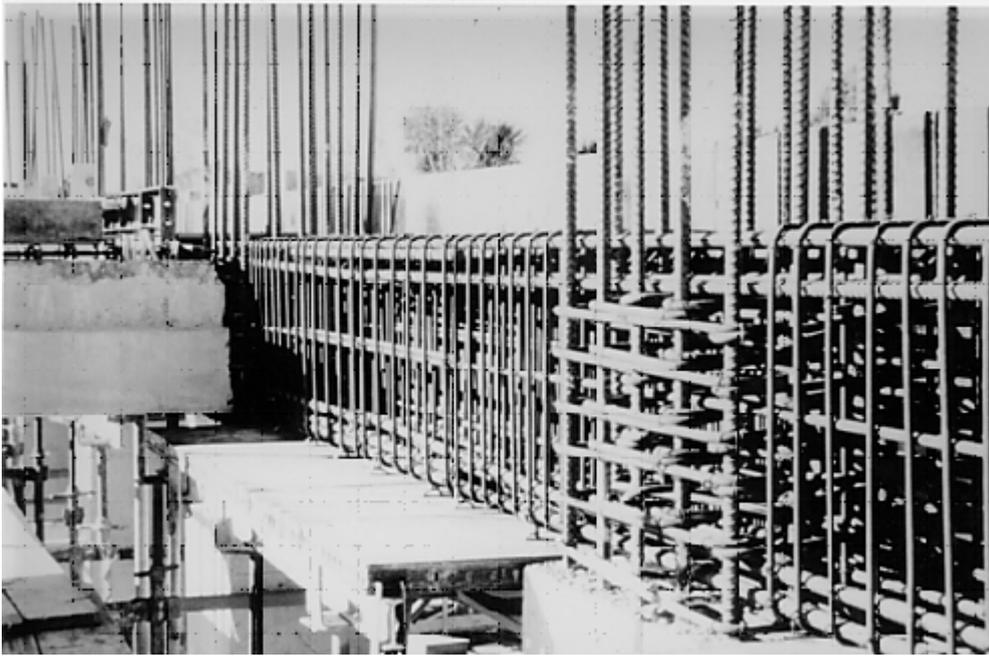
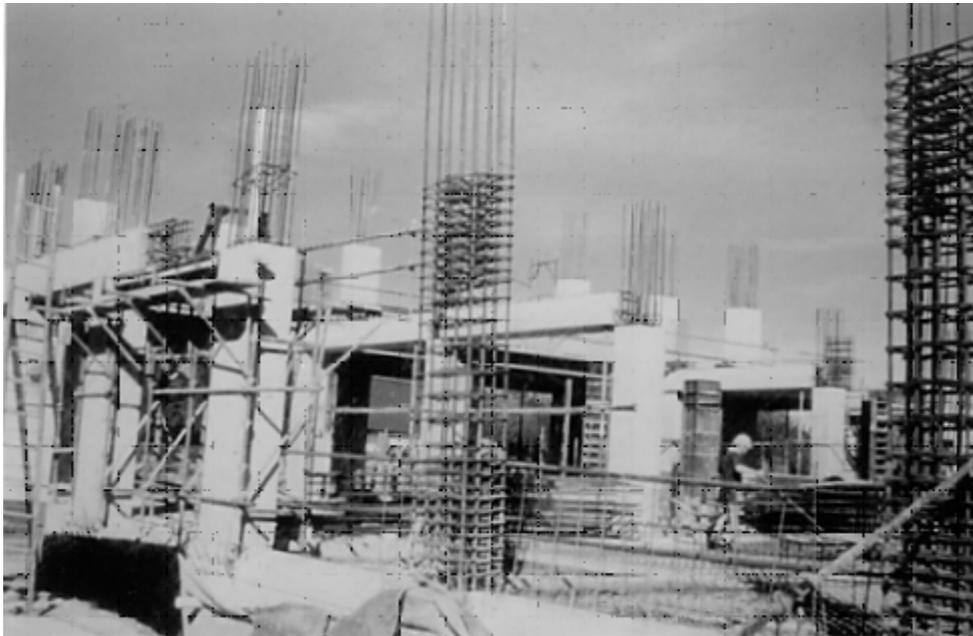
(a) Beam

(b) Beam-Column Joint

(c) Columns

Fig. 22 Typical Reinforcement for Ductile Moment Resisting Frames in New Zealand

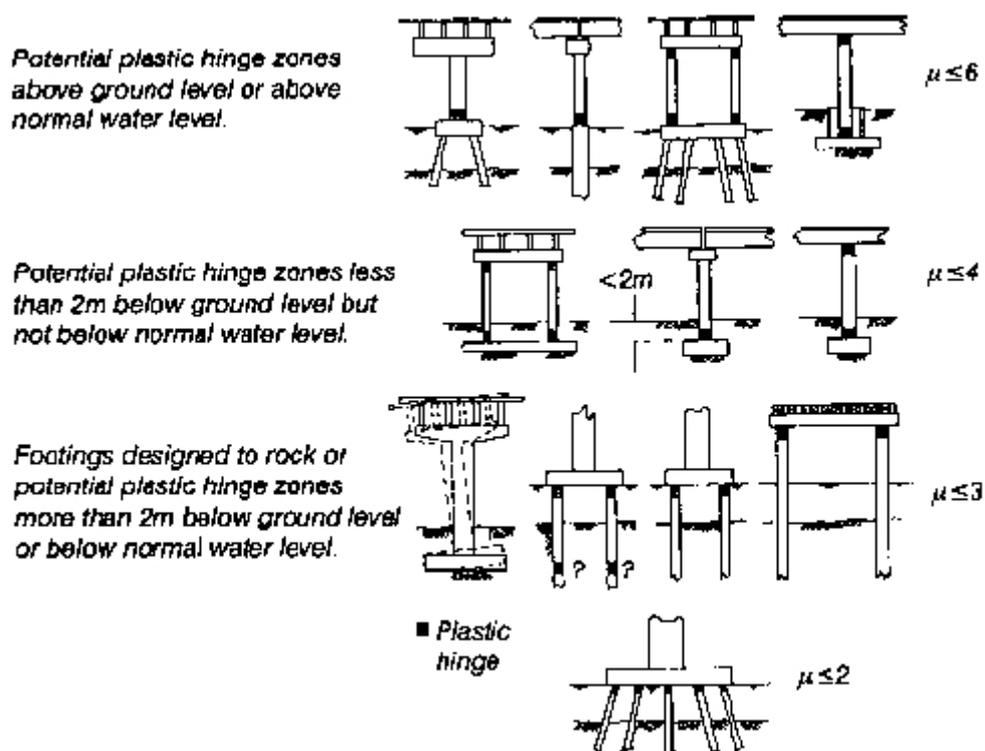
Fig. 23 Examples of Maximum Values of the Displacement Ductility Factor μ Permitted by the Bridge Manual of Transit New Zealand [20]

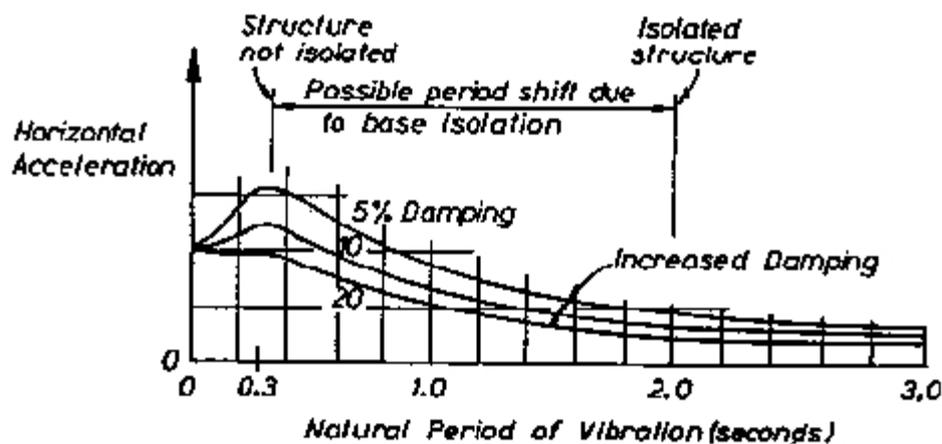
Fig. 24 Typical Design Elastic Response Spectra Illustrating Effect of Increased Period of Vibration and Damping

For example, Fig. 24 shows a typical elastic response spectra for horizontal acceleration used in seismic design. If the natural period of vibration of the structure is increased from 0.3 seconds to about 2.0 seconds, the horizontal acceleration is reduced by about 70%. Increasing the damping further reduces the acceleration.

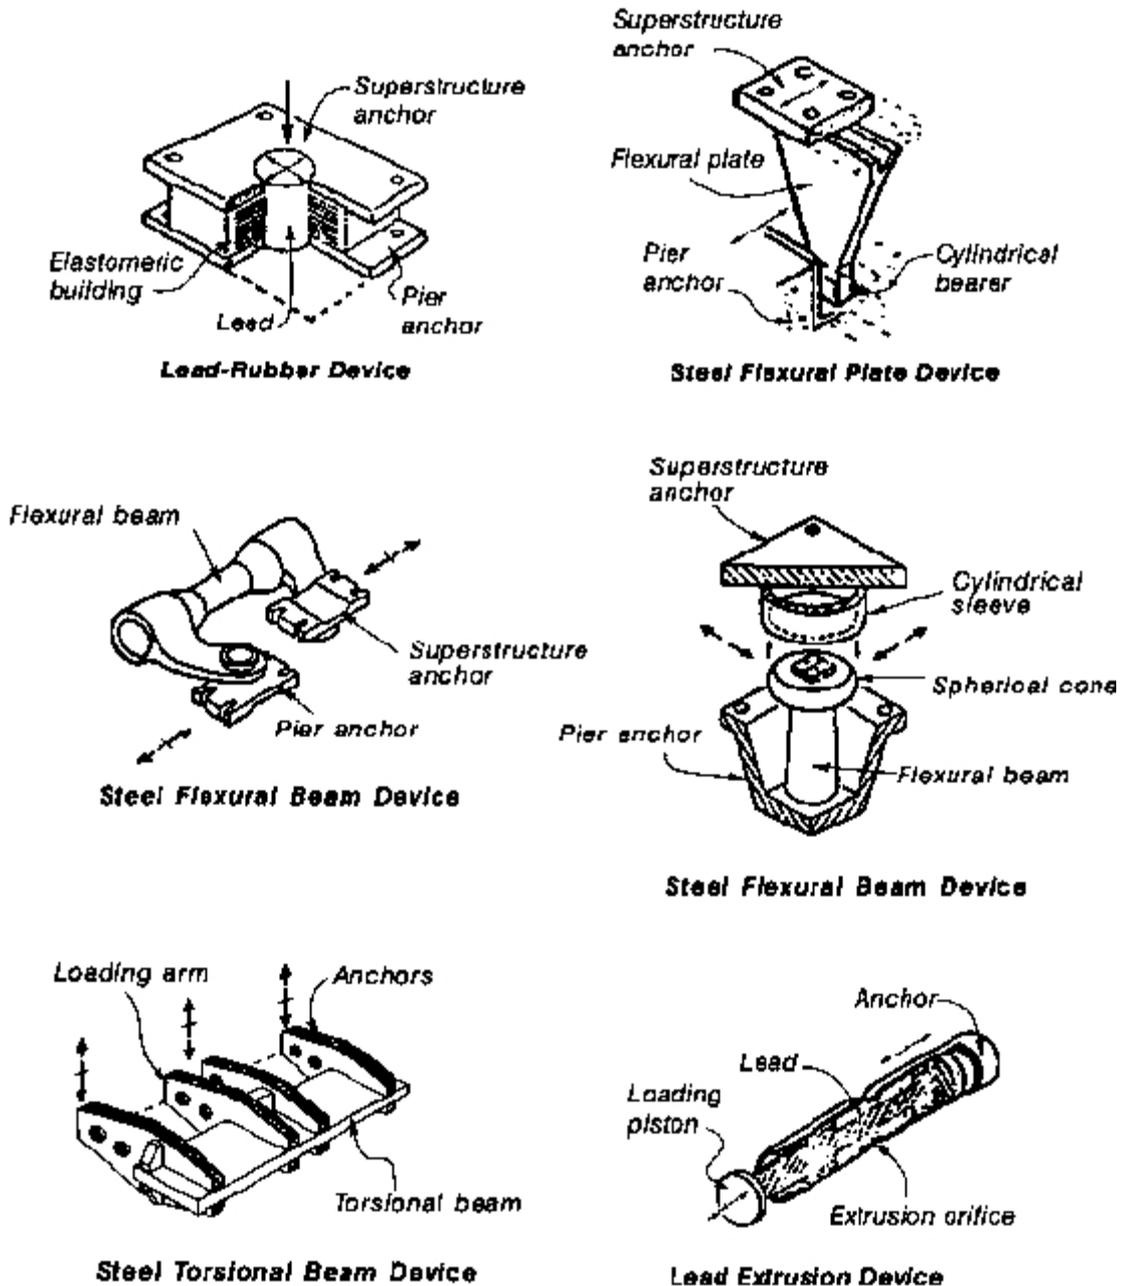
Fig. 25 Mechanical Energy Dissipating Devices[22]

and Industrial Research, New Zealand[22,23]. These energy dissipation devices may take the form of steel elements which bend or twist, lead extrusion or lead shear devices. Fig. 25 shows a range of possible energy dissipating devices which have been developed. Some of these devices are suitable for insertion between the foundations and the structure of buildings or the supporting structure and deck structure of bridges. The mechanical energy dissipating devices result in a decrease in the seismic forces in the structure during a severe earthquake and hence the strength and/or ductility requirements are reduced.

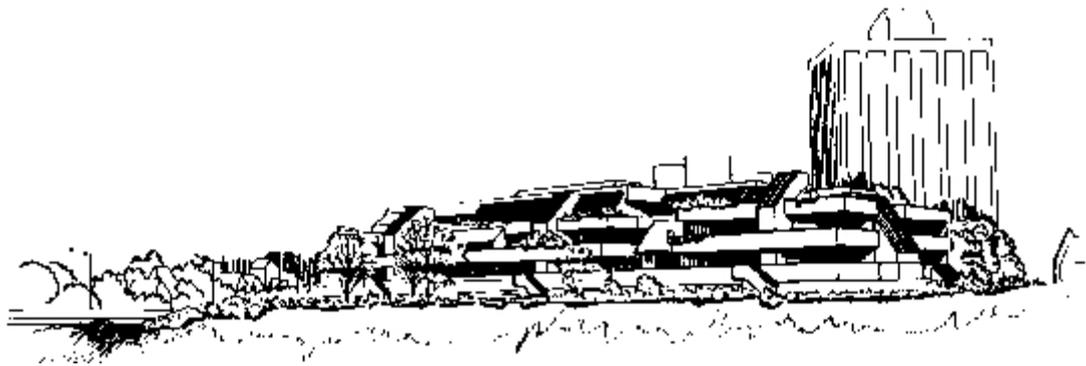
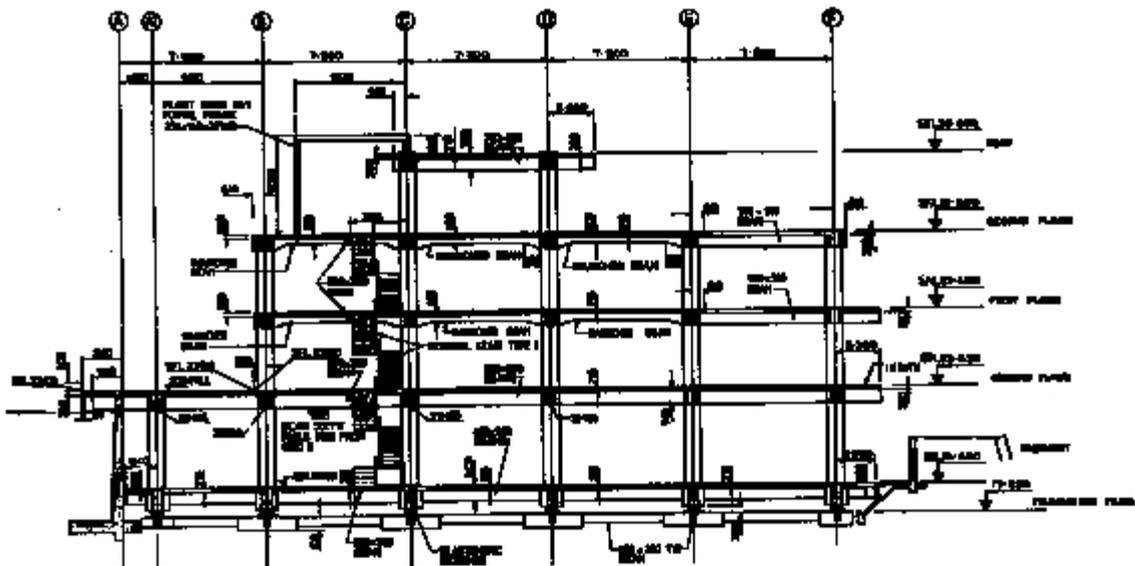
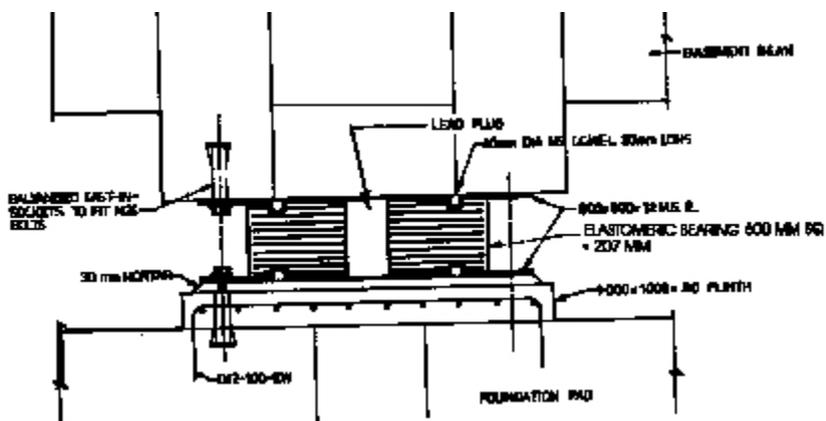
Fig. 26 William Clayton Building [24]

(a) Perspective of the Building

(b) Typical Elevation Through the Building

(c) Elevation Through Lead-Rubber Bearing
