Improving the Resistance of Structures to Earthquakes

Hopkins Lecture - 16 August 2000

ABSTRACT

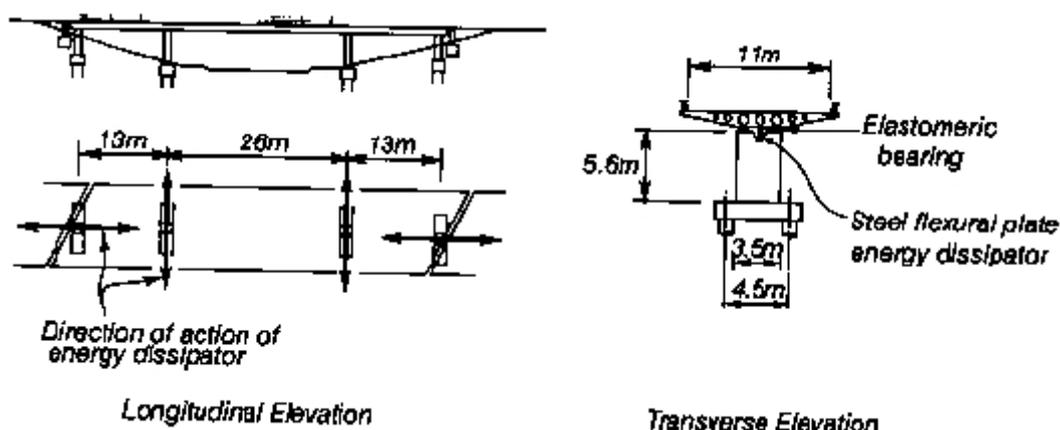
Fig. 28 A Typical Seismically Isolated Bridge in New Zealand

Up to 1995 a total of 50 road and rail bridges had been seismically isolated in New Zealand. The systems used were 40 bridges with lead-rubber bearings, 1 with lead-rubber bearings plus lead extrusion dampers, 2 with rubber bearings and lead extension dampers, and 7 with rubber bearings and flexural steel devices as dampers (see Fig. 28).

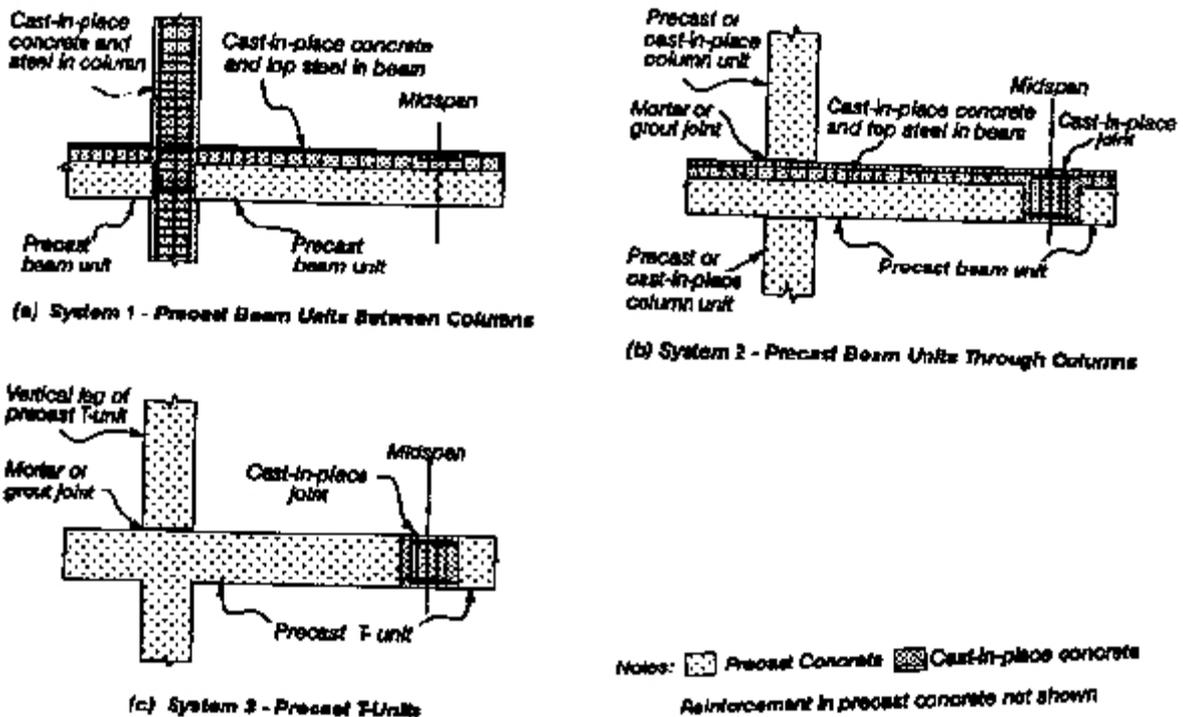
Fig. 29 Some Arrangements of Precast Concrete Members and Cast-in-Place Concrete Used in New Zealand for Constructing Reinforced Concrete Moment Resisting Frames[26,27]

frames, commonly used for strong column-weak beam designs in New Zealand, are shown in Fig. 29.

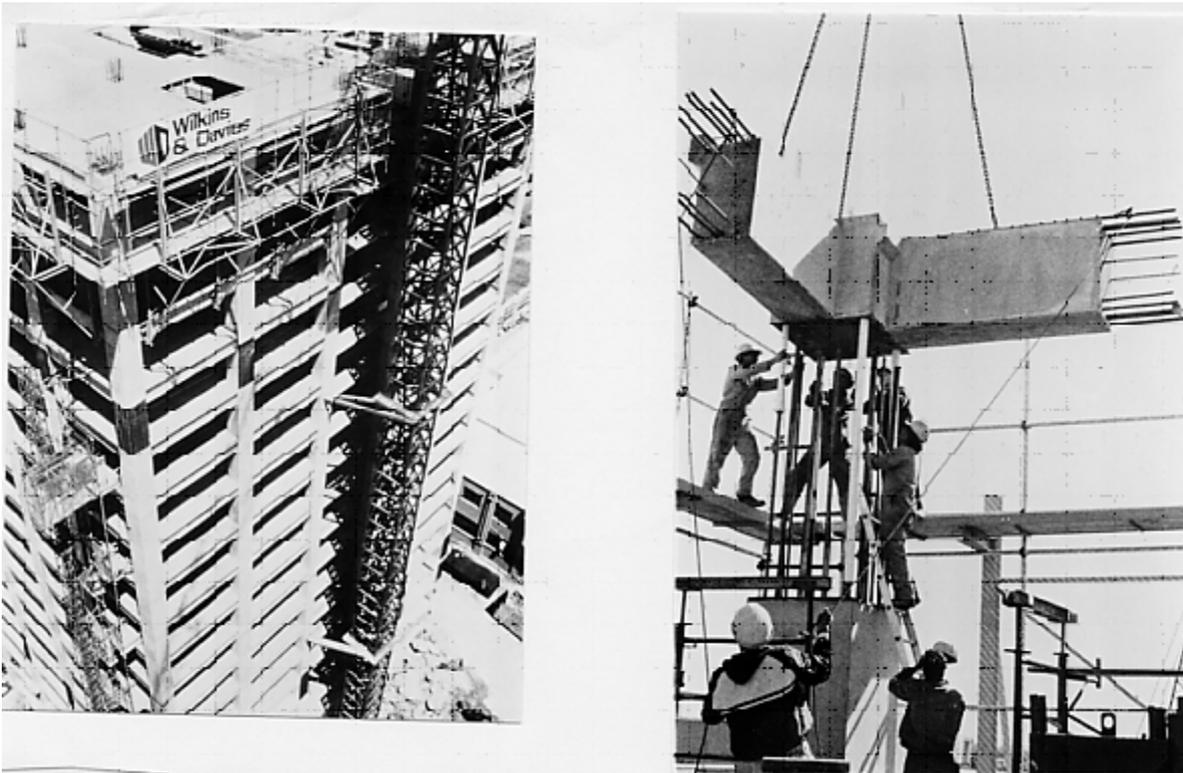
Fig. 30 Construction of the Price Waterhouse Building in Christchurch Using System 2

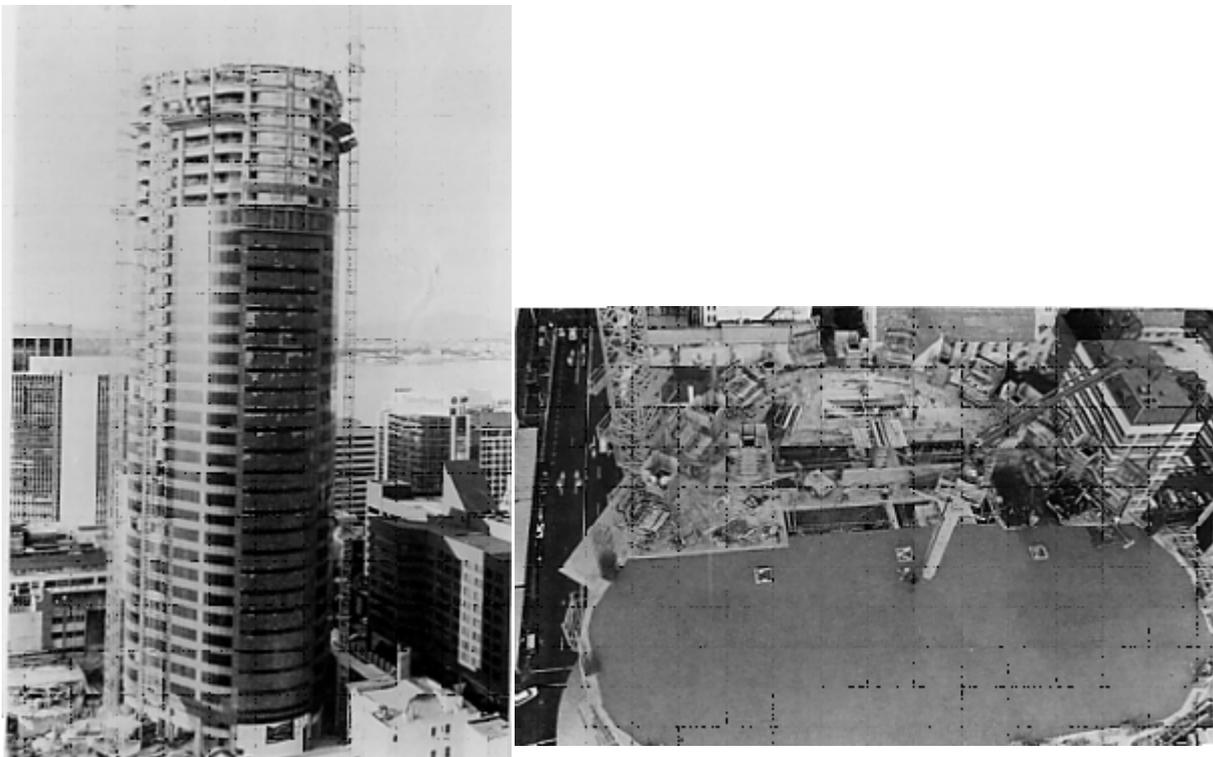
Fig. 31 Construction of the 152 m Tall Coopers and Lybrand Tower in Auckland Using System 2

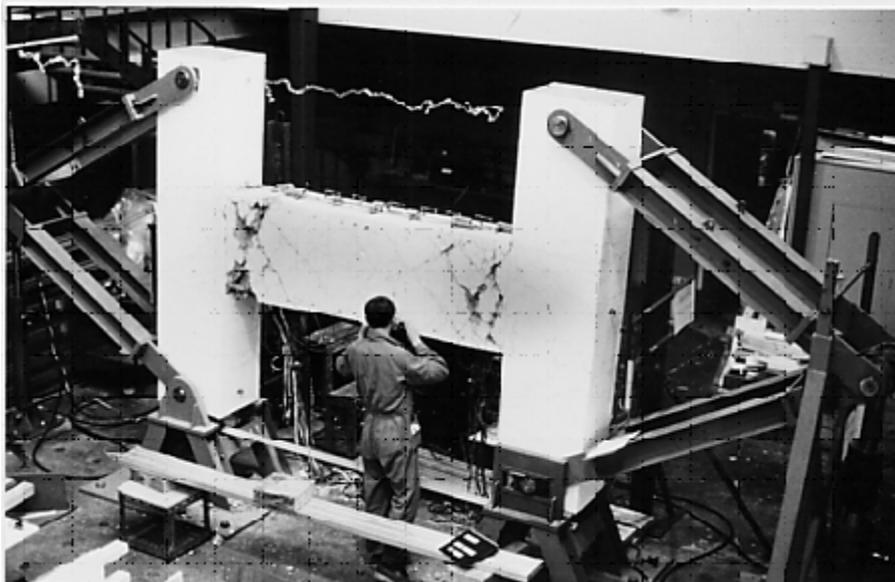
Fig. 32 Simulated Seismic Load Test on A Mid-Span Connection Between Precast Concrete Elements[29]

Many of the currently used connection details for moment resisting frames have now had experimental verification[29]. The verification involved simulated seismic loading tests conducted on typical beam-column joint specimens to determine their performance. (See Fig. 32).

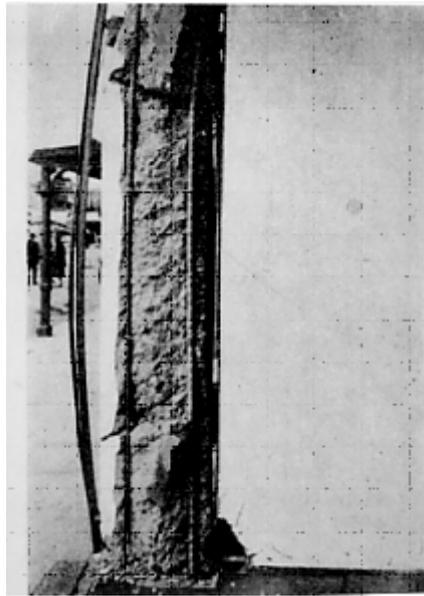
Fig. 33 Reinforced Concrete Column With Poor Transverse Reinforcement Damaged in the 1931 Hawke's Bay Earthquake

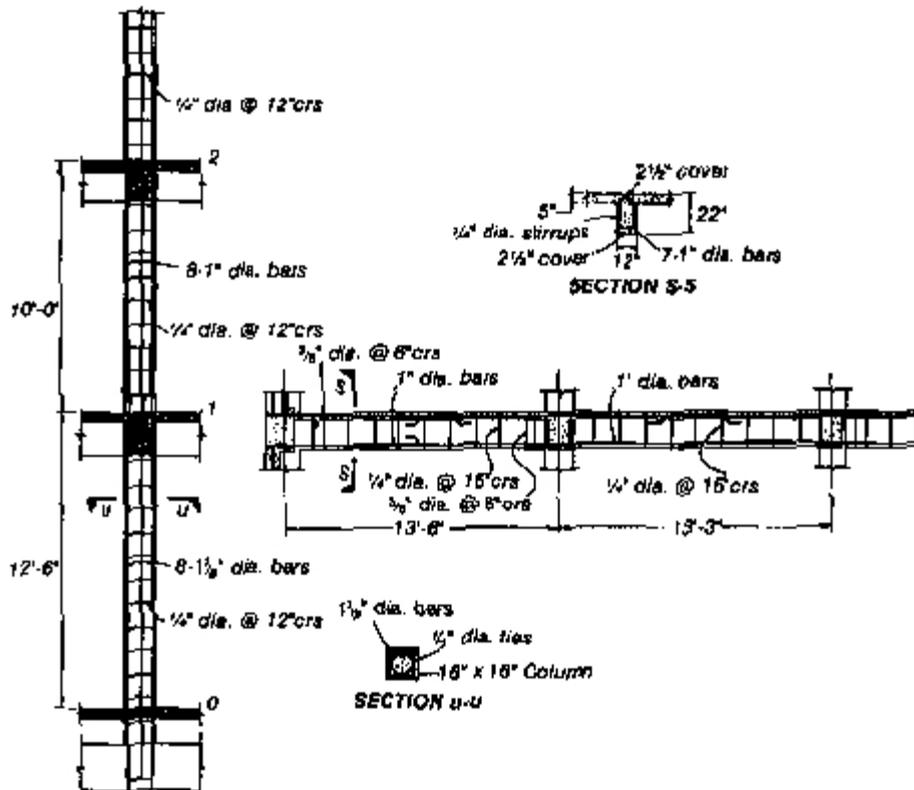
Fig. 34 Details of Typical Reinforcement in a Reinforced Concrete Moment Resisting Frame Designed in the late 1950s in New Zealand

As an example, Fig. 34 shows typical details of beam and column reinforcement in a building frame which was constructed in New Zealand in the late 1950s. As with many building structures designed to early codes, the reinforcing details are adequate for gravity and wind loads but some of the details are inadequate for earthquake forces if ductile behaviour is required. All of the previously listed shortcomings are present in various parts of the structure shown in Fig. 34.

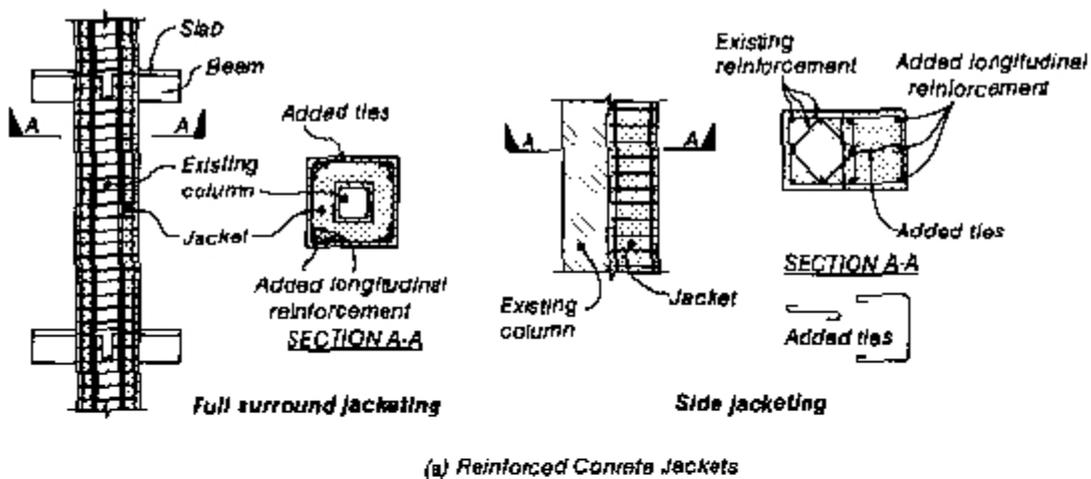
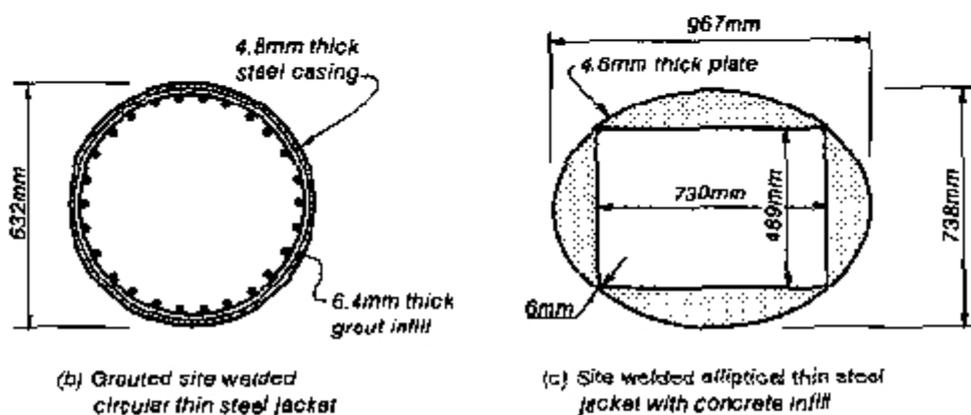
Fig. 35 Some Methods for Retrofitting Columns
