Delay of Onset of Charring to CLT Using Different Encapsulation Materials

T. R. Moser

FINAL REPORT

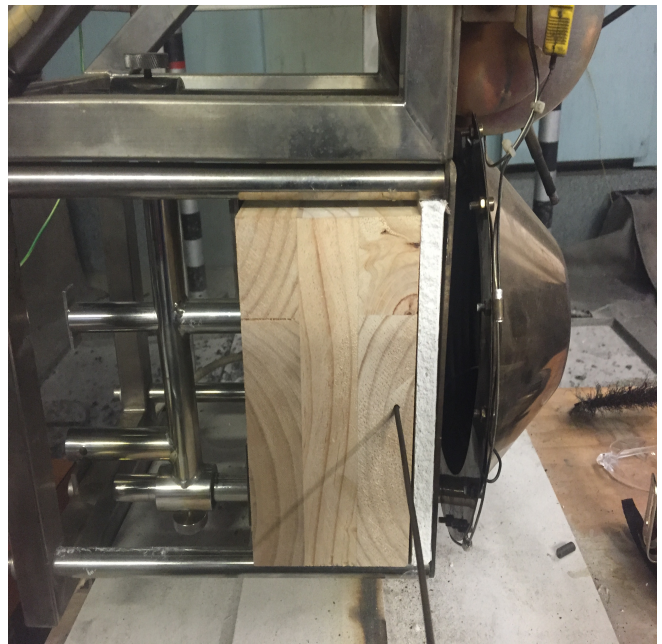
Figure 1. CLT sample with a Magnesium Oxide lining pictured before commencement of testing

Traditionally the ISO 5657 apparatus tests is used to test samples at a constant heat flux. The heat exposure by the cone heater is done so in a horizontal plane for a traditional test. For this research, samples will be exposed in the vertical plane at a constant heat flux. A sample before testing is shown in figure 1.

1/8" thermocouples (3.2 mm) were installed at the lining and timber interface as well as imbedded into the CLT samples at an average depth of 10 mm. In order to install the thermocouple at 10 mm a 1/8" hole was drilled a depth of 125 mm into the sample from the outer edge. For a 250 mm × 185 mm sample the thermocouple is placed at 125 mm × 92.5 mm. The centre of each sample placement and therefore the thermocouples was positioned at the centre line of the cone heater. Figure 1 shows a sample prepared and installed in the modified ISO 5657 apparatus.

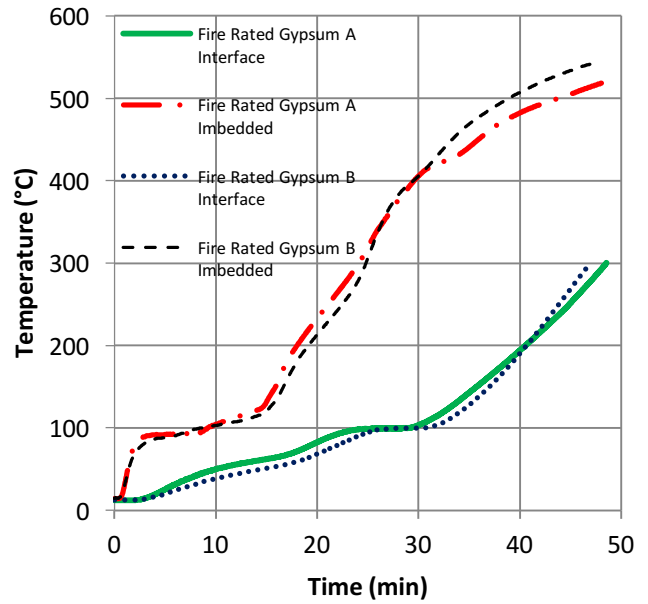
Figure 2. Thermal profiles for 13mm Fire Rated Gypsum A and B samples heated at 65 kW/m².

A typical set of results is shown below in Figures 2 and 3. The data shows the thermal profile at the interface and at an imbedded depth into the CLT sample. Figure 2 displays the temperature with time for 13 mm Fire Rated Gypsum A and B samples, whilst Figure 3 is of the 12 mm and 15 mm Magnesium samples. The profiles are for a heat flux of 65 kW/m².

The data set shown highlights key features such as the temperature plateau at 100°C where the moisture in the sample is being driven back into the sample.

Approximate linear gradients were found between 100°C - 400°C of the interface thermocouple. This is expected, as the make-up of the linings is relatively uniform.

Beyond the latent heat of gasification plateau, the heating gradients varied between tests as the total char depth differed among samples. Samples with a greater char depth took longer for the imbedded thermocouple to reach 300 °C and therefore had a lesser gradient than samples with smaller char depths.

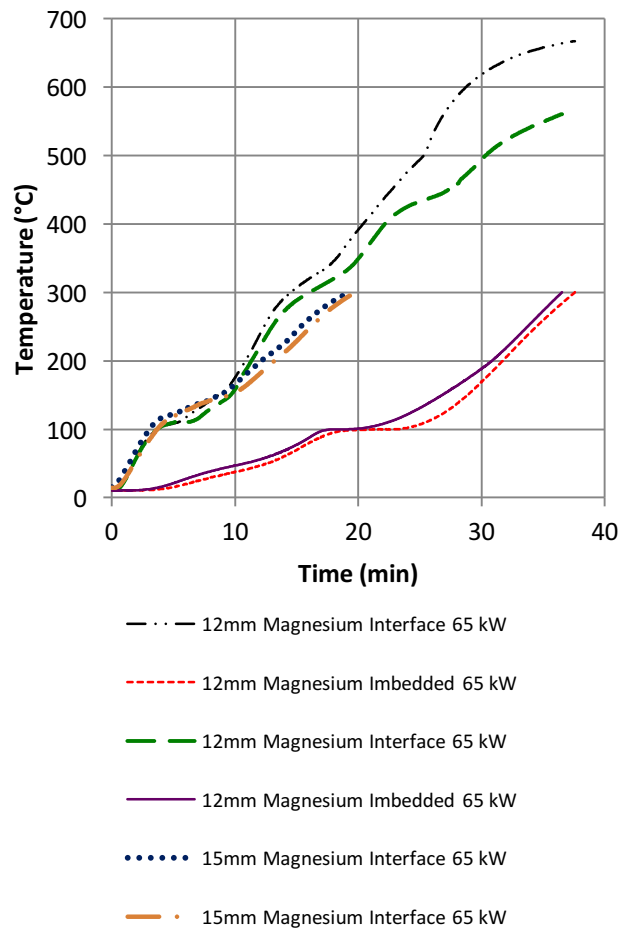
Figure 3. Thermal profiles for 12mm and 15mm Magnesium board tested at 65 kW/m².

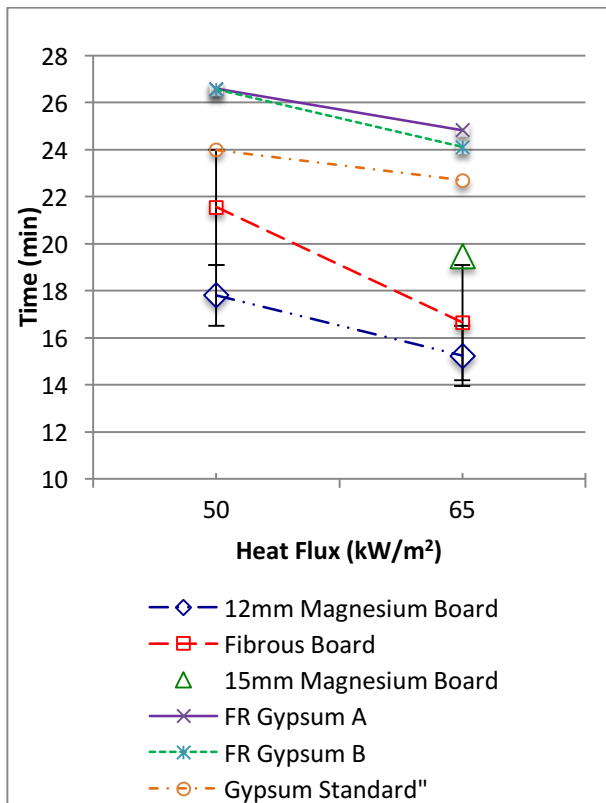
Figure 4 time to interface char when protected by respective linings.

Figure 4 shows the time for the interface to char under the protection of the protective linings.

Standard gypsum performed well lasting 24 and 23 minutes at 50 kW/m² and 65 kW/m² respectively. The biggest downfall of the standard gypsum was the integrity failure. Standard gypsum was the only product to show cracking that led to the sample falling apart upon lining removal at completion.

The 12 mm Magnesium Board stopped temperatures above 300°C reaching the CLT sample by 18 and 15 minutes at 50 kW/m² and 65 kW/m² respectively. Using the gradient of the 12 mm Magnesium sample and the data point of the 15 mm board, it can be predicted that the 15 mm Magnesium sample would last approximately 22 minutes at 50 kW/m².

The Fibrous lining took slightly longer than the 12 mm Magnesium board to reach 300°C at the interface, this is expected as the Fibrous board is a slightly thicker sample. The Fibrous board showed no signs of integrity failure.

Furthermore, Figure 4 can be used to predict the insulation time for heat fluxes between 50 and 65 kW/m². Interpolating outside the range of heat fluxes tested can be done but in doing so caution is advised.

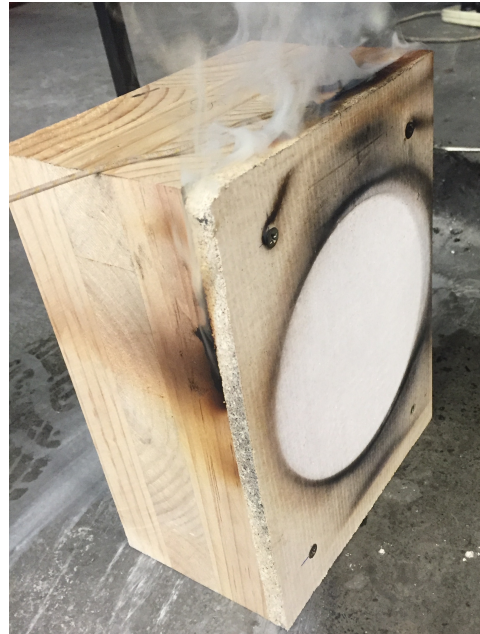
Figure 1 sample of CLT with 12 mm Magnesium Board lining pictured at completion of 65 kW/m^2 test

No 15 mm magnesium board samples were tested at 50 kW/m^2 . This was due to a limitation in the number of CLT backing samples. 65 kW/m^2 was the more demanding of the heat fluxes and it was therefore decided to test two 15 mm magnesium board samples at this heat flux. Figure 5 shows a magnesium sample immediately after completion of a 65 kW/m^2 test. No integrity damage to the sample can be seen.

Integrally the magnesium and fibrous board performed the best of all the samples tested at both heat fluxes. No cracking was observed during testing and the board remaining rigid during removal.
