TREES FOR CANTERBURY

Optimising Native Plant Regeneration on Marley Hill

Lauren Arnold, Julie-Ann Buick, Holly Luzak, Paul Price & Phoebe Siva

10/13/2014

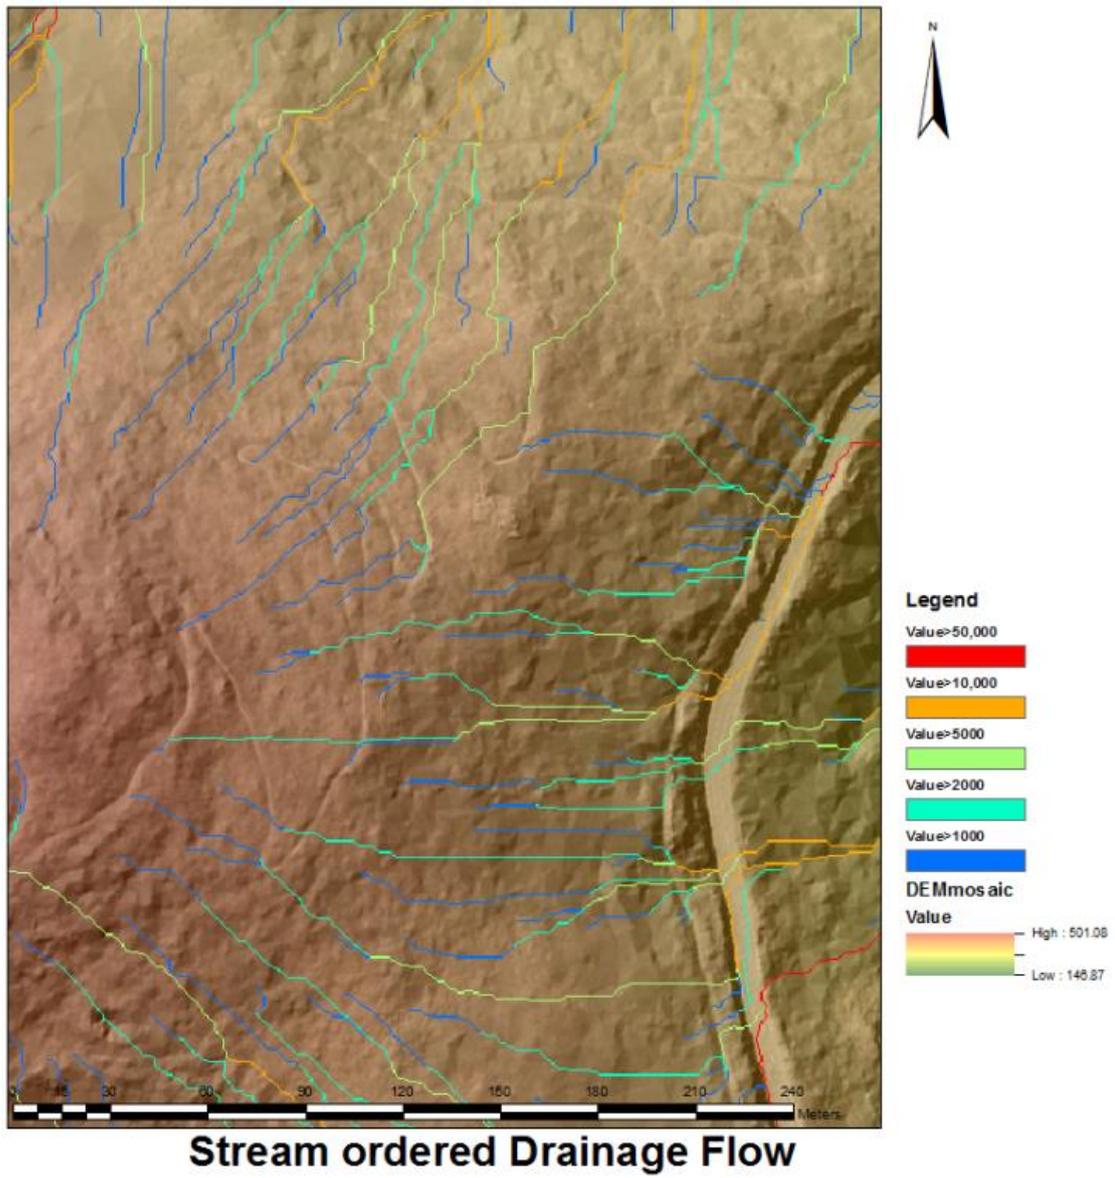
Figure 1: Stream Order Drainage

The result from the GIS hydrology modelling produced two specific maps. *Figure 1* displays a stream order or drainage network. This ordered network defines different channels by a threshold value from >1000 to >50000 (Refer to Legend). These different thresholds represent increasing levels of flow across the area. *Figure 2* identifies the location of waypoints taken in the field that identify physical drainage channels or areas saturated by draining water. Waypoints Fn2, Fn3 and Fn4, (*Figure 2*) all have corresponding photographic evidence displaying what has been identified as drainage.

Figure 1 identifies the location of these channels or drainage networks and more crucially indicates which networks carry substantial flows of water due to the threshold values the model assigns based on a measurement of contributory cells. In these areas it could be inferred that saturation would be more intense in the adjacent soil and remain saturated for longer periods of time than channels identified as primary due to a threshold of surface runoff. These maps could be further improved by including modelled length of time moisture will remain and saturate soil after a rain full event.

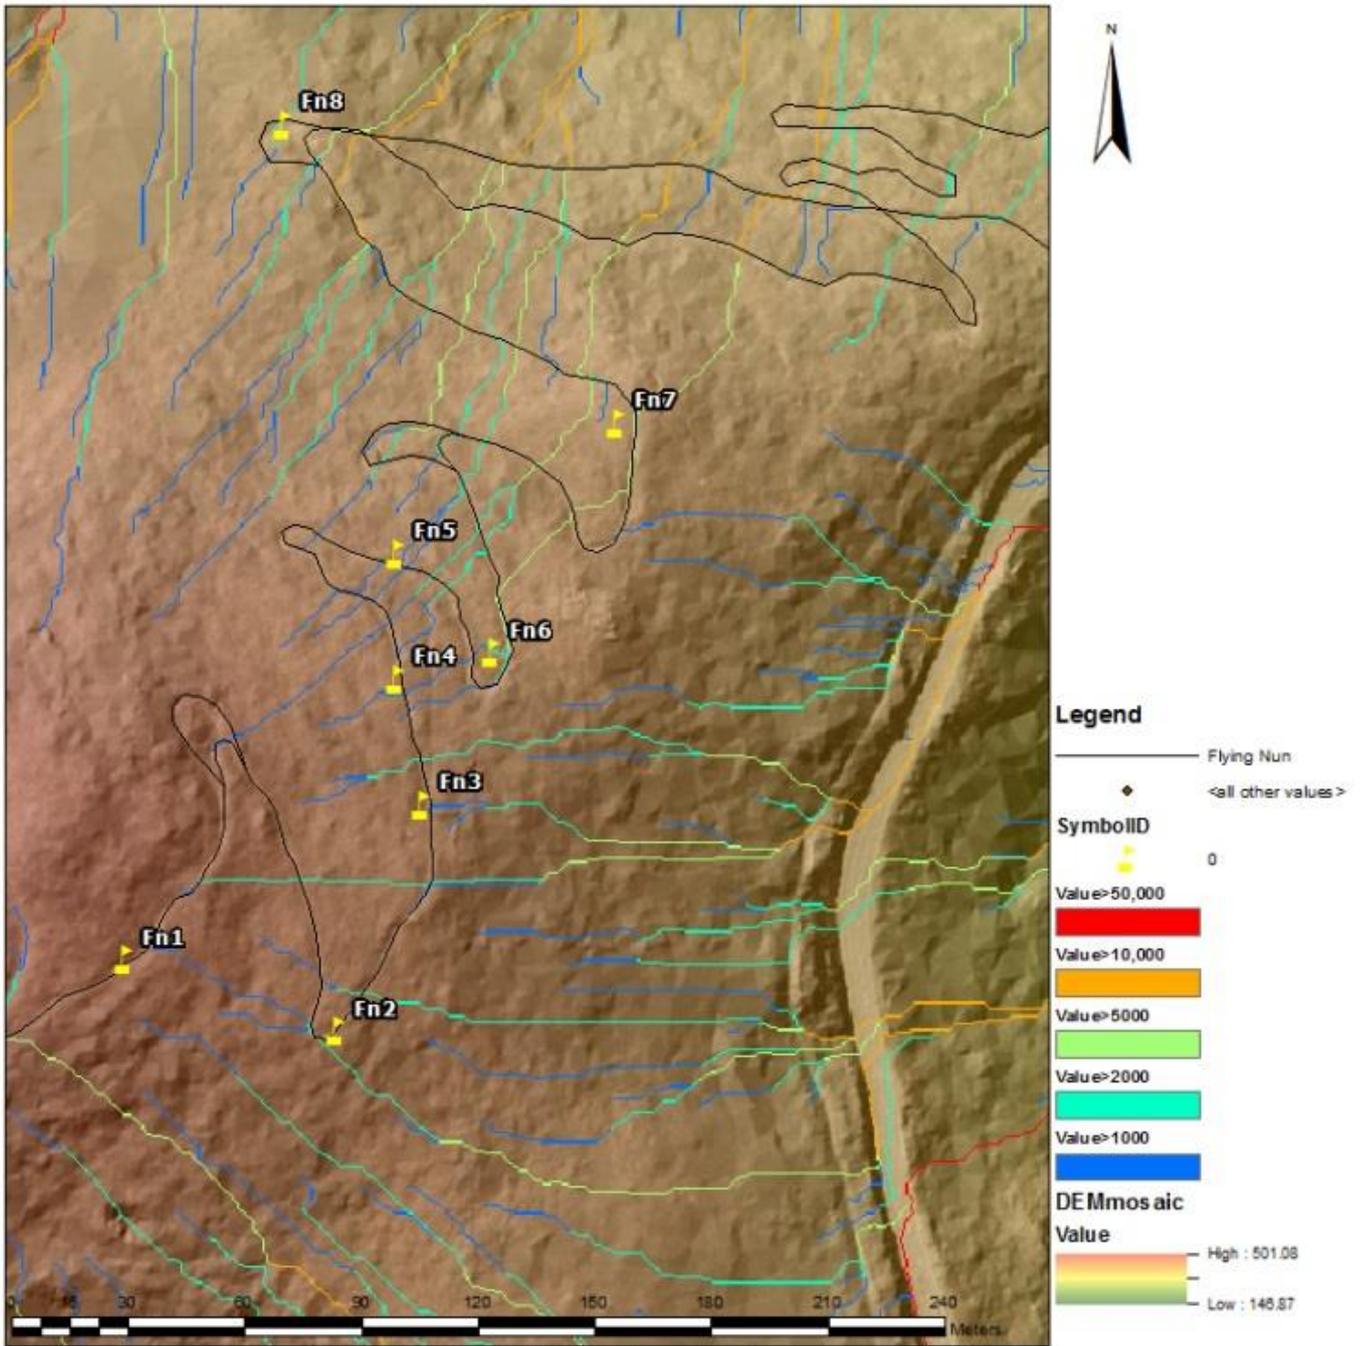
Figure 2: Validity

GPS Validity Exercise

The use of ArcGIS to model hydrology became the foundation of the final planting guide. The maps that were produced accurately identified the location of drainage channels. This is displayed by Figure 2, which plots the position of validation waypoints measured in the field close to modelled channels. The hydrology is accurately modelled because the DEM manipulated was of high resolution LiDAR data, which has the benefit of penetrating the thick vegetation of the research area, producing a clean digital surface layer. This could not be achieved as accurately if an Orthophoto of the area have been interpolated to form a DEM.

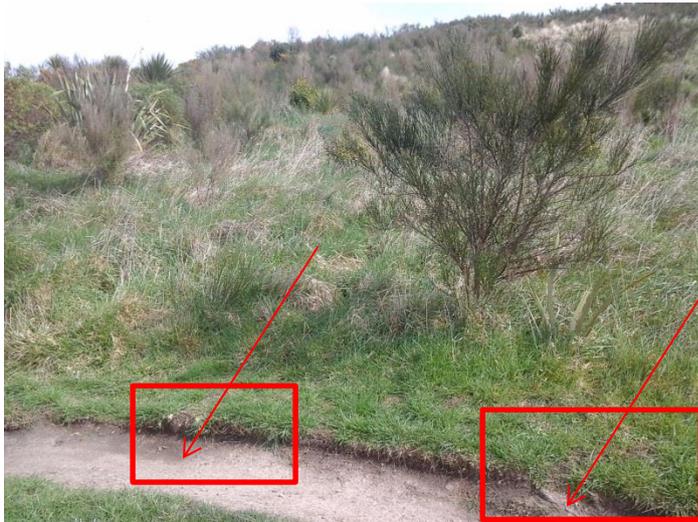
Fn2:

The GPS Waypoint for this location has an error of +/- 3m to the SE of the photos location. This photo is illustrating the distinct fork shape (Figure 2 above point Fn2) of two primary >1000 value drainage channels which combine at the track edge to form a secondary >2000 value drainage network channel.

The red boxes highlight areas of track which are visibly more saturated than the remaining area of track.

The photographs, as seen in Figure 3, are illustrated with arrows and boxes indicating areas of track saturation. The photos were taken on a fine day so no surface runoff is visible.

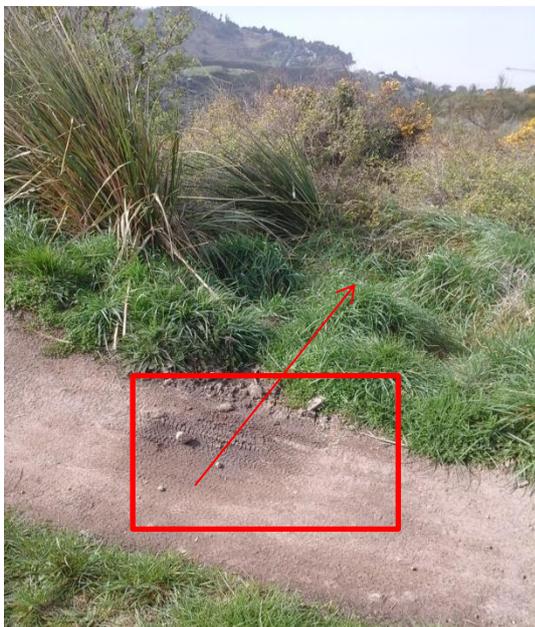
Fn3:

This GPS Waypoint illustrates a point of track surface runoff accumulation, which acts as a source of a primary >1000 network channel. There is evidence of human manipulation of the accumulation area, presumably in an effort to increase the rate of drainage in order to dry out this section of track.

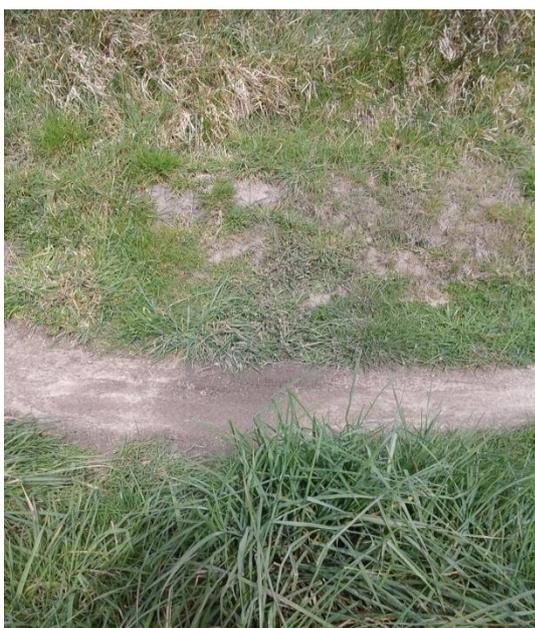
Fn4:

At this Waypoint a demonstration of the drainage channel flowing across the track is identified.

Figure 3: Photograph evidence validating the GIS hydrological model

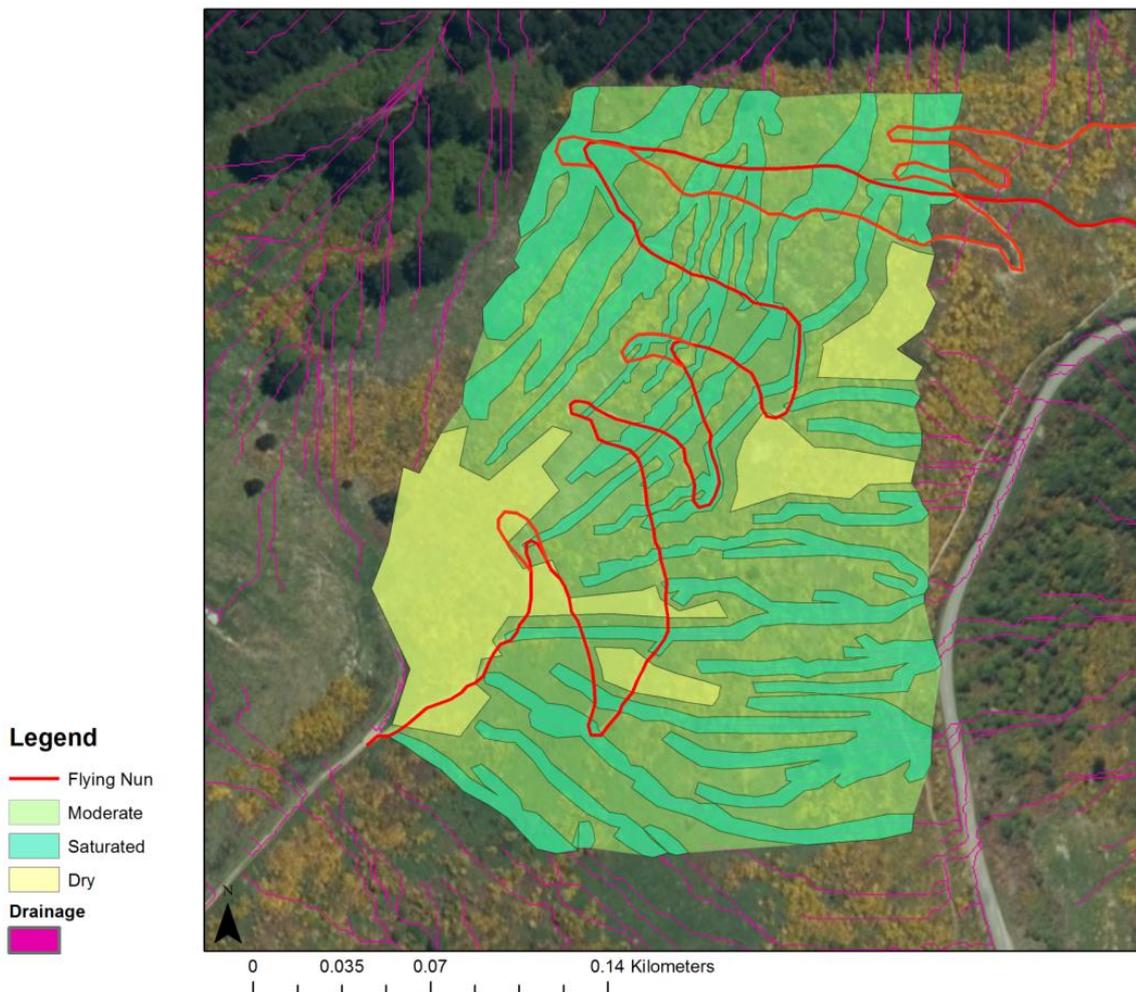
Figure 4: Native plant regeneration map

The proposed distribution of native plants regeneration on the research site was generated based on the drainage map (Figure 4). It is advised that the plants are planted according to the drainage and soil moisture, which is a consequence of drainage, determines suitability of plants on different areas on the site.

Plants more suited to saturated conditions (Refer to Table 1), are planted on the drainage flows, which are shaded in blue. Plants suited for drier areas are to be planted on the drier areas shaded in yellow. Plants with no preference or prefer moderate conditions are planted between the dry and saturated areas which are shaded in green

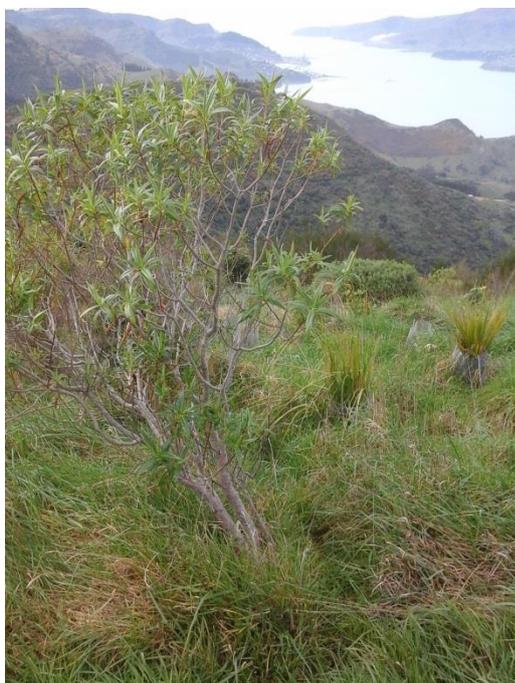
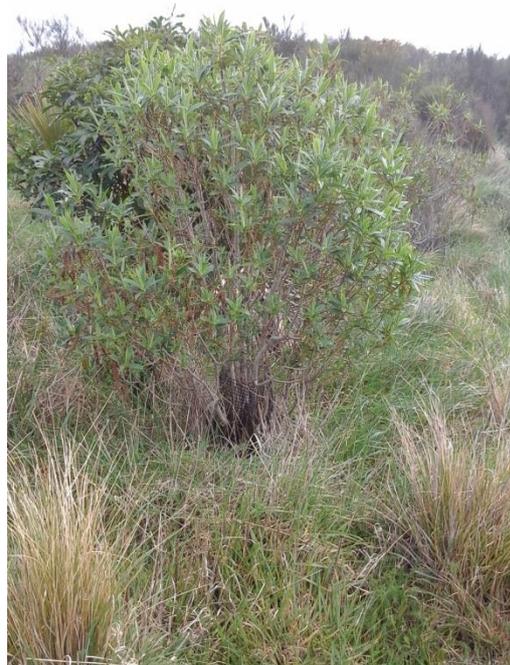
Figure A.1: An example of native regeneration which is struggling because of drainage flowing at its base. (a) is an example of a healthy native plant species, this photo was taken 100m above Waypoint Fn2 (Figure 2) along the Flying Nun track facing west up the hill slope. (b) is taken to the left is on the opposite side of the track looking east toward Lyttelton.

determine the direction that ecological restoration processes take. This can be witnessed by regeneration efforts on Marley Hill as Trees for Canterbury and CCC operate to restore land use activities from economic driven agriculture back to a regenerated natural ecosystem. Thurston and Reader (2001) concluded that in relatively short-term time scales (years) effects on soil and forest habitat would be impacted greatest by mountain biking and other recreational activity. Because of this recreational impact it is of great importance that any regeneration efforts made are planned effectively for optimal survival of plants. This not only benefits the natural ecosystem, but maximises Trees for Canterbury's investment and involvement in native regeneration. Trees for Canterbury and the CCC have been investing time in the Marley Hill recreational area prior to approaching the University with an opportunity. It had been noticed that the same species of native plants were experiencing different growth rates and survival potential within close proximity to each other, as seen in Figure A.1, Appendix A.

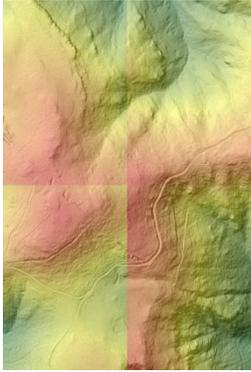
Figure C.1: Initial site representation by four individual DEMs

Initially, the research site was represented by four individual DEM(s), as seen in Figure C.1, Appendix C. The hydrological model requires on continuous layer and so a Data Management tool, *Mosaic to New Raster* was used to create a single DEM, seen in Figure C.2, Appendix C. This DEM was then used as an input for a *Flow Direction tool* which created an output layer that measured the direction of surface flow across the research area. A depressionless DEM was then created using a *Fill tool* to remove any imperfections or 'sinks' in the data. A *Flow Accumulation* was measured from the depressionless DEM, which assigned a weighted value to each cell in the DEM depending on variables such as flow

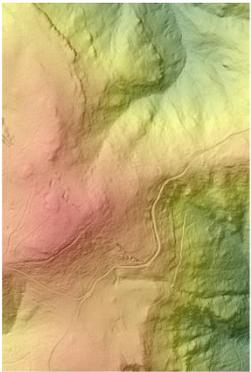
Figure C.2: Single DEM used as an input for Flow Direction

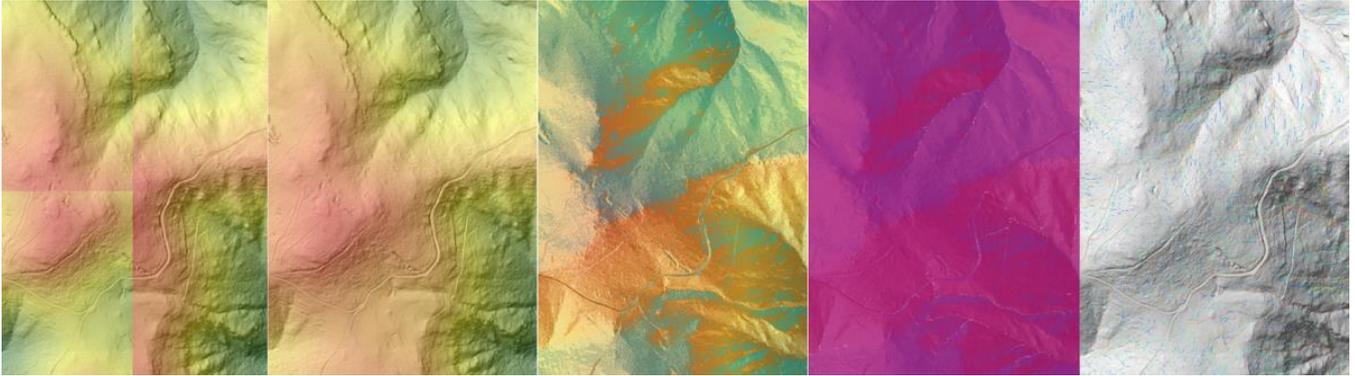
Figure D.1: Visual representation of creation of GIS drainage modelling

direction. Finally, a stream order tool was used to infer a drainage network (these steps are visually shown in Figure D.1, Appendix D and described in a flow chart Figure D.2, Appendix D). Stream ordering is a method of assigning numeric order to a network by identifying and classifying types of streams based on a numeric threshold. For example, first order streams are dominated by overland or surface water flow and do not have any contributory flow from above streams.

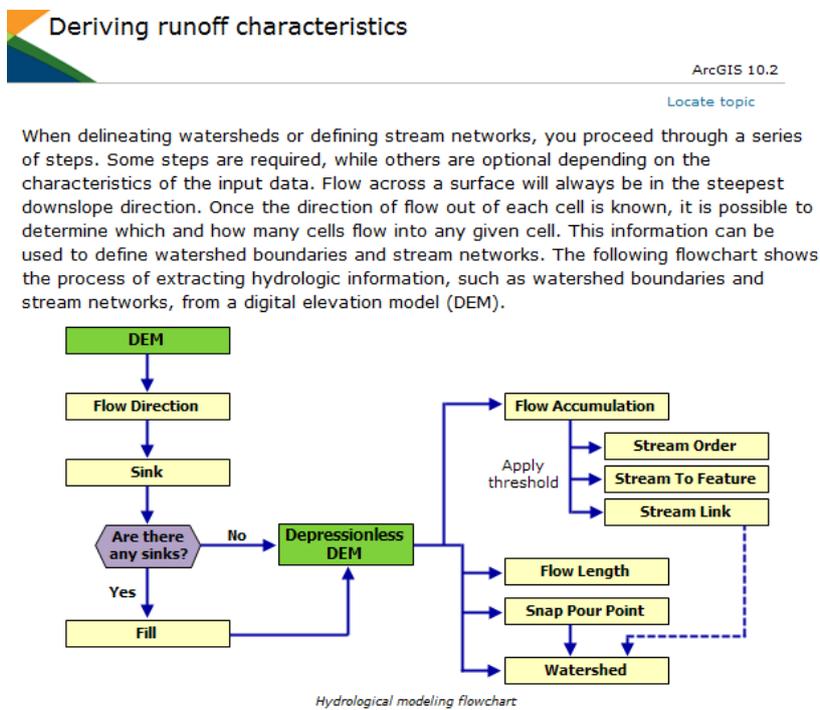
Figure D.2: Flowchart of steps taken in GIS drainage modelling

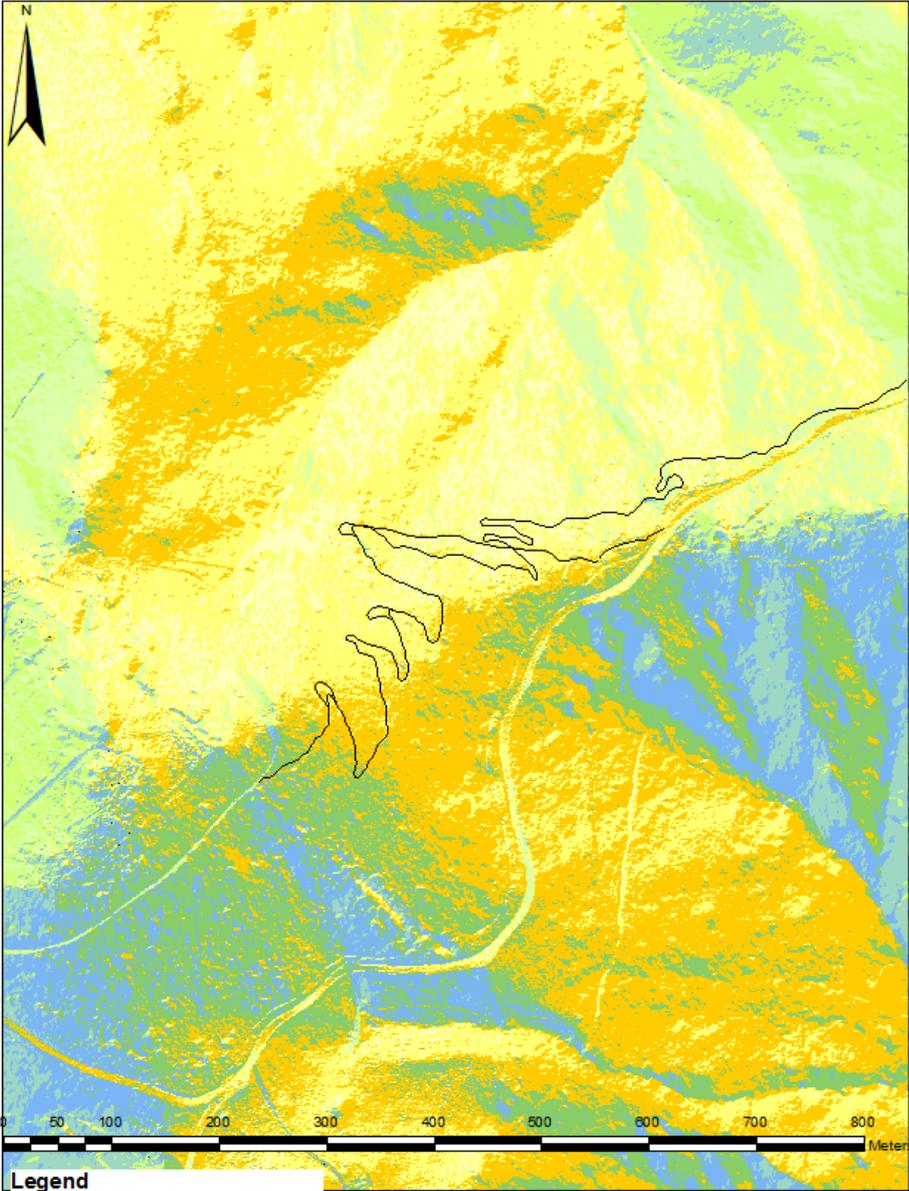
Figure E.1: Map showing the aspect of Marley Hill
