A Natural Character assessment of the Okuku and Kaiapoi Rivers in the Waimakariri District, New Zealand.

GEOG309 - Research for Resilient Environments and Communities in Geography

Final Project Report

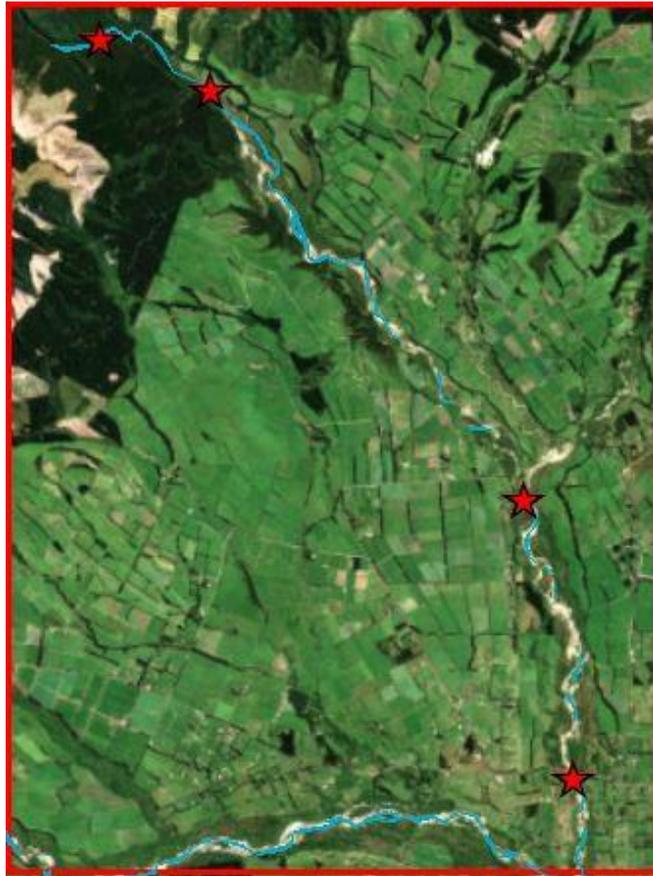
Figure 2: The red stars on this map show the Okuku Catchment assessment sites. Site O1 starting in the top left of the map in native bush, through to O2 in partial bush and O3 as you follow the river down into farmland, with O4 being at the bottom right of the map near the Okuku-Ashley confluence.

Okuku River is unenriched, has good recreation and fishing values and is made up with unmodified tussock (38%), native forest (19%), scrub (19%) and pasture (12%) (Suren *et al*, 2003). Okuku River starts near the Puketeraki range and flows into the Ashley River (**Figure 1**). Four sites were sampled along this river (**Figure 2**). There is a lack of knowledge on the Okuku River, which makes it an alluring river to study.

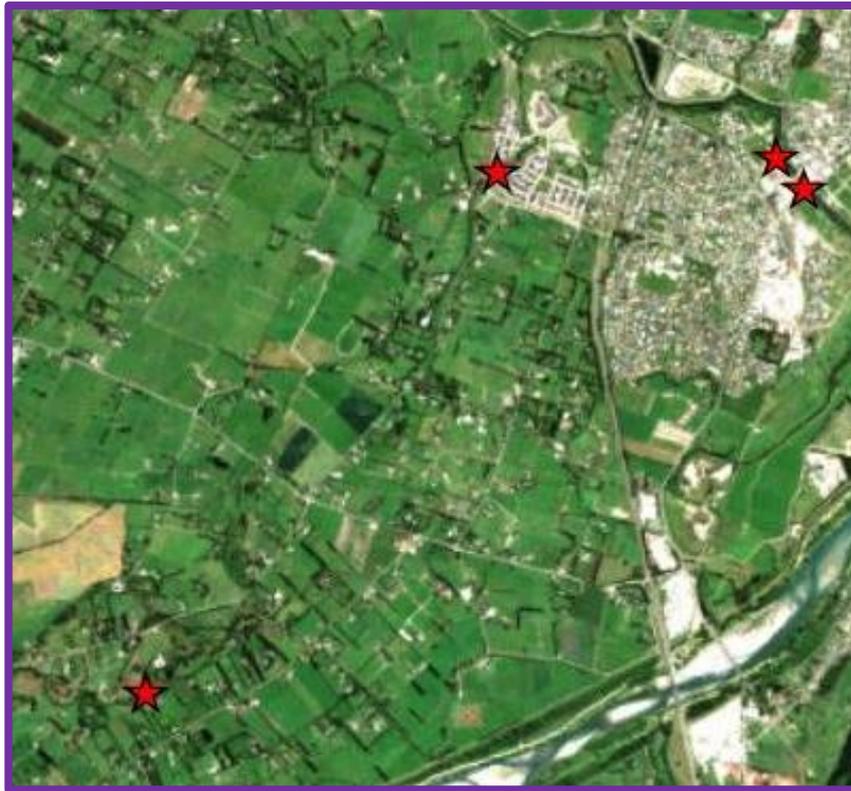
Figure 3: Red stars on this map show the Kaiapoi Catchment assessment sites. K1 is in the bottom left of the map, leading up to K2 at the edge of rural and urban, through to K3 and K4 in the top right of the map in central Kaiapoi town.

Kaiapoi River rises up from a spring northwest of Christchurch City (Winterbourn, 1978). Near its source it is surrounded by farmland and a fish hatchery. Then it flows eastbound across the Canterbury Plains (Winterbourn, 1978) through the centre of Kaiapoi Township (Knight, Giovinazzi, & Liu, 2012). Four sites were also sampled along this river (**Figure 3**).

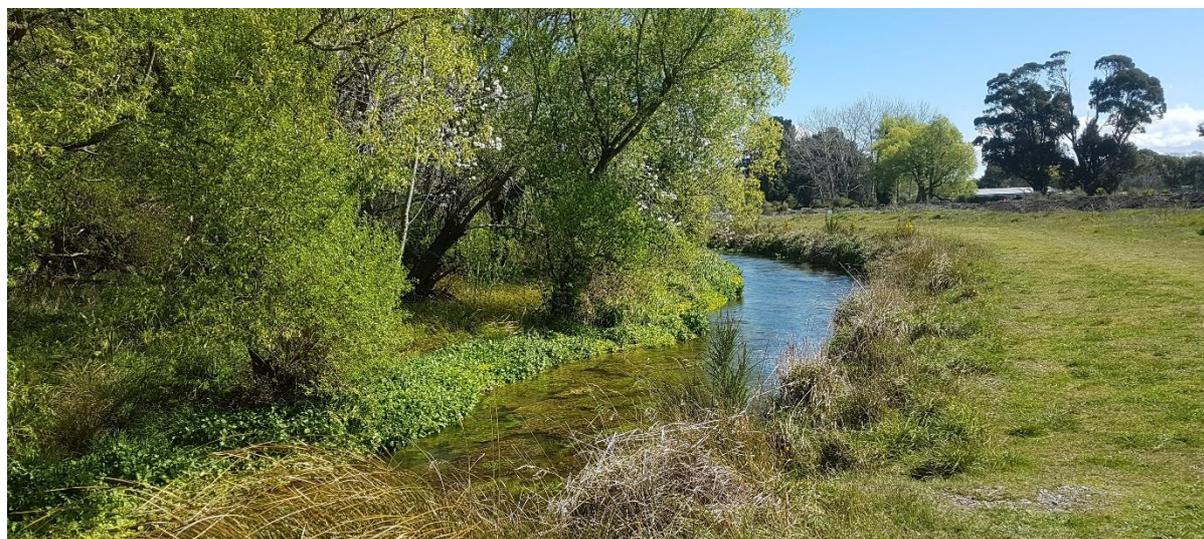
Figure 1b: Photo taken at Kaiapoi Site 1, looking upstream. River here has been able to act naturally eroding its banks with a high variation in riverbed characteristics and no fine sediments. Poor vegetation cover due to the nearby park and pasture however high vegetative habitat variation was present. This site experiences moderate road noise with pastures nearby bringing rural smells while mahinga kai support was high.

Table 3: Showing Kaiapoi Site 1 as overall having a 'High' Natural Character Value.

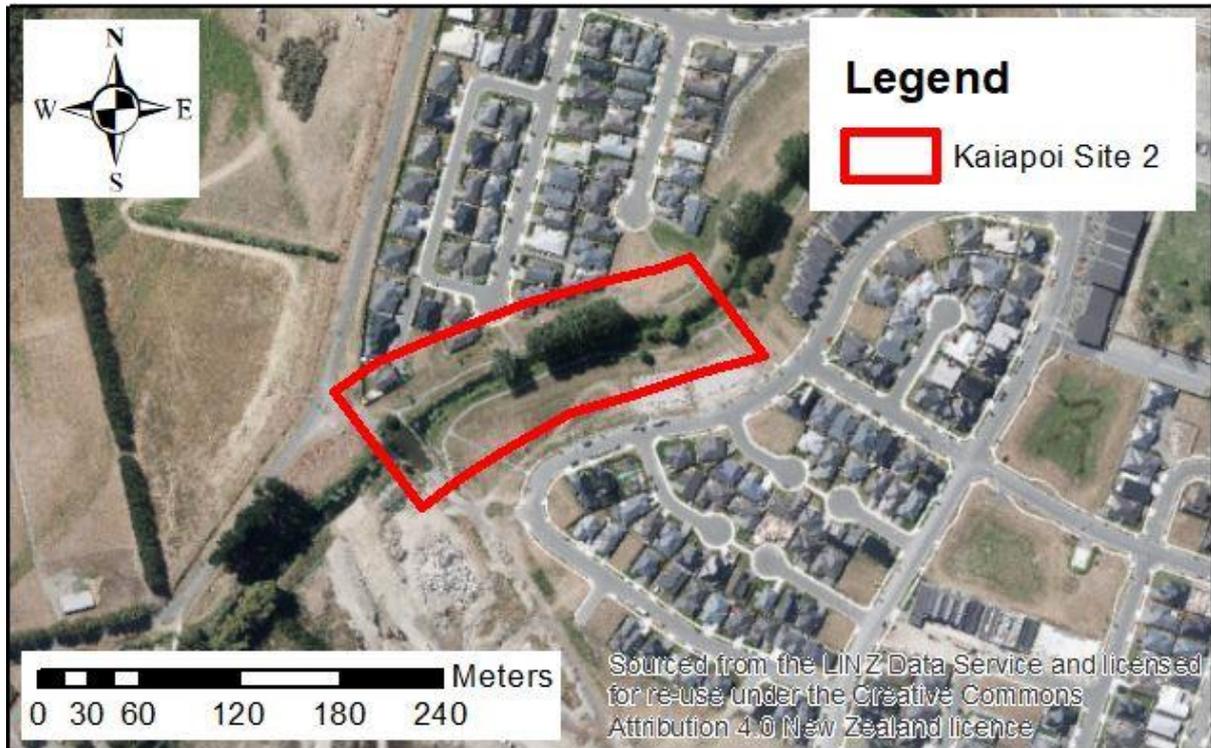
Kaiapoi Site 2 - Downstream of Butchers Road Bridge

Figure 2a: Aerial image showing the outline of the Kaiapoi Site 2 assessment area (red), located immediately downstream of Butchers Road bridge and between two new housing developments (not yet built in this image).

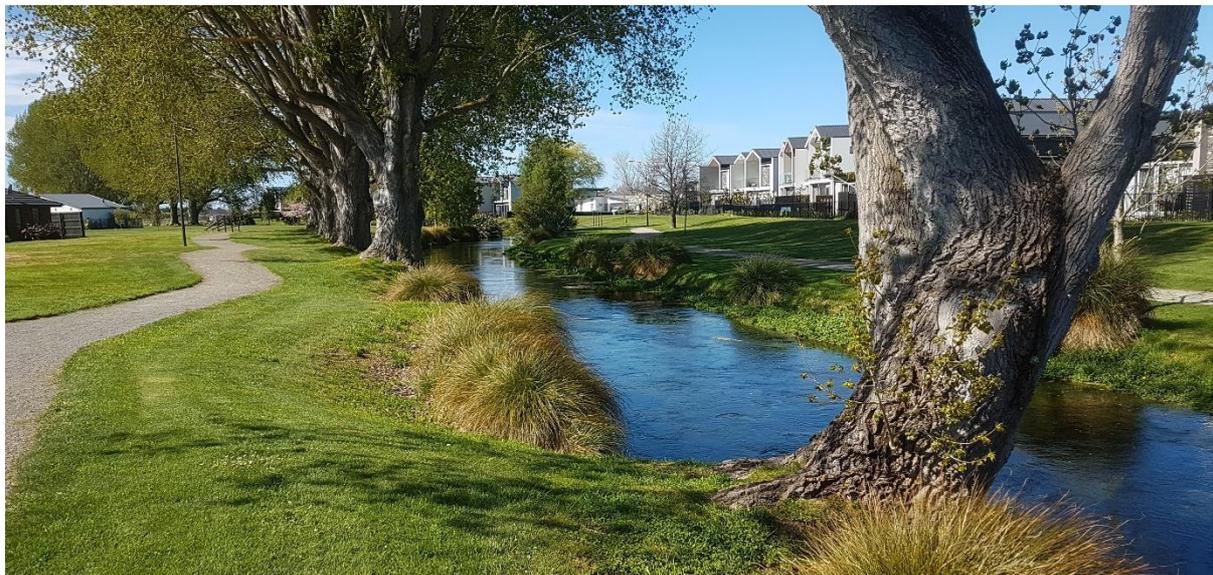
Figure 2b: Photo taken at Kaiapoi Site 2, looking downstream. River here has high variation in bed characteristics with a moderate ability to erode its banks however restricted by stabilising vegetation. Biological habitat here has moderate variation however is very sporadic with little ability to foster ecosystem services. Natural experiential value here was moderate due to nearby road noise and presence of development.

Table 4: Showing Kaiapoi Site 2 as overall having a ‘Moderate’ Natural Character Value.

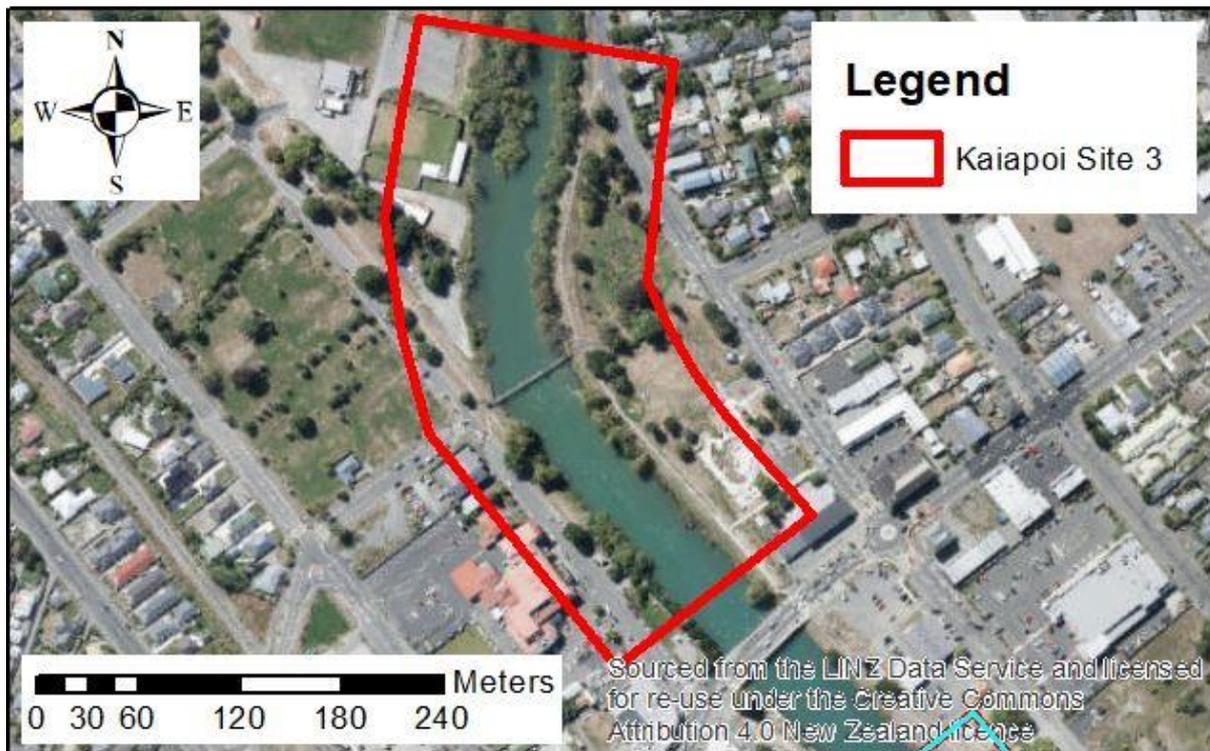
Kaiapoi Site 3 - Kaiapoi town centre (above bridge)

Figure 3a: Aerial image showing the outline of the Kaiapoi Site 3 assessment area (red), located upstream of the Williams Road vehicle bridge. Very urban environment with a dominance of buildings, roads and parks.

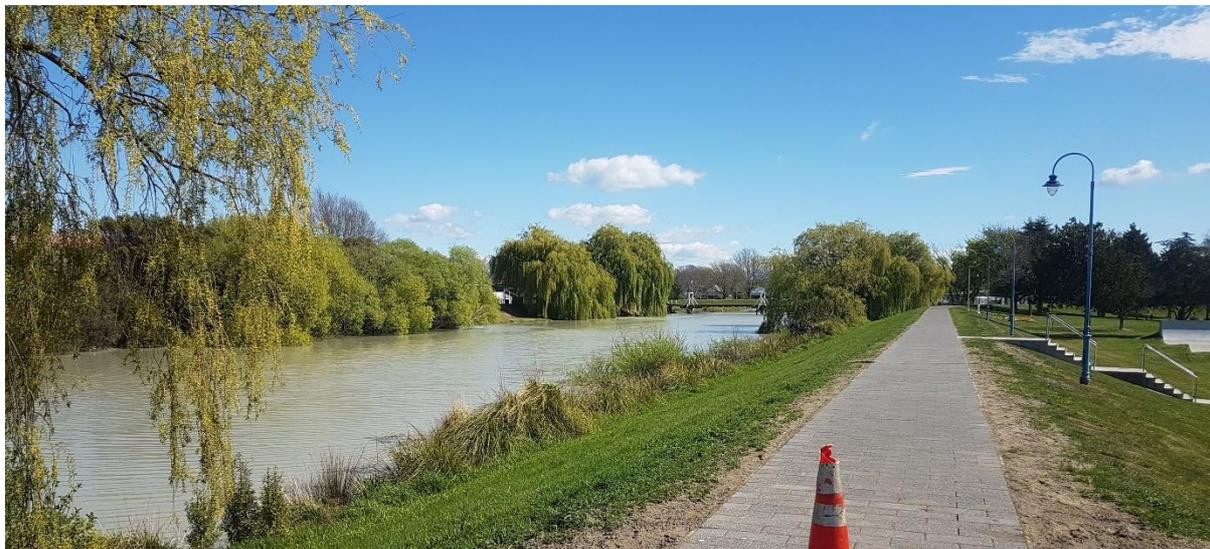
Figure 3b: Photo taken at Kaiapoi Site 3, looking upstream. River here is confined by stop banks and some sections have concrete banks. Very little variation in riverbed characteristics with a prominence of fine sediments. Biological habitat here has moderate variation, however, is very sporadic and does not foster many ecosystem services. Natural experiential value is moderate as vehicle noise and poor due to water clarity. Mahinga kai support here was also low.

Table 5: Showing Kaiapoi Site 3 as overall having a 'Moderate' Natural Character Value.

The lowest scoring site within the geomorphological attribute were the Kaiapoi town sites (K3, K4) and the lowest site on the Okuku near the Ashley River confluence (O4) which are all far from their source. This may be due to the anthropogenic influence of engineering stop banks to control rivers and prevent flooding. Which in turn alter the natural geomorphological processes, disrupt flow of sediment, causing riverbed and bank erosion downstream (Poeppel, Keesstra and Hein, 2015). Conversely, the best geomorphological conditions were the sites on each river nearest to their source (O1, K1).

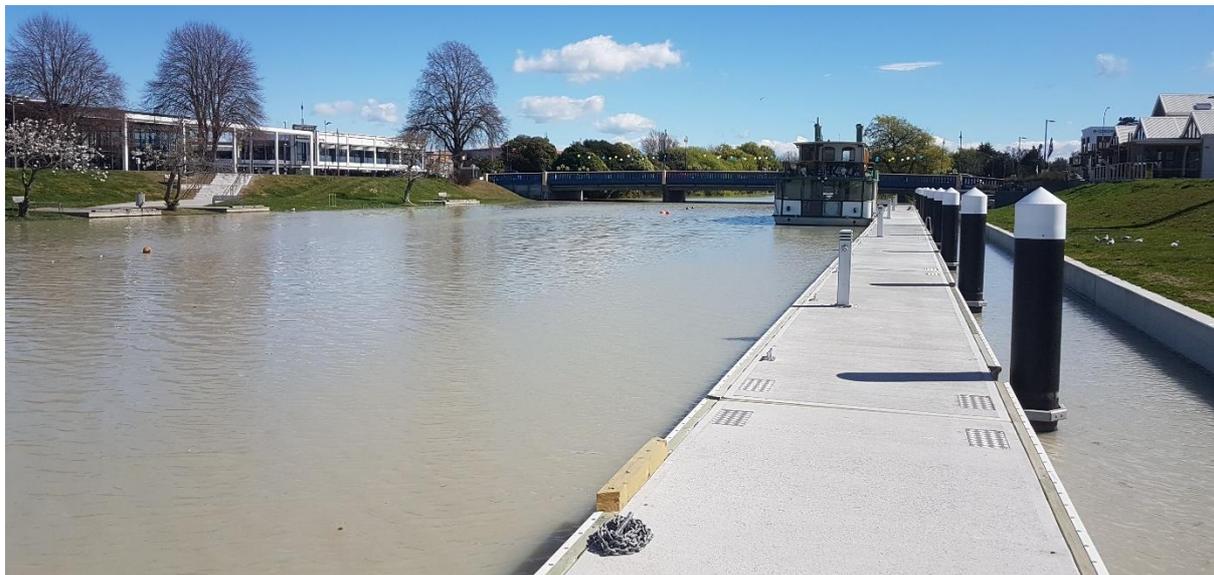
Figure 4b: Photo taken at Kaiapoi Site 4, looking upstream. The river has been modified by urban structures including concrete banks jetties and a bridge which all inhibit natural river processes. Biological habitat is almost non-existent apart from mown grass and few large trees. Natural experiential value here is low due to the road noise, poor water clarity and few natural characteristics. Mahinga kai support here is also low.

Table 6: Showing Kaiapoi Site 4 as overall having a 'Low' Natural Character Value.

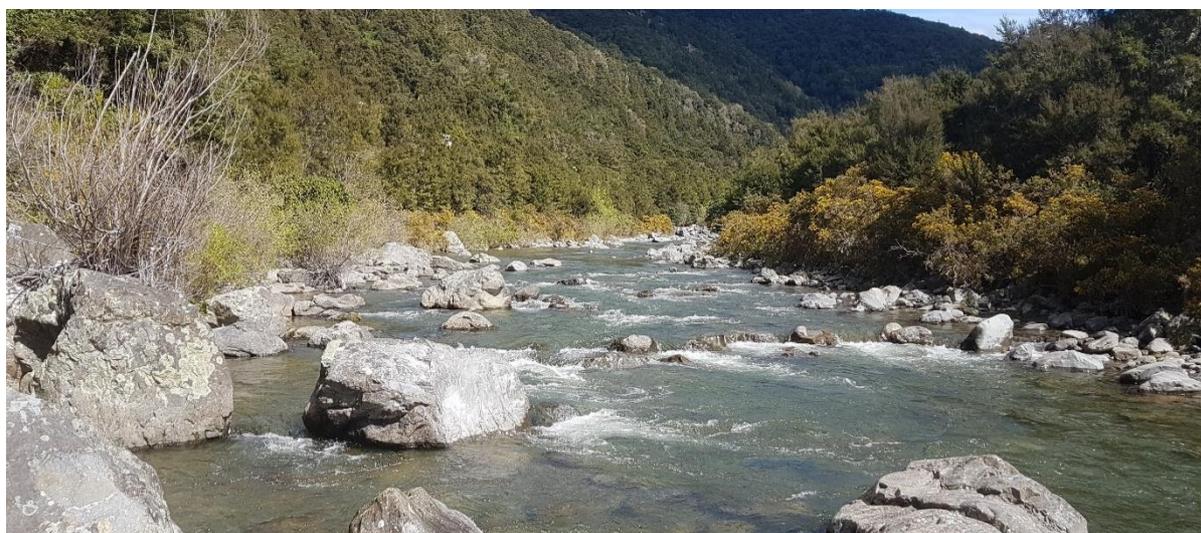
Figure 5b: Photo taken at Okuku Site 1, looking upstream. The river here can carry out its natural processes and has high variation in bed characteristics with no fine sediments. Biological habitat has high variation and coverage fostering a range of ecosystem services; however, presence of gorse and willow is detrimental. Natural experiential value is high and mahinga kai support is also high.

Table 7: Showing Okuku Site 1 as overall having 'High' Natural Character Value.

The results identified that none of the sections of the river assessed had 'Very High' Natural Character Values, this could help inform the Council of where to prioritise restoration. For example, Okuku Site 1 had significant issues with gorse bush - even though it is remote, distant from developed land. This Natural Character assessment toolset thus allows the sections of the rivers to be assessed, identifying their failings, which will require restorative action.

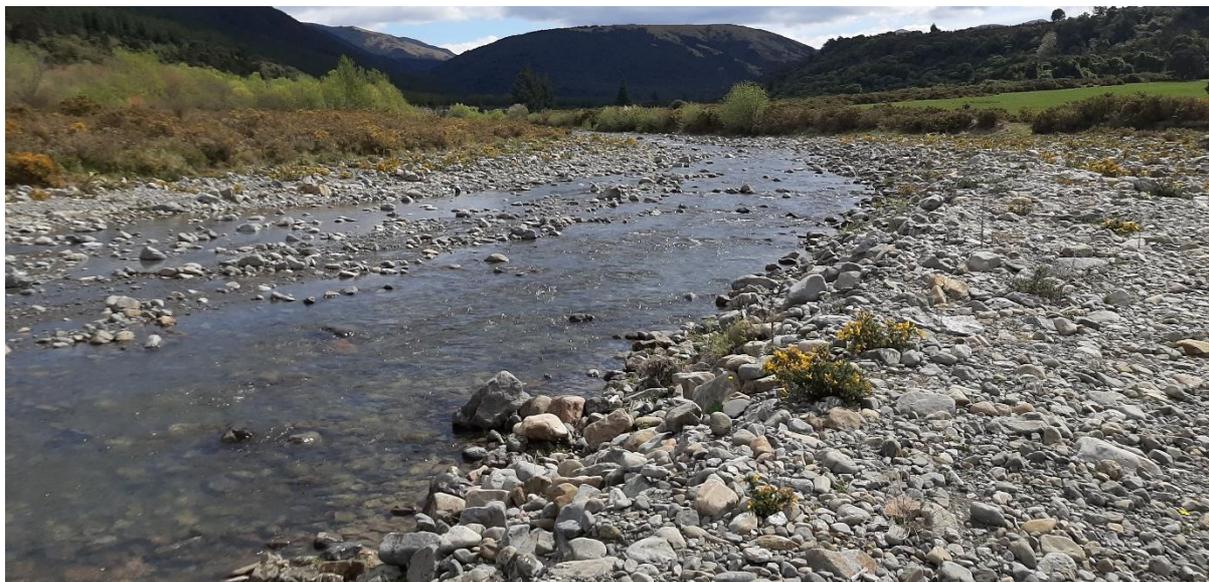
Figure 6b: Photo taken at Okuku Site 2, looking upstream. The river here has high variability in bed characteristics with no fine sediment. Biological habitat has high variation however is dominated by gorse and willows. Natural experiential value here is moderate due to the presence of pastures and dominance of gorse.

Table 8: Showing Okuku Site 2 as overall having 'High' Natural Character Value.

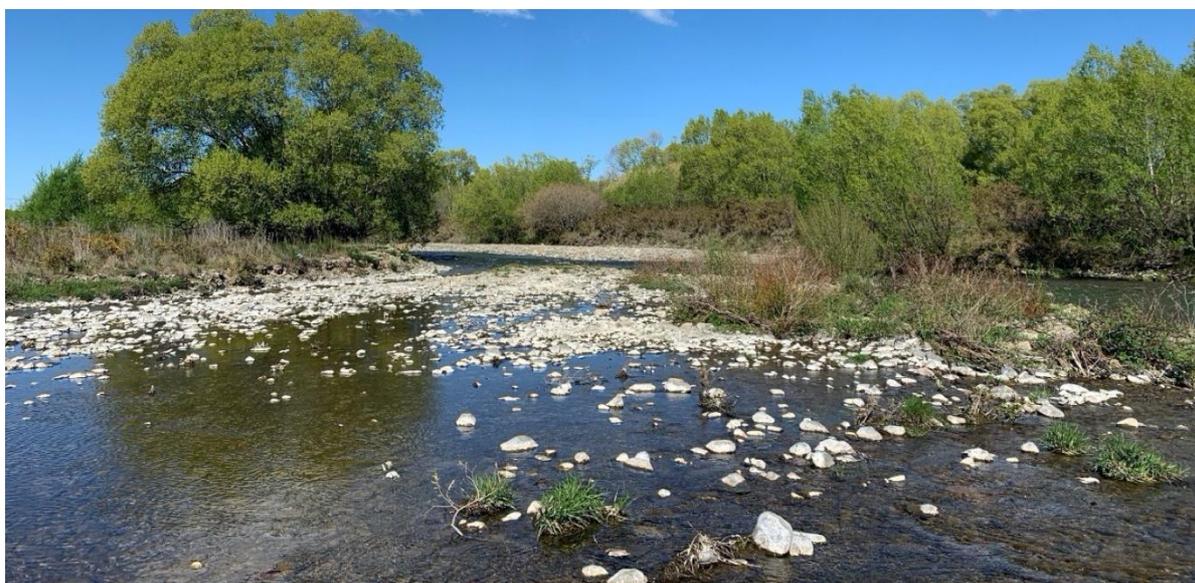
Figure 7b: Photo taken at Okuku Site 3, looking downstream. The river here has moderate variability in bed characteristics with little fine sediment. Biological habitat has moderate variation and coverage, however, is dominated by willows. Natural experiential value here is high and Mahinga kai support is moderate.

Table 9: Showing Okuku Site 3 as overall having 'High' Natural Character Value.

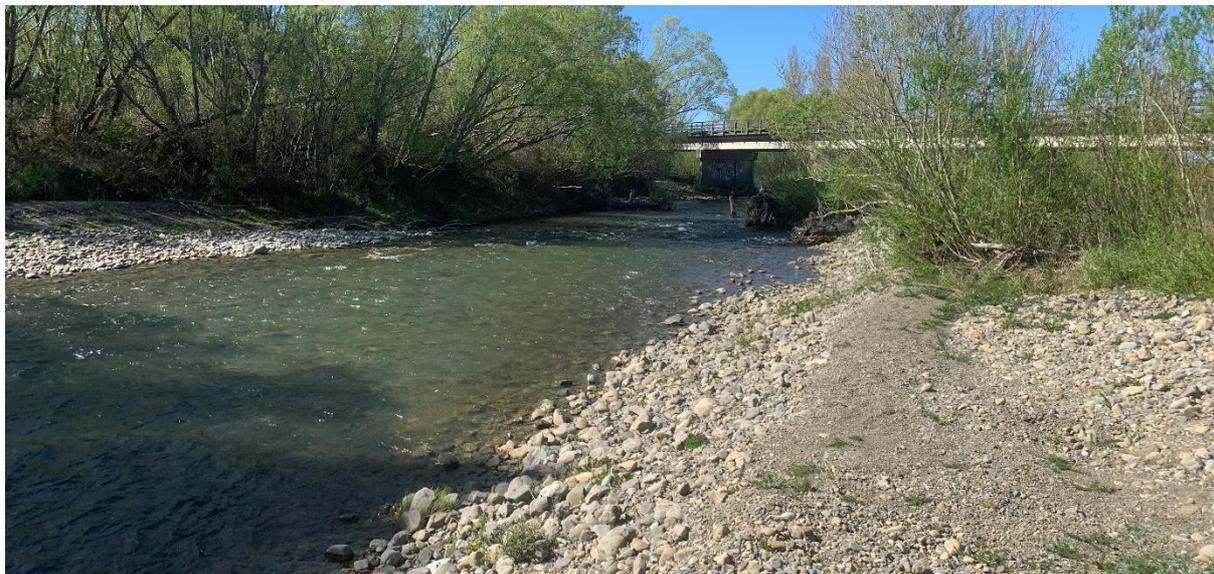
Figure 8b: Photo taken at Okuku Site 4, looking downstream. The river here has moderate variability in bed characteristics with little fine sediment. Biological habitat has moderate variation and coverage however is dominated by willows on its banks. Natural experiential value here is moderate due to the presence of the bridge, vehicle noise and Mahinga kai support was also moderate.

Table 10: Showing Okuku Site 4 as overall having 'Moderate' Natural Character Value.
