BASELINE STUDY OF THE RANGITATA RIVER MOUTH ENVIRONMENT

Caitlin Frazer, Livvy Harris, Sophie Newsham, Jordan Ballisat,
Dennis Fogarty

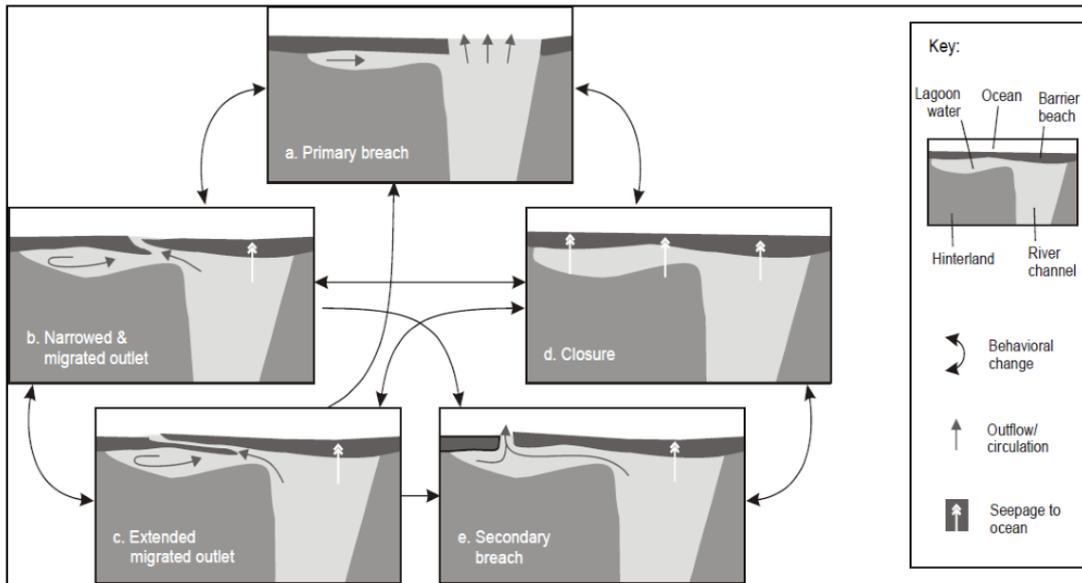
Figure 2. A flow diagram composed by Hart, 2009 of the common morphological stages observed in Canterbury rivers mouths such as the Opihi, Ashburton, Hurunui, Rangitata, Rakaia and Waitaki. A Primary breach (a) is mostly associated with high flow events and can sometimes occur due to high waves. Whereas a secondary breach (e) can occur during moderate floods as the migrated and elongated outlet is truncated. The combination of the outlet migration (b) and channel elongation (c) is attributed to low to moderate flow events and the longshore transport direction. Lagoon closure (d) would result from low river levels combined with low-high energy waves on the

Sediment transport and hydrological effects, driven by fluvial and marine physical processes, control the geomorphology of river mouths (Kirk, 1991; Hart, 2009). Variations in river flow change the sediment transport and erosional rate while sea storm events, swash, and cross-shore sediment exchange are the major marine processes that drive changes within hāpua (Hart, 2009; Kirk 1991). The combination of these processes causes the most significant changes at the mouth (Figure 2).

Models composed by Todd (1998) and Hart (2009) (Figure 2) are comparable to what was observed at the RRME (Figure 20). Links can be made with these morphological stages to both river flow and wave conditions. An increase in river flow can cause primary and secondary breaching of the barrier bar as the flow overtops the bars (Figures 18 & 19)(Apx. F). While the northern longshore current is the probable driver for the northern outlet migration and elongation (Figure 21)(Apx. D3) (Hart, 2009; Kirk 1991; Todd 1998). Generally, the outlet is wider when it is in a southern or central position (Apx. G). This was associated with high flow events and recent breaches, while outlet narrowing and elongation with near-parallel alignment to the coastline was associated with low flows. This corresponds with prior research (Hart, 2009; Todd, 1998). Low flow events can also cause hāpua and bar closures (Figure 17) (Todd 1998). Although no bar closures were observed in this research, it is still a possibility.

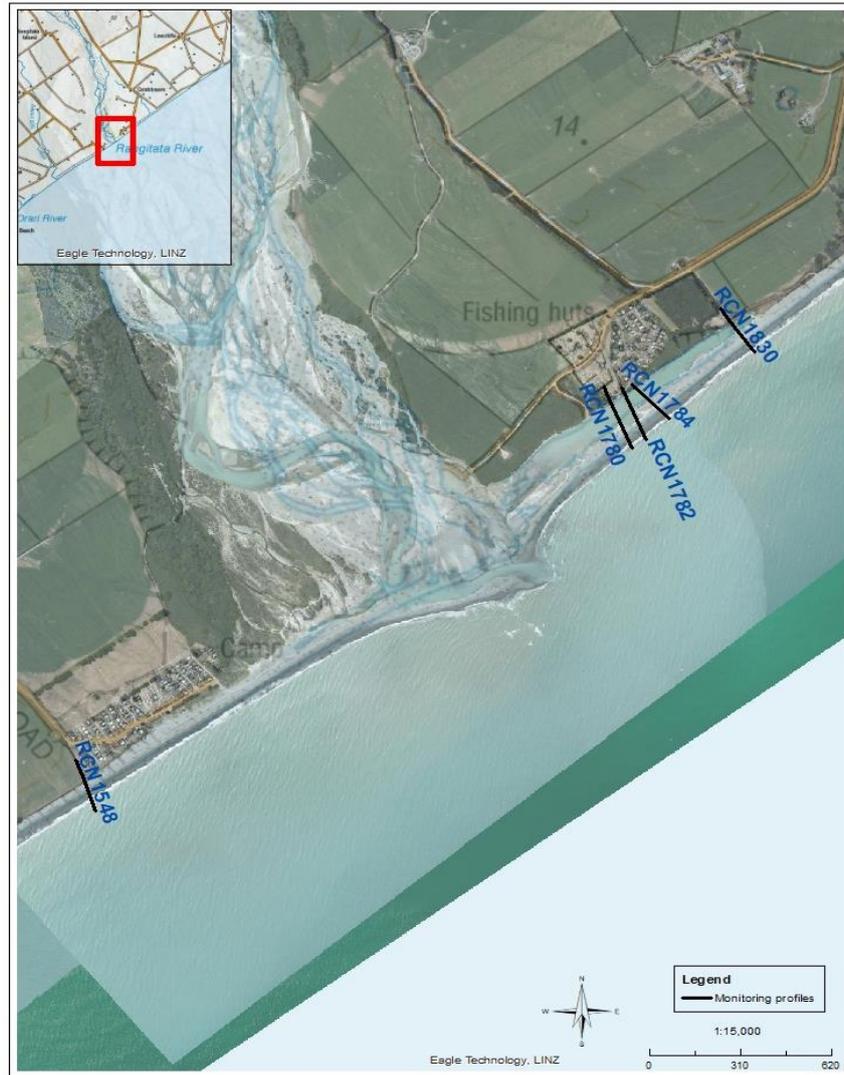
Figure 3. Map showing the location of the five beach profile sites. There is one south of the river mouth and four to the north. The four northern ones run through the hāpua.

Beach profile surveys have been completed by ECan across five sites in the RRME (Figure 3). Matlab was used to create beach envelopes, and subplots for the four northern profiles, which were used to identify trends in geomorphic variability. Matlab was also used to calculate sediment volumes at each site. Time series graphs created in Microsoft Excel (ME) showed changes in sediment volume. ME was used to create excursion plots for the profile sites.

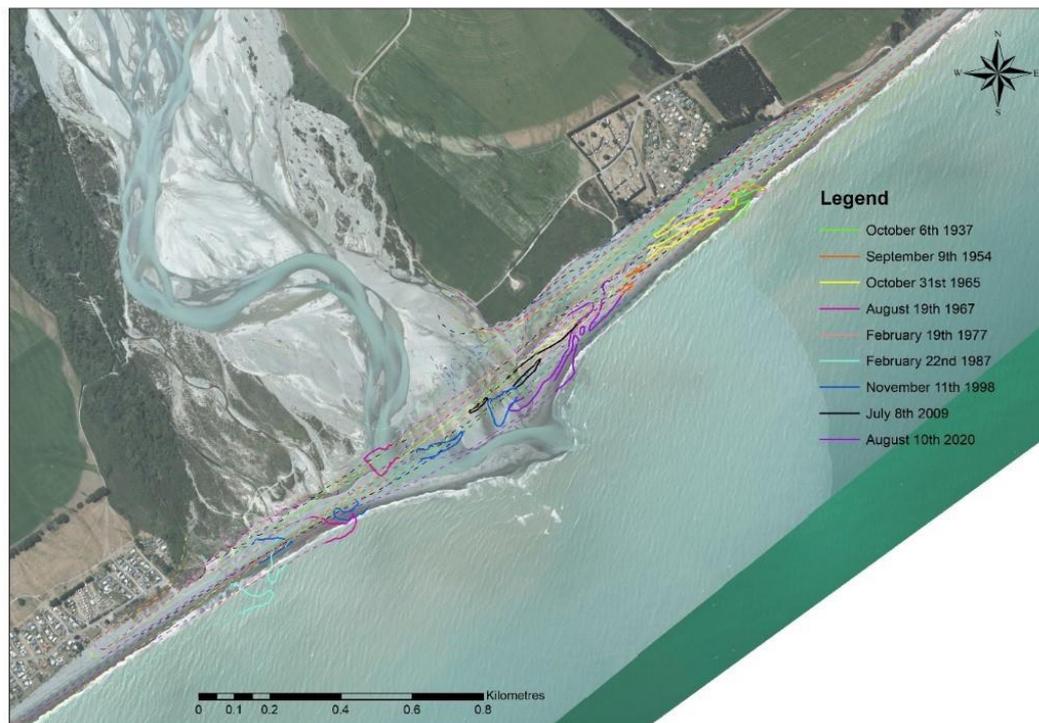
Figure 4. Map of the long-term trends (1937-2019), with around 10-year intervals between years. The rare years when there was also a hāpua in the south-east were 1954, 1965, and 1976. This was created in ArcMap, incorporating Retrolens, Google Earth, and Planet Labs imagery. Bold lines represent the river outlet, while the dashed lines outline the shorelines. Basemap is February 2019 Latest Aerial Imagery from Canterbury Maps.

The long-term imagery analysis found that the hāpua is more commonly located northeast of the river (Figures 4 and 5) which was also noted by Kirk (1991) and Todd (1998). However, there were instances of a second hāpua in the south before 1976. No links with river flow or wave data were obtained but a possible reason for this is the location of the main river flow further south than it is today (Figure 21).

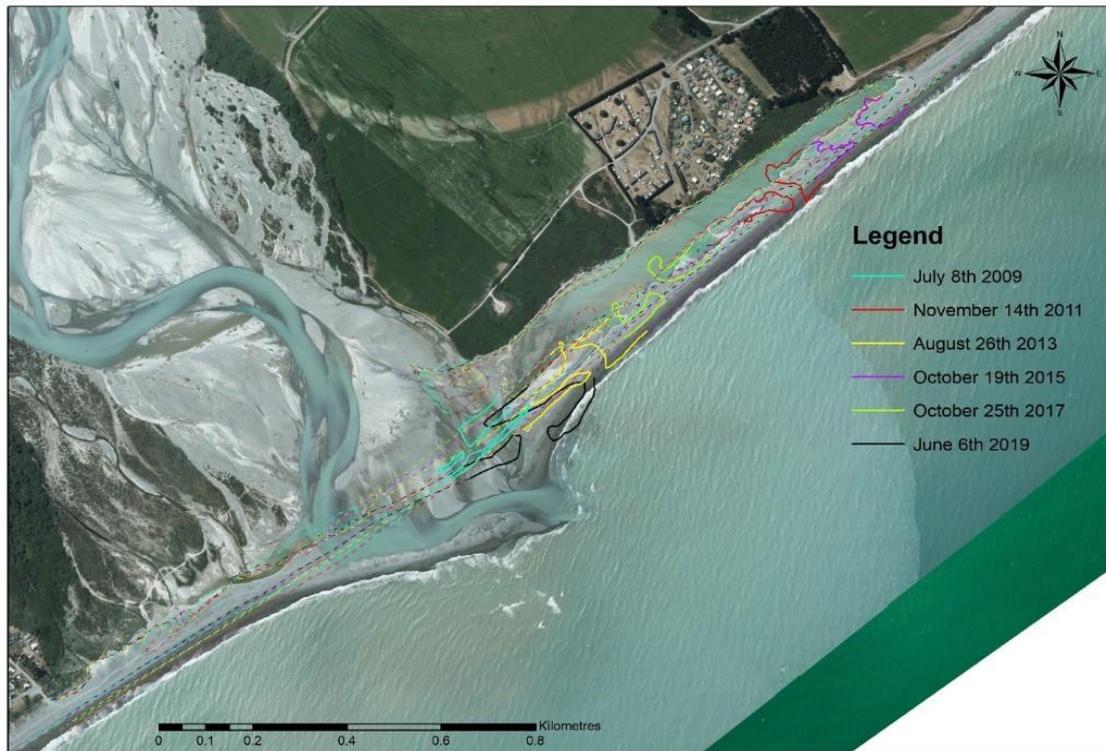
Figure 5. Map of the latest trends (2009-2019), with 2-year intervals between years. This was created in ArcMap, incorporating Google Earth and Planet Labs imagery. Bold lines represent the river outlet, while the dashed lines outline the shorelines. Basemap is February 2019 Latest Aerial Imagery from Canterbury Maps.

There were differences in trends over the last 10-years of imagery compared to the last 80-years (Figure 5). The outlets tend to be in the northeast portion of the RRME, while the hāpua is not observed south of the river mouth since 1976.

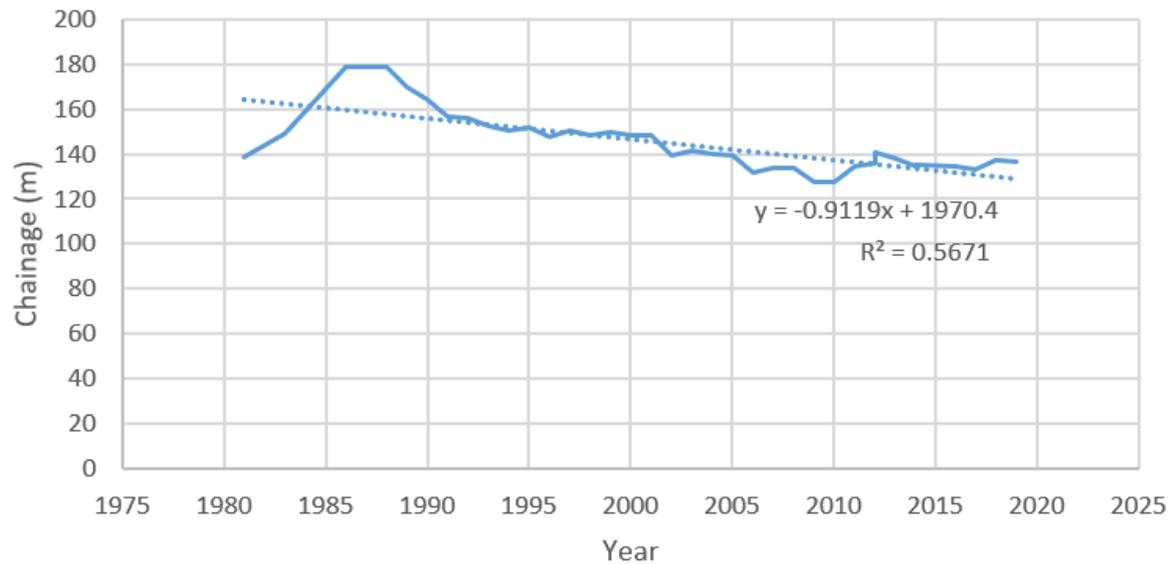
Figure 6. This excursion plot shows a short accretionary period from 1981 to 1988. Then the beach has been in an erosional state from 1989 to 2019. This erosional trend is also shown by the negative trendline and the R-squared value of 0.57 which shows a reasonable strong relationship. Data sourced from ECan.

The southern beach profile envelope (RCN1548) (Apx. B1) shows that the site has been extremely dynamic from 1981 to 2019. However, from 1989 the site has been in an erosional state (Figure 6), which has also resulted in decreasing sediments volumes (Figure 7).

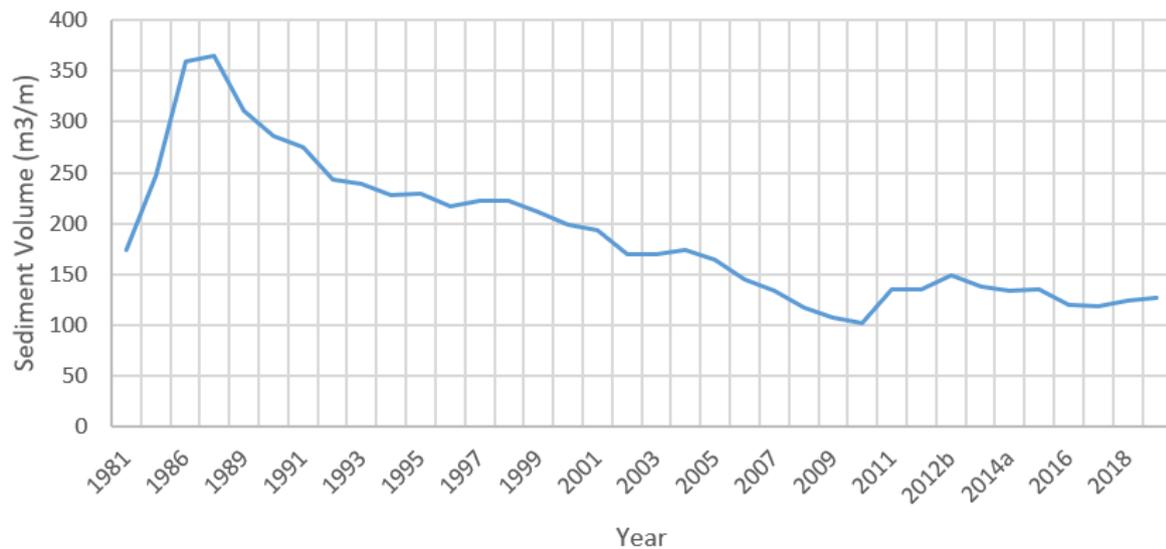
Figure 7. Changes in sediment volume at RCN1548. The peak sediment volume at the end of the short accretionary period was 365.4 m³/m. This had decreased to 126.89m³/m in 2019. Data sourced from ECan.

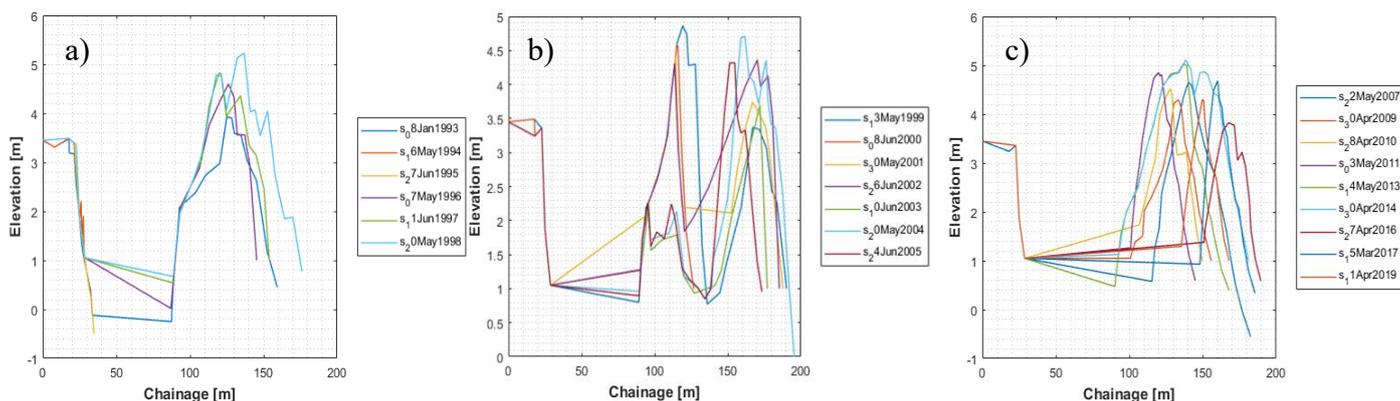
Figure 8. Profiles for site RCN1782 showing changes in shape. a) illustrates one main channel, which is the hāpua, and one bar feature. b) shows the formation of a secondary bar between approximately 150m to 200m. c) shows the change back to the only one bar. Data sourced from ECan.

The middle three profile sites (RCN1782, RCN1780 and RCN1782) showed the same trends so only one (RCN1782) will be referred to here. The beach envelope for 1993 to 2019 (Figure B2) shows that RCN1782 is a dynamic site which has experienced changes in the shape of the profile. The formation of a secondary bar at this site occurred in 1998 and persisted until 2005 (Figure 8). This site has had distinct periods of erosion and accretion (Figure 9), which is also shown by changes in sediment volume (Figure 10).

Another key trend identified for RCN1782, is the formation of a secondary bar between 1999 and 2005 (Figure 8). However, due to no imagery for this time period and annual collection of profile data the causes of this feature have not been investigated. Furthermore, the formation of the secondary bar doesn't coincide with any significant increases or decreases in sediment volume. The mean sediment volume between 1993 and 1998, when there was only one bar, was 213.8m³/m. Whereas between 1999 and 2005 the mean sediment volume was 210.08m³/m. Although this research was unable to identify any causes for the dynamics at RCN1782, they still need to be incorporated into a baseline and can be an area for further research.

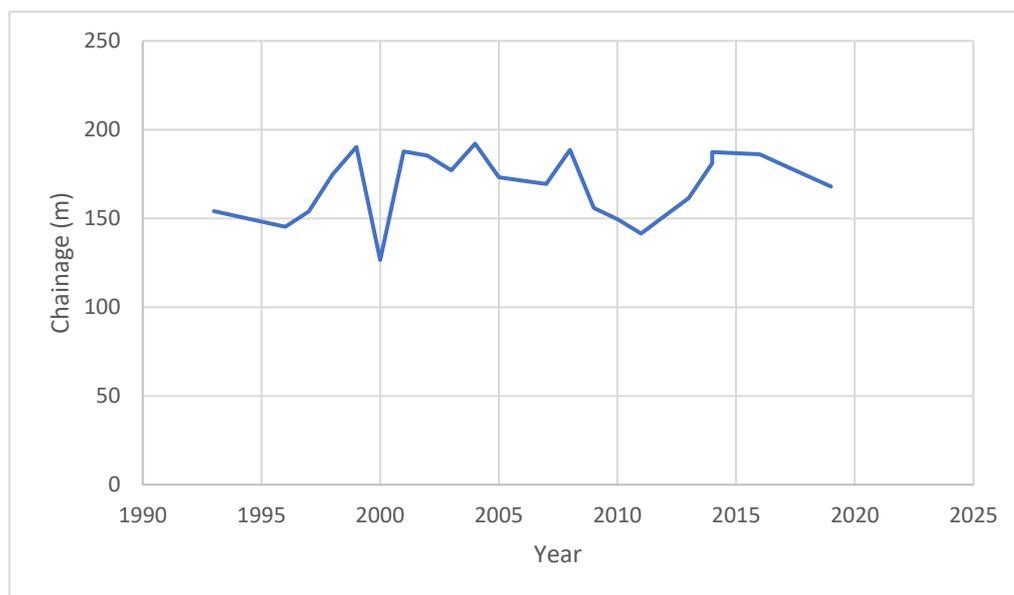
Figure 9. Excursion plot for RCN1782. There are clear periods of erosion and accretion, however, no long-term trend is visible. Data sourced from ECan.

RCN1782 has experienced erosional and accretionary periods, but no long-term trend (Figures 9 and 10). A possible reason for these dynamics is El Niño Southern Oscillation (ENSO). ENSO is a multiyear oscillation, consisting of two phases, which effects climatic processes on a global scale (Christopherson & Birke, 2015). During phases of El Niño high-pressures persist in the Western Pacific causing increased rainfall over the West Coast of NZ (NIWA, n.d.). However, when comparing erosional periods for RCN1782 to the Southern Oscillation Index (SOI) no obvious links between phases can be identified (Australian Government Bureau of Meteorology, 2020). Figure 22 shows the monthly SOI from 1996 to 1998, during this time there were two La Niña occurrences and one El Niño. However, from 1996 to 1998 RCN1782 was accreting and the sediment volume increased by 108.86m³/m. This indicates that moving between El Niño and La Niña had no impact on moving between erosional and accretional periods at RCN1782. However, the profiles were only taken annually, so if more regular data had been collected then the effects of ENSO may have been identified.

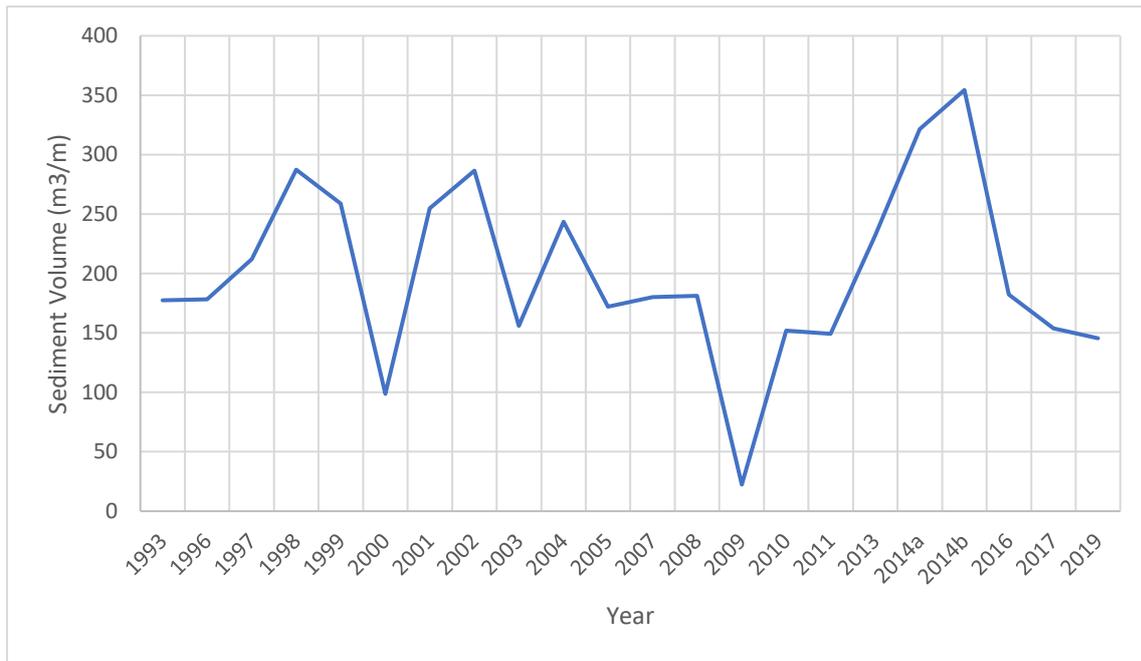
Figure 10. Time series showing changes in sediment volume for RCN1782. There are clear periods of erosion and accretion, however, no long-term trend is visible. Data sourced from ECan.

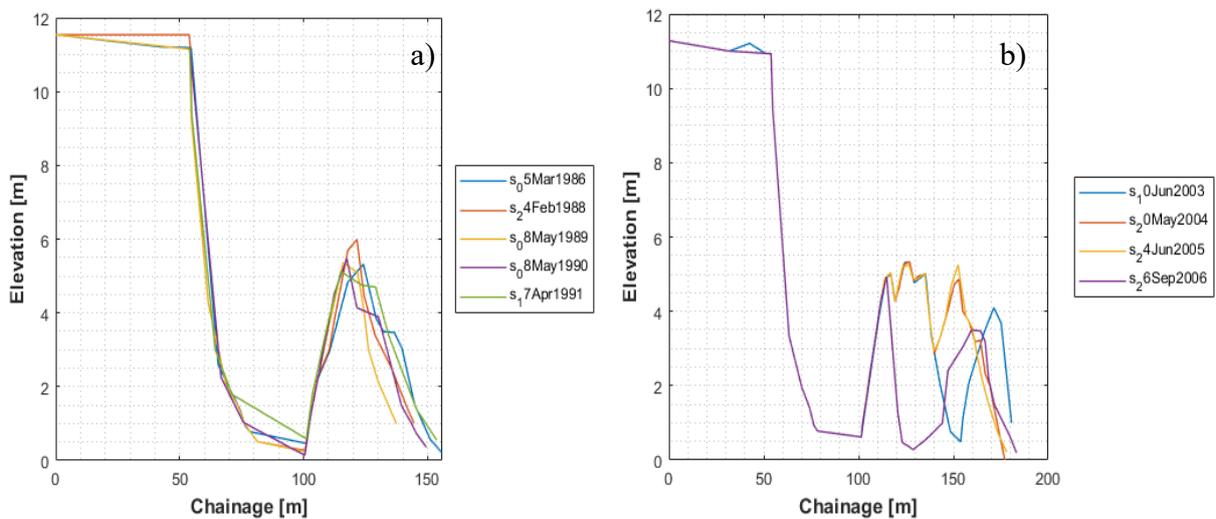
Figure 11. Profiles showing examples of different shapes identified at RCN1830. a) shows one main channel, which is the hāpua between 1986 and 1991, and one bar feature. b) shows the formation of a secondary bar between approximately 150m and 200m. Data sourced from ECan.

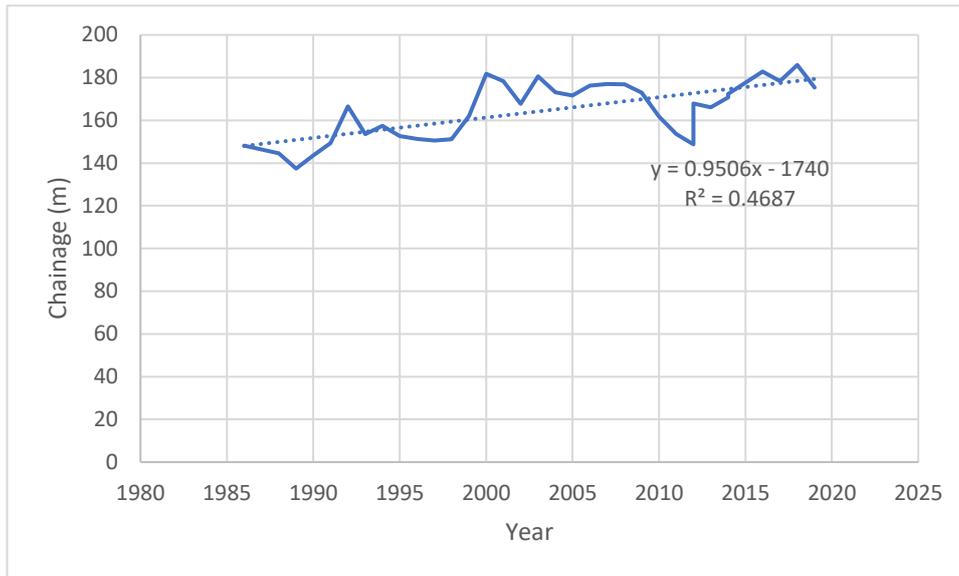
Figure 12. Excursion plot for RCN1830. There have been periods of erosion and accretion, but there has been a long-term trend of accretion. This is demonstrated by the positive trendline and R-squared value of 0.47. Data sourced from ECan.

The coastline north of the RRME (RCN1830) has experienced an overall trend of accretion since 1986 (Figure 12). The trend of net accretion is contrary to what is expected according to the Department of Conservation (2000) who suggests that hāpua will roll back. This means that a hāpua would maintain its morphology but would move in a landward direction in response to rising sea levels. However, the results from this study found that RCN1830 is

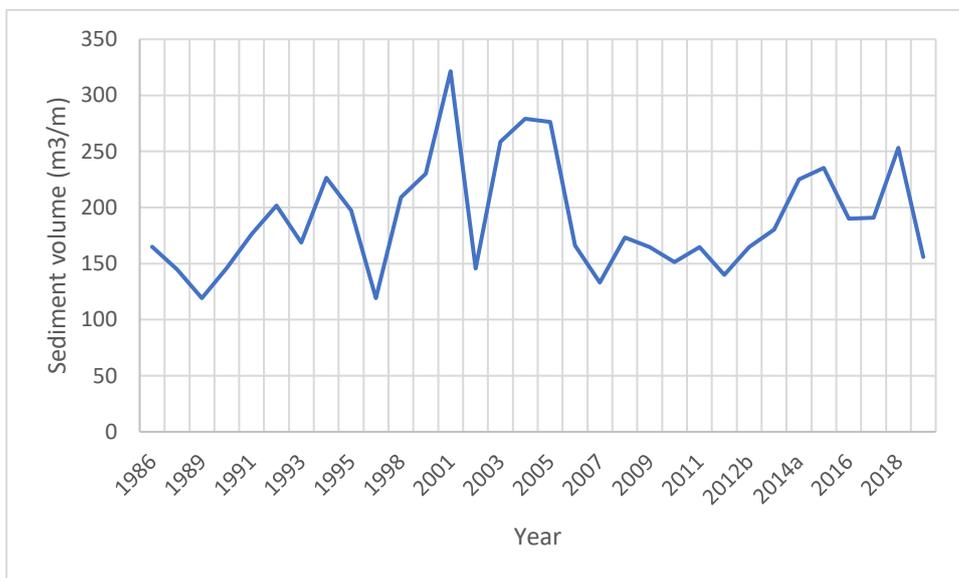
Figure 13. Changes in sediment volume for RCN1830. There have been distinct periods of erosion and accretion, but no long-term trend visible. Data sourced from ECan.

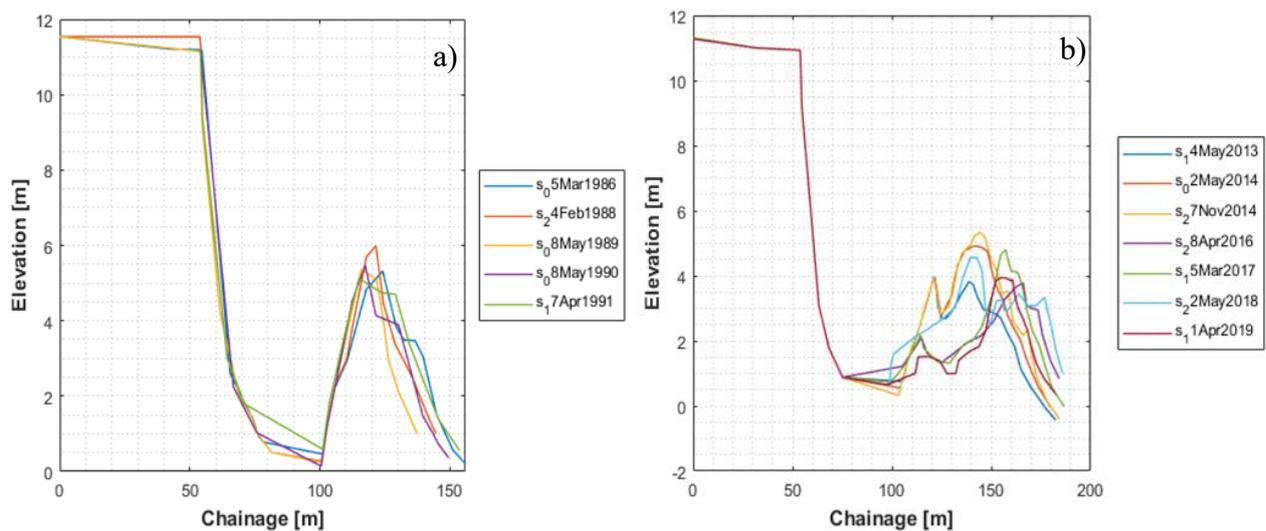
Figure 14. Profiles for RCN1830 showing widening of the barrier bar. The width was approximately 50m from 1986 to 1991 (a), and between 2013 and 2019 it was approximately 80m (b). Data sourced from ECan.

The northern profile site (RCN1830) has been a highly dynamic location from 1986 to 2018 (Figure B3). The formation of a secondary bar feature is also a common occurrence at this site (Figure 11). There have been periods of erosion and accretion however, a long-term trend of accretion can be identified (Figure 12). This same pattern is shown by changing sediment volumes from 1986 (Figure 13). There has also been a widening of the main barrier bar feature (Figure 14).

RCN1830 has also displayed a widening of the barrier bar (Figure 14). This is supported by long-term accretion and increases in sediment volumes. The mean sediment volume between 1986 and 1991 was 150.23m³/m, which increased to 203.34m³/m between 2013 and 2019. This is most likely due to the influence of the northern longshore current in this region (Figure 23). The accretionary trend and widening of the barrier bar occurring at RCN1830 are important elements to incorporate in a baseline of the RRME.

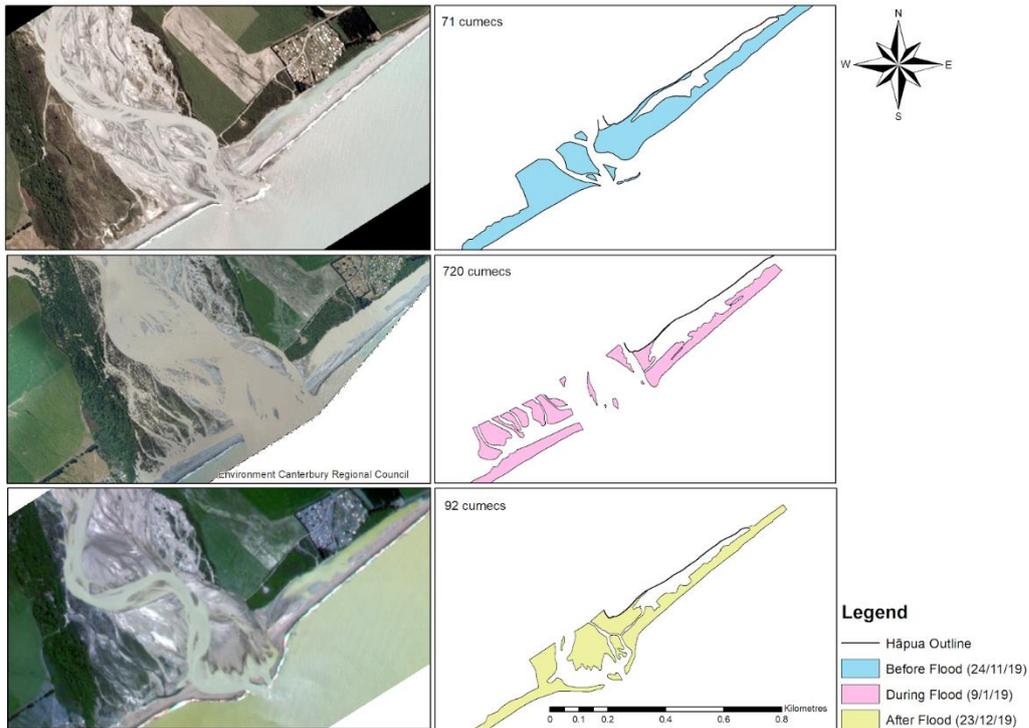
Figure 15. This sequence of images and polygons represents a flood event in November 2018 of 1847m³/s. The blue polygon represents where the bars were prior to the flood while the pink represents the bars during the flood. It is illustrated in the yellow polygon that after the flood the bars either side of the outlet moved seaward in a convex shape.

A barrier bar may experience significant morphological changes in response to high-energy flow events (Hart, 2009; Kirk, 1991; Masselink et al., 2014). It is common for barrier bars become truncated forming a wide outlet in a new position at RRME (Figure 15). A primary or secondary breach can be observed after high-flow conditions (Figures 15 and 16) (Apx. C)

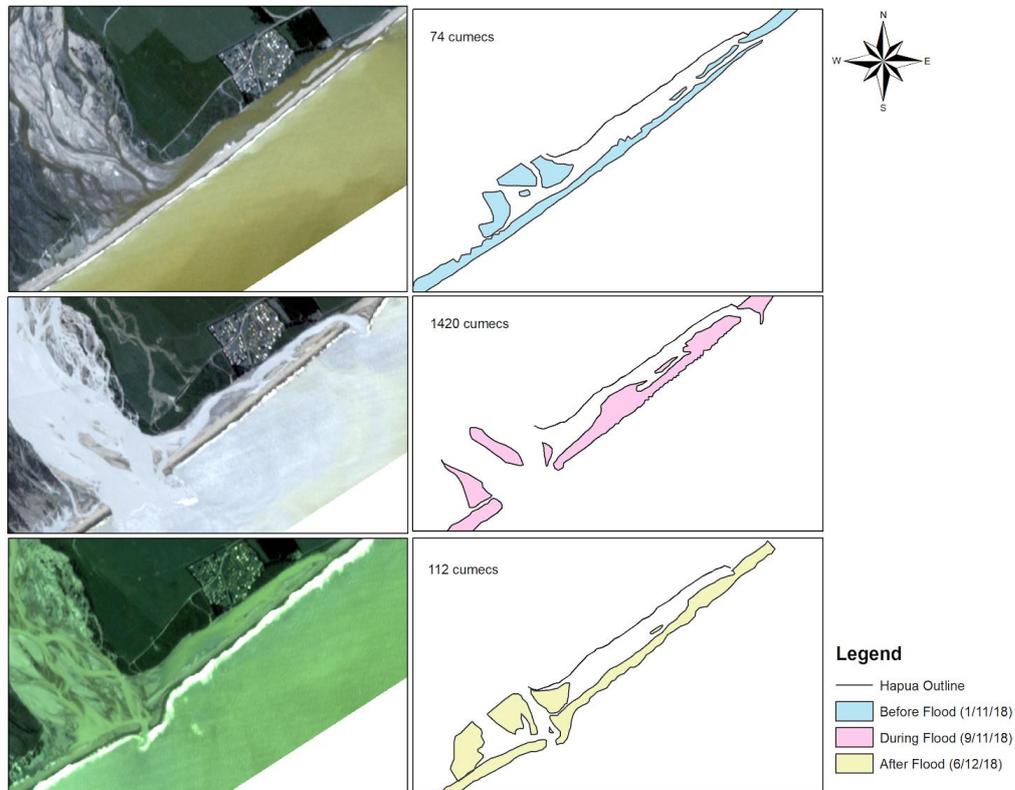
Figure 16. A sequence of prior, during and after a flood event in November 2018 of maximum 1847m³/s. The coloured polygons represent the bar features. Images sourced from Planet Labs.

Analysis of the five largest flood events from 2016-2020 showed similar trends. This time period was chosen because there was access to near-to daily imagery. The dominant morphological patterns were widening of the outlet channel, seaward movement of the bars near the outlet (Figure 15) and breaching of the barrier bar directly downstream of the main river flow (Figure 16) (see Apx. C for further detail).

A trend discovered following high flow events is the generation of a convex shape of the barrier bars (Figure 16). In the discussed flood examples, the seaward movement of the barrier bars surrounding the outlet was caused by deposition of sediment along the bars (Jowett, Richardson, & Bonnett, 2005).

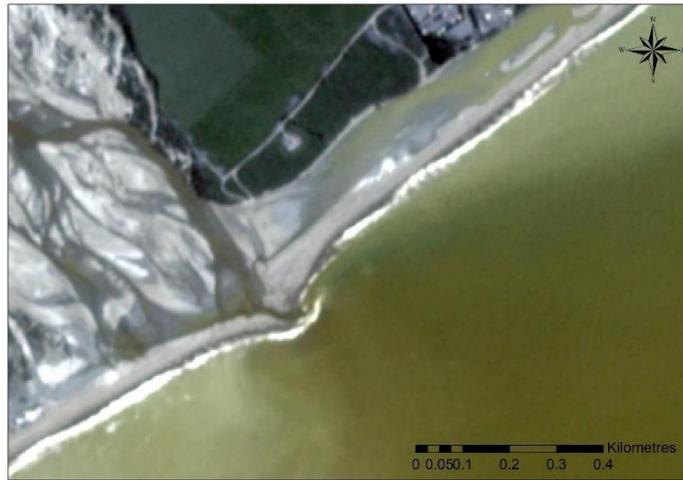
Figure 17. A false-colour image indicating a time period when the hapua is separated from the main river flow. The river flow was ~65m³/s on average for the date of 19th of February 2019. Image sourced from Planet Labs.

Images since 2016 with corresponding river flows of less than 70m³/s indicates that the hāpua can separate from the main river flow for up to days at a time (Figure 17). There was no clear evidence to show full barrier bar closure.

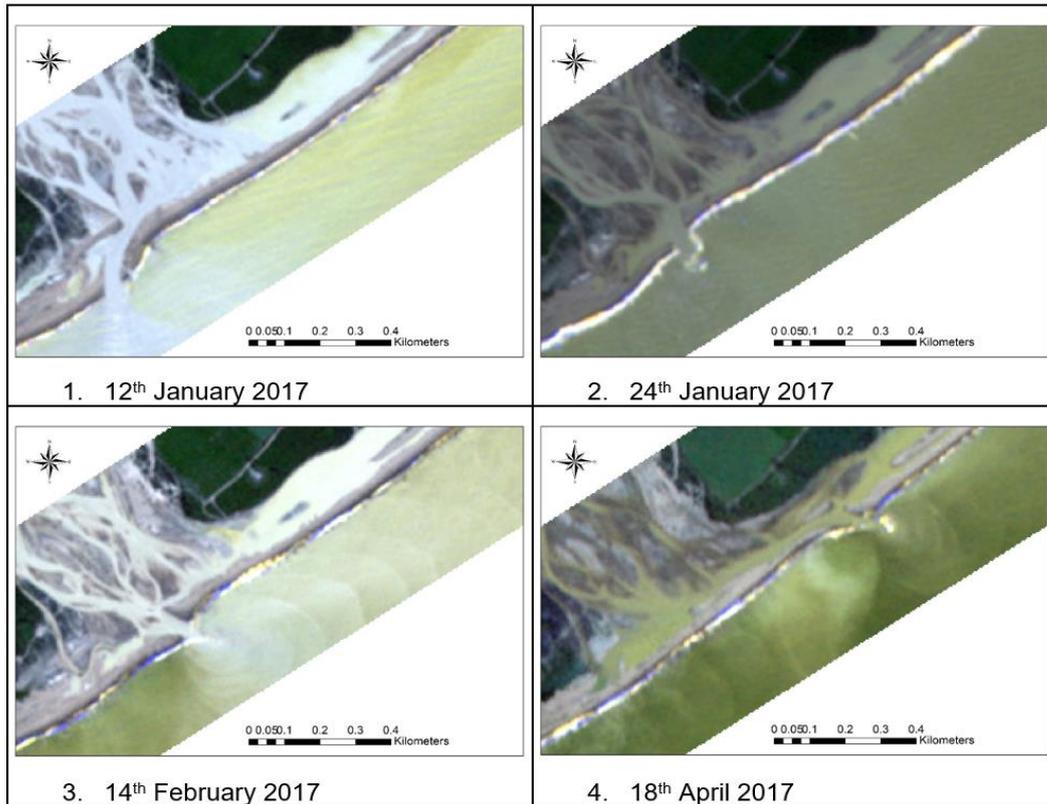
Figure 18. This series of false colour maps shows northern outlet migration. The measured distance between image 1 and 2 is $170\text{m} \pm 10\text{m}$ which represents on average 14m per day over this time period. The distance measured between image 2 and 3 is $60\text{m} \pm 10\text{m}$ which represents on average less than 3m of migration per day. The distance measured between image 3 and 4 was $520\text{m} \pm 20\text{m}$ which represents on average 8m per day. Overall, the outlet moved north-east $\sim 800\text{m}$ over the four-month period. Images sourced from Planet Labs.

Episodes of northern outlet migration were observed and commonly followed a flood event (Figure 18). Faster migration occurred initially after a flood as opposed to when the outlet was adjacent to the middle of the hāpua.

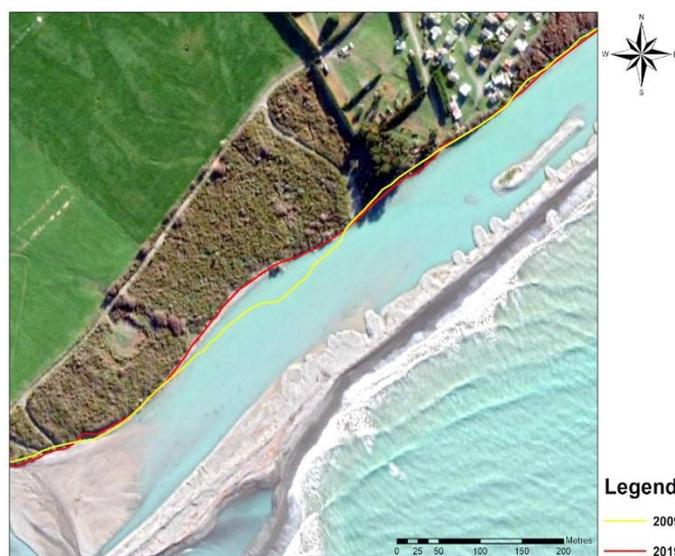
Figure 19. Map of the erosion into the bank SE of the Rangitata

Over the past 11-years significant erosion has occurred southeast of the Rangitata Huts (Figure 19). The yellow line represents the shoreline of the hāpua in 2009, while the red is 2019. This erosion was estimated to be $\sim 35\text{m} \pm 10\text{m}$ using measurement tools in ArcMap.

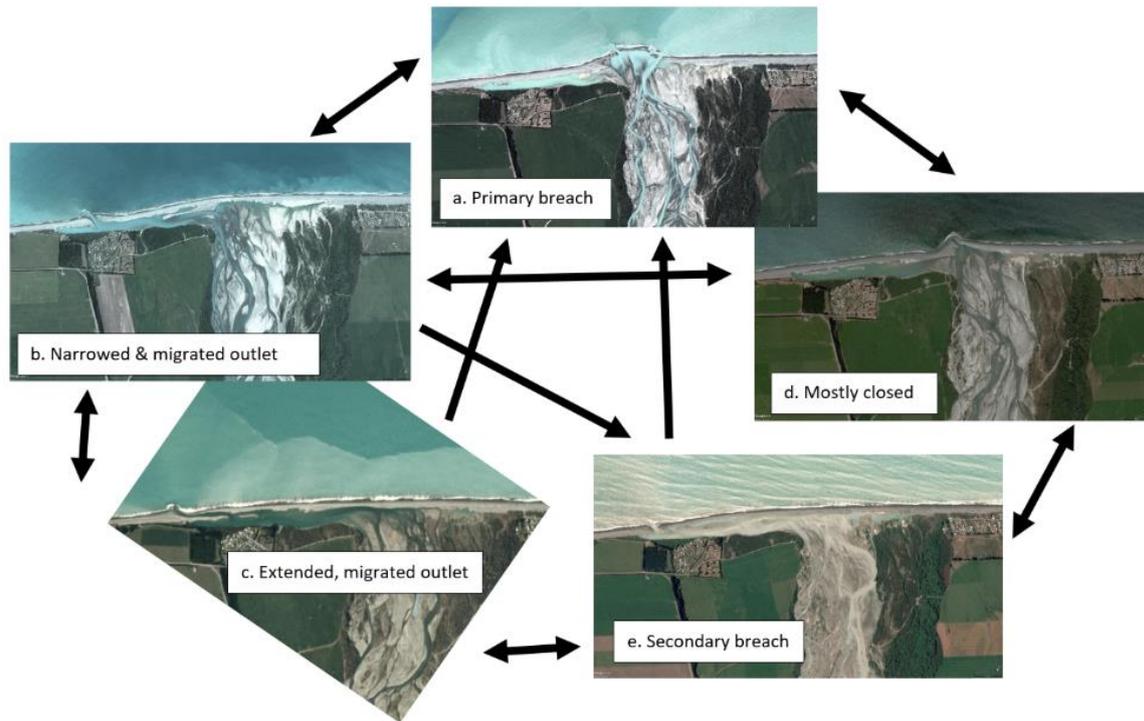
Figure 20. A flow diagram illustrating the stages of commonly observed morphology of the RRME. Adapted from Hart, 2009 pg. 1357.

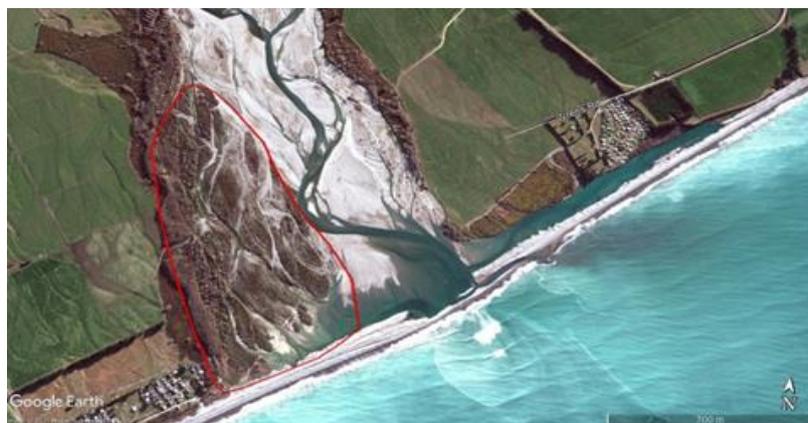
Figure 21. Image of the RRME showing extinct river channels further south of the main flow than in more recent years which could explain the hāpua position south of the river mouth in previous years such as 1954, 1965, and 1976. Images sourced from Google Earth Pro and was taken on the 8th of July 2009.

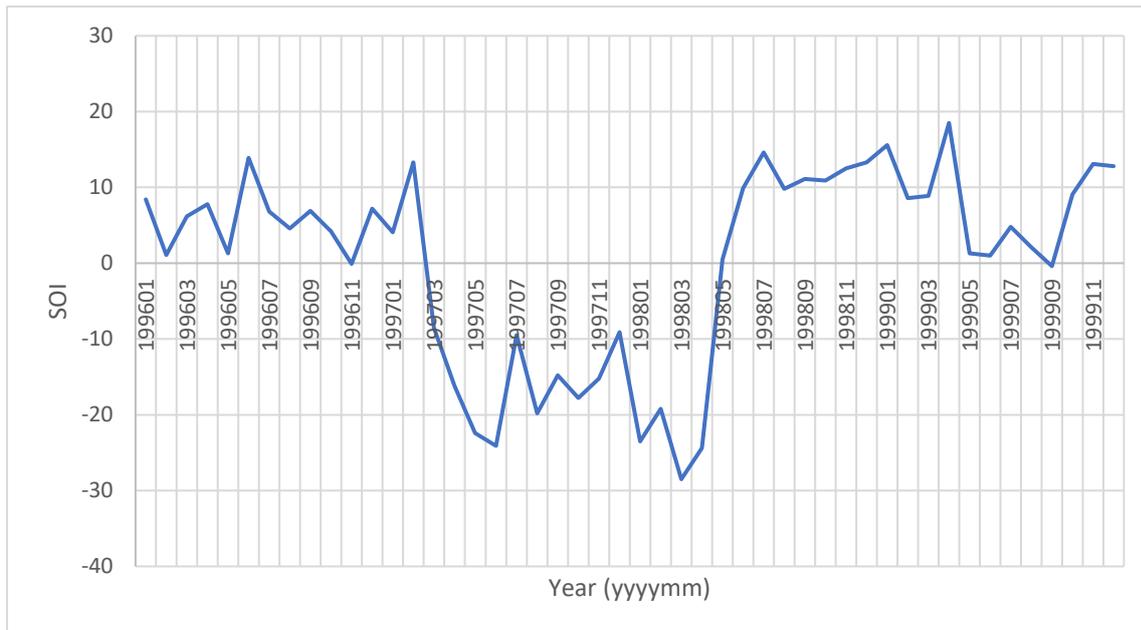
Figure 22. SOI from 1996 to 1999. When there are sustained periods of +7 or above this indicates La Niña. Whereas sustained periods of -7 indicate El Niño. Data sourced from Australian Government Bureau of Meteorology.

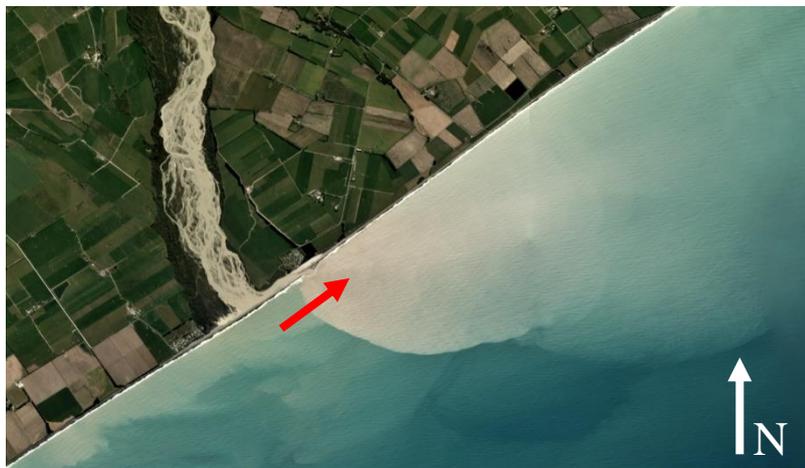
Figure 23. Aerial image showing long-shore transport of sediment in a south to north direction, indicated by red arrow. This is moving sediment away from the southern end of the RRME and towards the northern end, which could be contributing to erosion in the south and accretion in the north. Image sourced from *Planet Labs*.

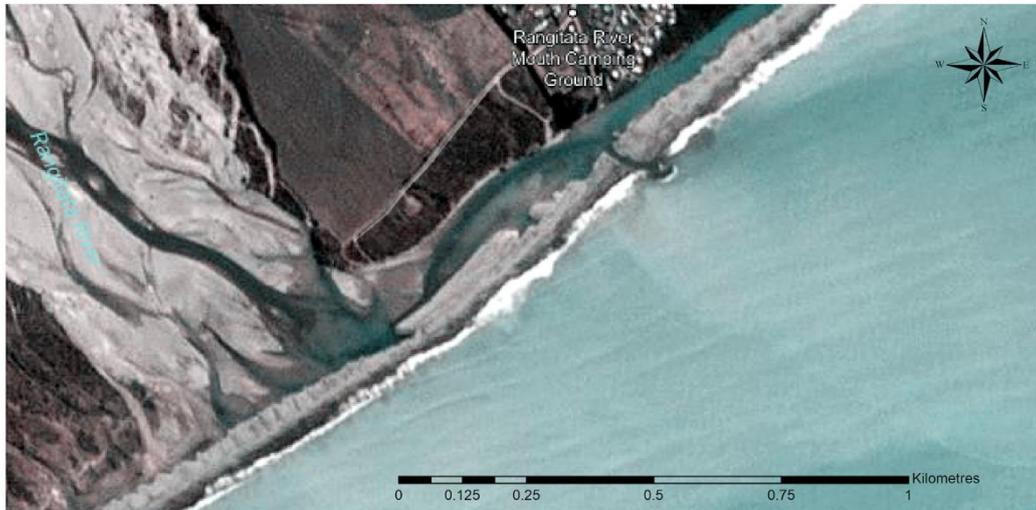
Figure 24. Image demonstrating the river channel flowing further into the usual hāpua location. This may be a possible reason for the shape of the bank erosion seen south-west of the Rangitata Huts. Image sourced from Planet Labs.

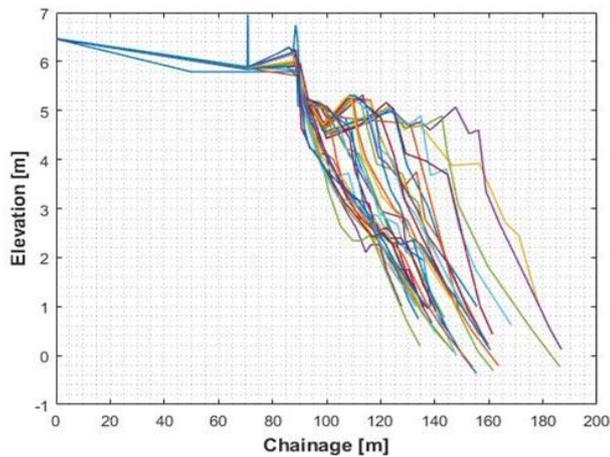
Figure B1. Beach envelope for RCN1548 for 1981 to 2019, which shows the minimum and maximum extent of the beach face. This envelope demonstrates that this site has experienced no change in profile shape over the years on record. Data

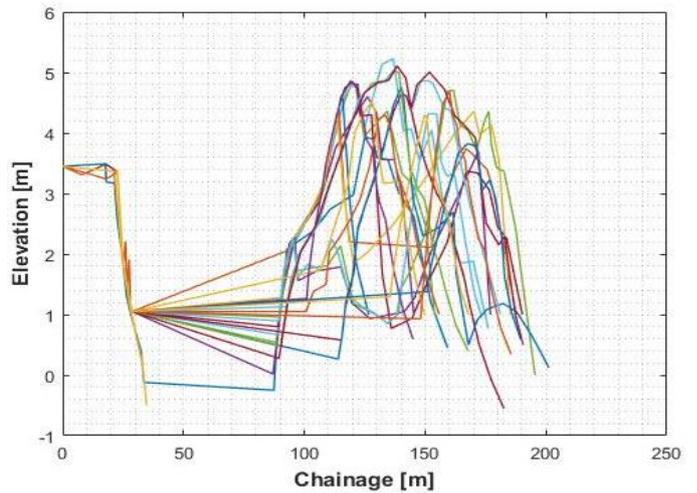
Figure B2. Beach envelope for RCN1782 1993-2019.

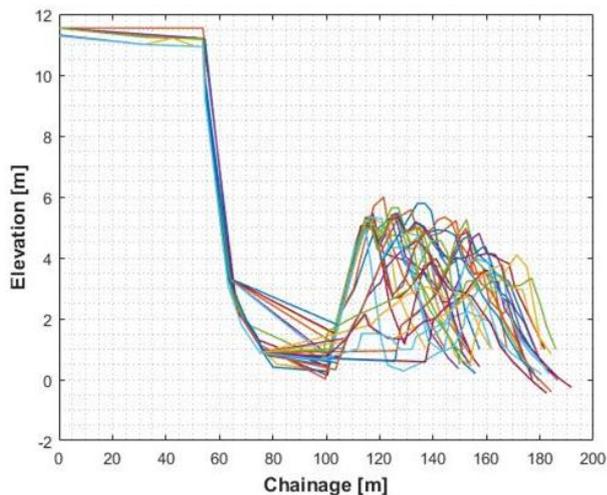
Figure B3. Beach envelope for RCN1830 1986-2019. One main channel, which is the hāpua, can be clearly identified. Data sourced from ECan.

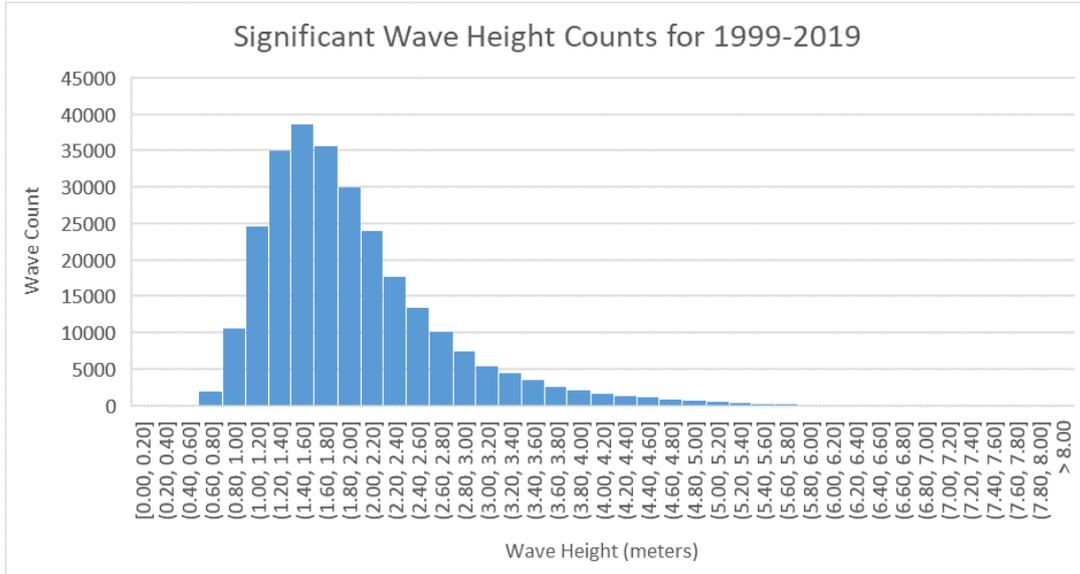
Figure D1. Histogram showing significant wave height counts recorded for 1999-2019. The most common waves (20,000 or more) consisted of heights ranging from 1 metre to 2.2 metres.

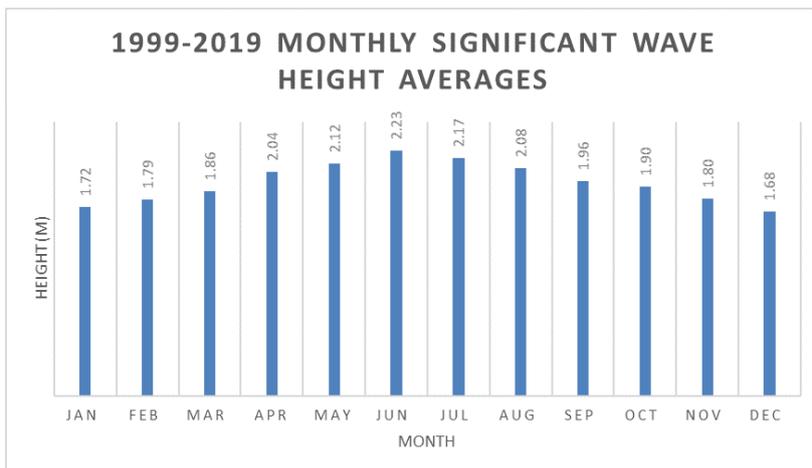
Figure D2. Bar chart showing the monthly significant wave height averages from 1999-2019. June and July feature the highest monthly averages of 2.23 and 2.17 respectively.

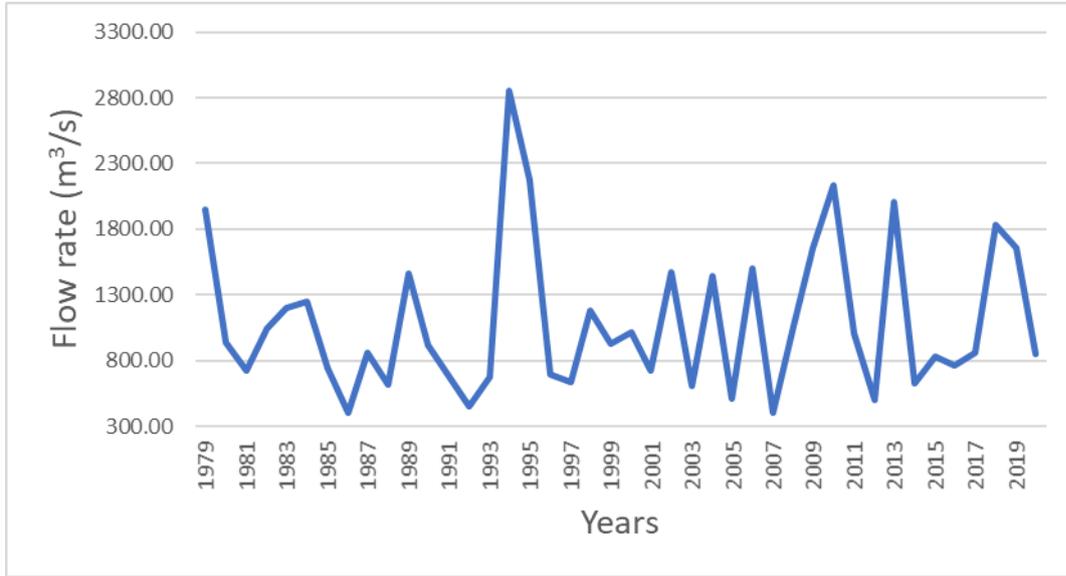
Figure E1. Graph showing annual high river flow averaged over the three largest events per year from 1979-2019. It shows a peak in high flow during 1994-1995. Data sourced from ECan.

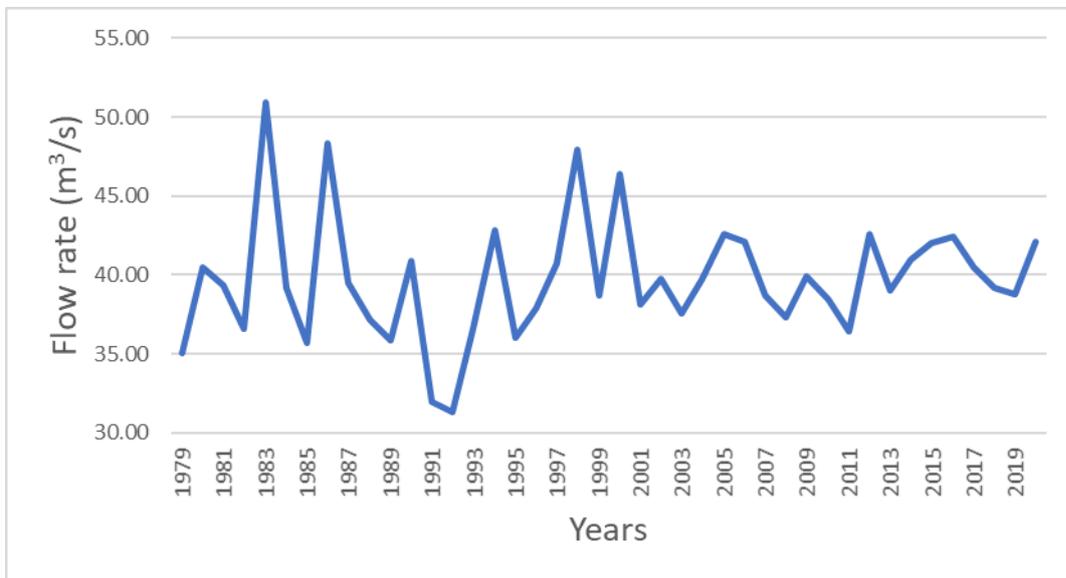
Figure E2. Graph showing annual low river flow averaged over the three smallest events for each year. It shows fluctuations in flow rate between 32 and 52 m³/s over the 41-year period. The lowest flow occurred from 1991-1992. Data source is ECan.

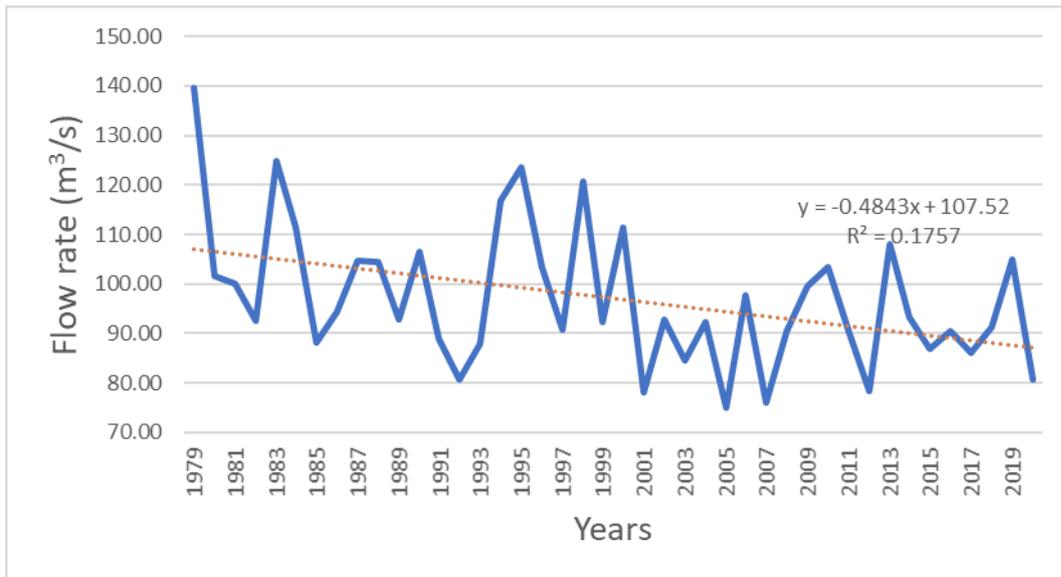
Figure E3. Graph showing annual average river flow. Fluctuates between 75-140 m³/s with an overall decrease in flow rate since 1979. Data source is ECan.
