BASELINE STUDY OF THE RANGITATA RIVER MOUTH ENVIRONMENT

Caitlin Frazer, Livvy Harris, Sophie Newsham, Jordan Ballisat,
Dennis Fogarty

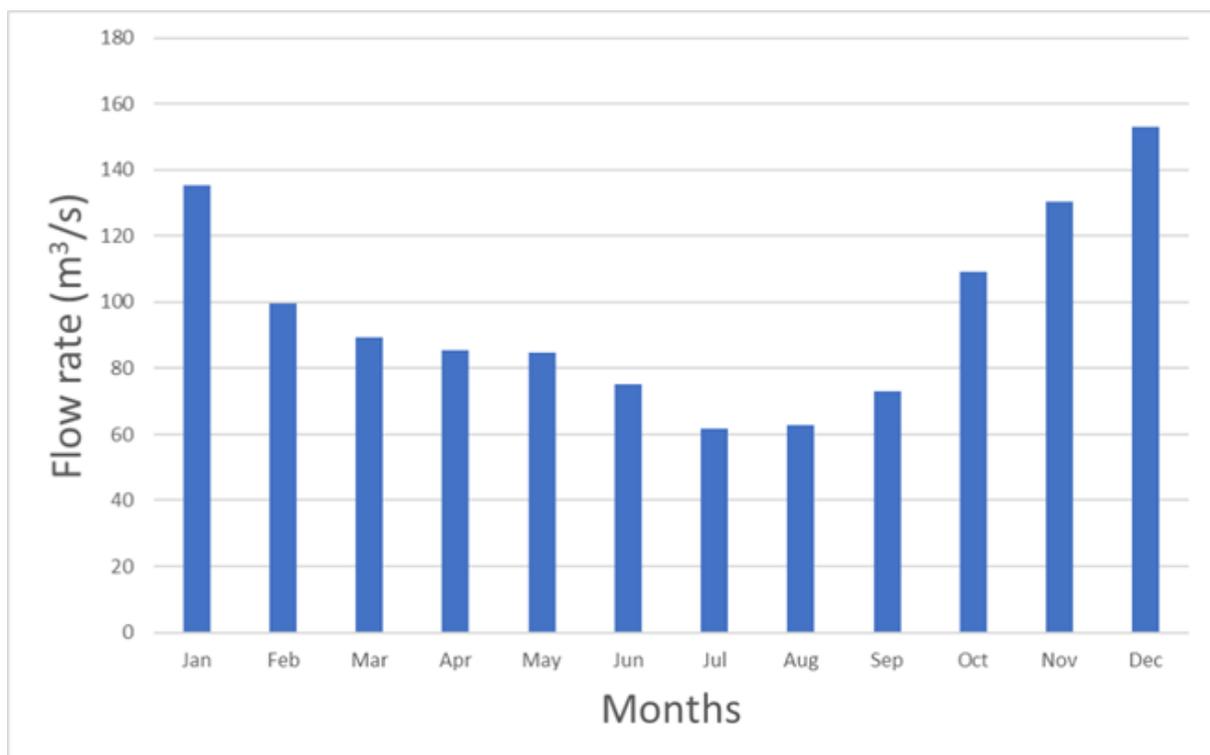
Figure E4. Graph showing average monthly river flow. The months of higher river flow are October through to February whereas July represents the month of lowest average flow. Data source is ECan.

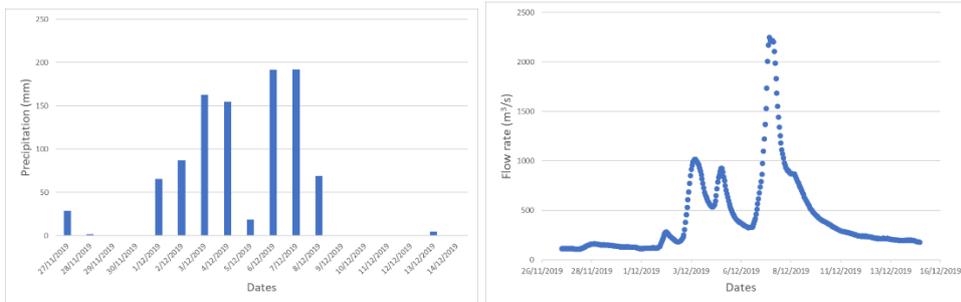
Figure F1. Rainfall at Mistake Flats Rain Gauge (December 2019) and Rangitata River flow at Klondyke for the associated period. Data source is ECan.

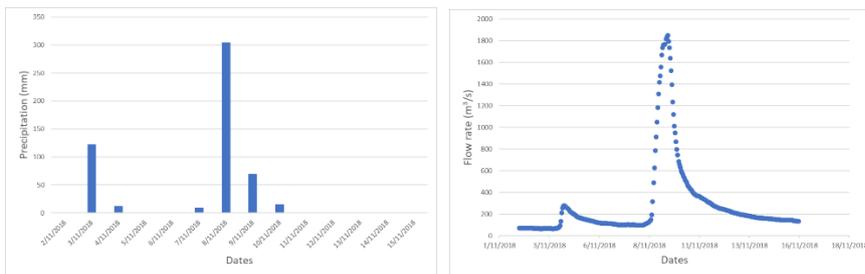
Figure F2. Graphs showing rainfall at Mistake Flats Rain Gauge (November 2018) and Rangitata River flow for the corresponding week. Data source is ECan.

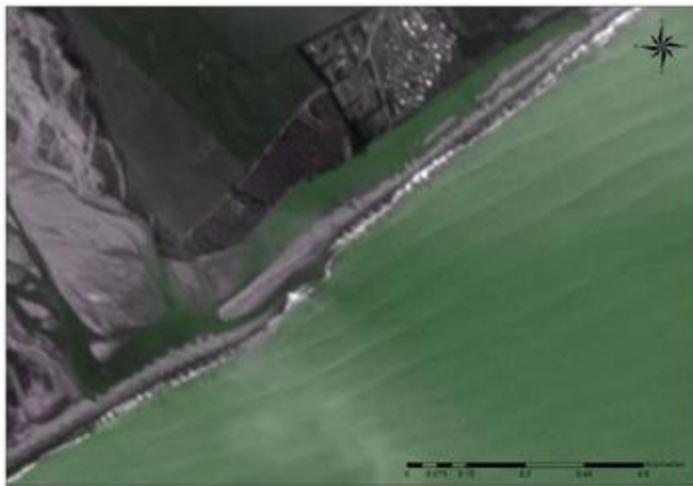
Figure G2. Map in false colour showing scalloped foreshore and lobed backshore with large south-easterly waves. Image sourced from Planet Labs.
