How to facilitate access to Motukauatirahi (Cass Bay) Reserve taking into consideration conservation and restoration

2021

A GEOG309 project by Jessica
Rodwell, Rachael Nilsson,
Jamie Wisker, Ella Harford and
Arlia O'Sullivan

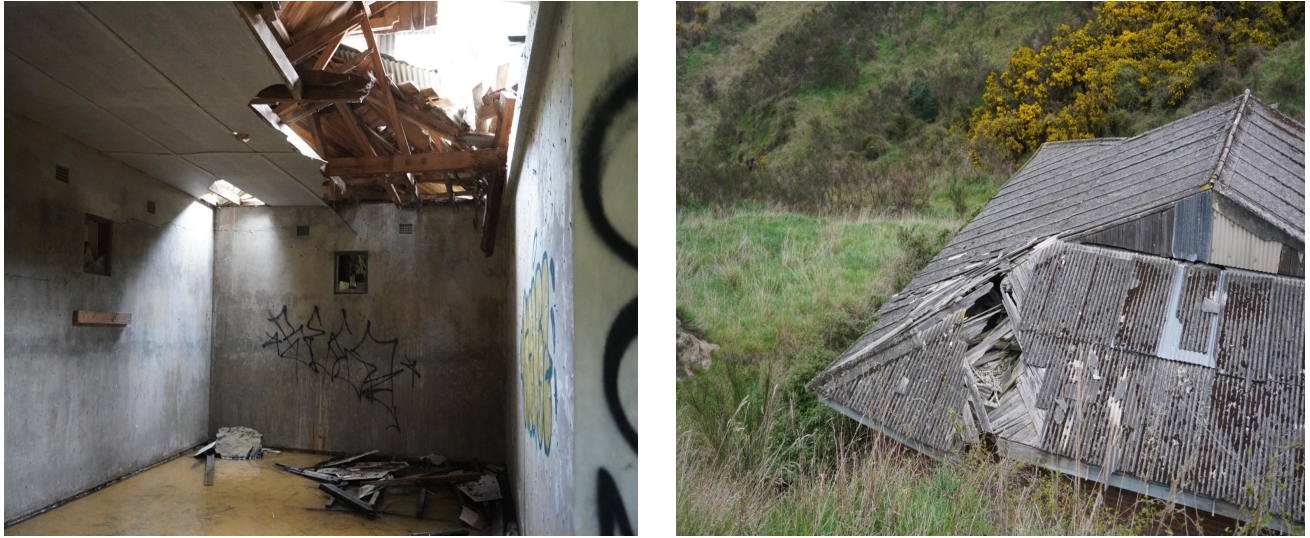
Figure 1. These images show the damage caused by rockfall to the bunkers in the Cass Bay Reserve.

The main physical hazard in the Cass Bay Reserve site is the bunkers. These bunkers are currently in varying conditions, ranging from fully intact to “no-go zones”. These “no-go zones” were caused by rockfall triggered by the Christchurch earthquake penetrating the roofs, as can be seen in Figure 1 (Christchurch City Council, 2021). There is limited information as to what was originally stored in the bunkers, however, it is known that these buildings have asbestos roofs. Interaction with asbestos will be hazardous to the community and hence will need to be taken into consideration when opening the area to the public (Lyttelton Review, 2020).

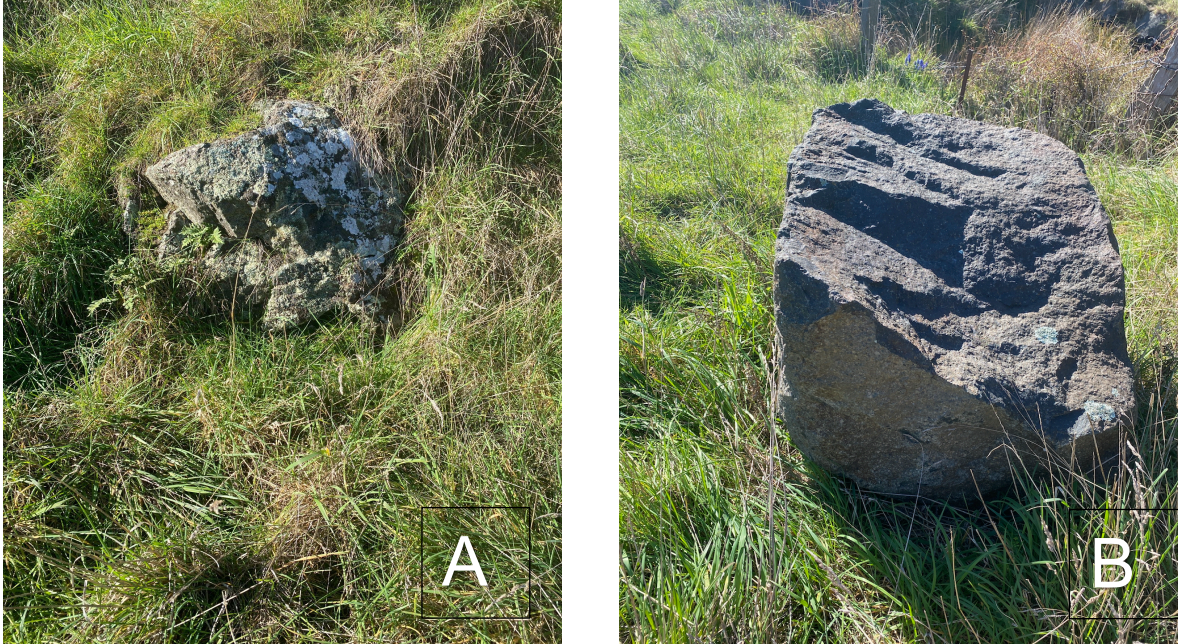
Figure 2. This figure shows the comparison between the historical Post Christchurch earthquake rockfall. The historical rockfall in image A has a large amount of colluvium build up and lichen growth on the deposit because it has been sitting undisturbed for a long period of time. This was then compared to Image B having one face containing lichen growth, correlating with the face exposed to weathering before it fell, as well as the limited colluvium build up around the deposit.

In terms of the data collection for the hazards present on the site, the resources that were already available were first assessed. This included a mass movement investigation in the Port Hills that was undertaken by the Christchurch City Council (n.d.) and a hazard assessment created by AECOM (2016) for the Cass Bay Reserve. From these investigations, gaps in knowledge and what could be improved on were recognised. Looking at previous hazard maps as it was found that both investigations lacked proper mapping of the rockfall hazard at a local level (Figure B.1, Appendix B & Figure D.1, Appendix D). Taking this into account, a simplified method of Borella et al. (2016) that was used in the qualitative assessment of the lichen growth and colluvium build up around the rockfall to assess the ages of each deposit. Using this method, the Reserve site was walked, marking out the geographic coordinates on a handheld GPS (MyTracks) of each rockfall deposit. From this data, the rockfall was split up into groups of historical and post-Christchurch earthquake rockfalls. This data was then assessed and used to determine the hazard rating of the areas within the reserve. These hazard ratings were then used to create a map of the overall hazards within the Cass Bay Reserve site.

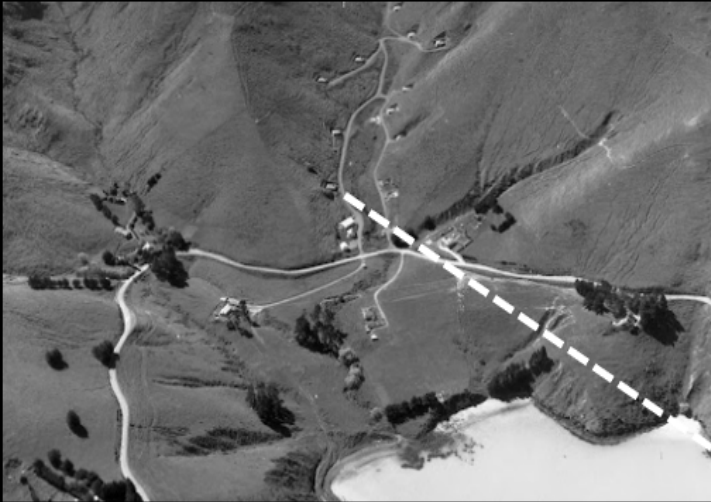
History of Motukauatirahi reserve

Aerial view of Cass Bay 1962.

Bunkers:
In this reserve, there were a total of 10 bunkers. These included brick concrete magazines, an ammunition processing building, administration building, four-man hut, guardhouse, and a flag station. This area was selected upon due to the uninhabited area not visible from the Lyttleton Harbour heads, which could be accessed by the sea. The aspect of the landscape being quite steep also made this area favourable. Currently (2021) there are 9 bunkers, a detonation chamber, and a blown-up bunker. All bunkers are double brick layered to send explosions up through the roof. However, they are unable to be accessed due to asbestos within the roofs.

Figure 8. Proposed historical signpost signboard to include along the walking tracks. This signboard incorporates a general timeline of the area and outlines World War II history.

Figure 8 shows what is proposed to be portrayed on the historical signpost to be placed along a point of the walking track. This includes an image on the top left of Cass Bay in 1962. This is then followed on the top right with a timeline of historical events in Cass Bay. This ranges from volcanic formation 7-11 million years ago, through to early human settlement and then locking of the gates in 2003. The picture on the bottom right is a current image of war bunker number three. Information obtained from interviews and literature have been collated.

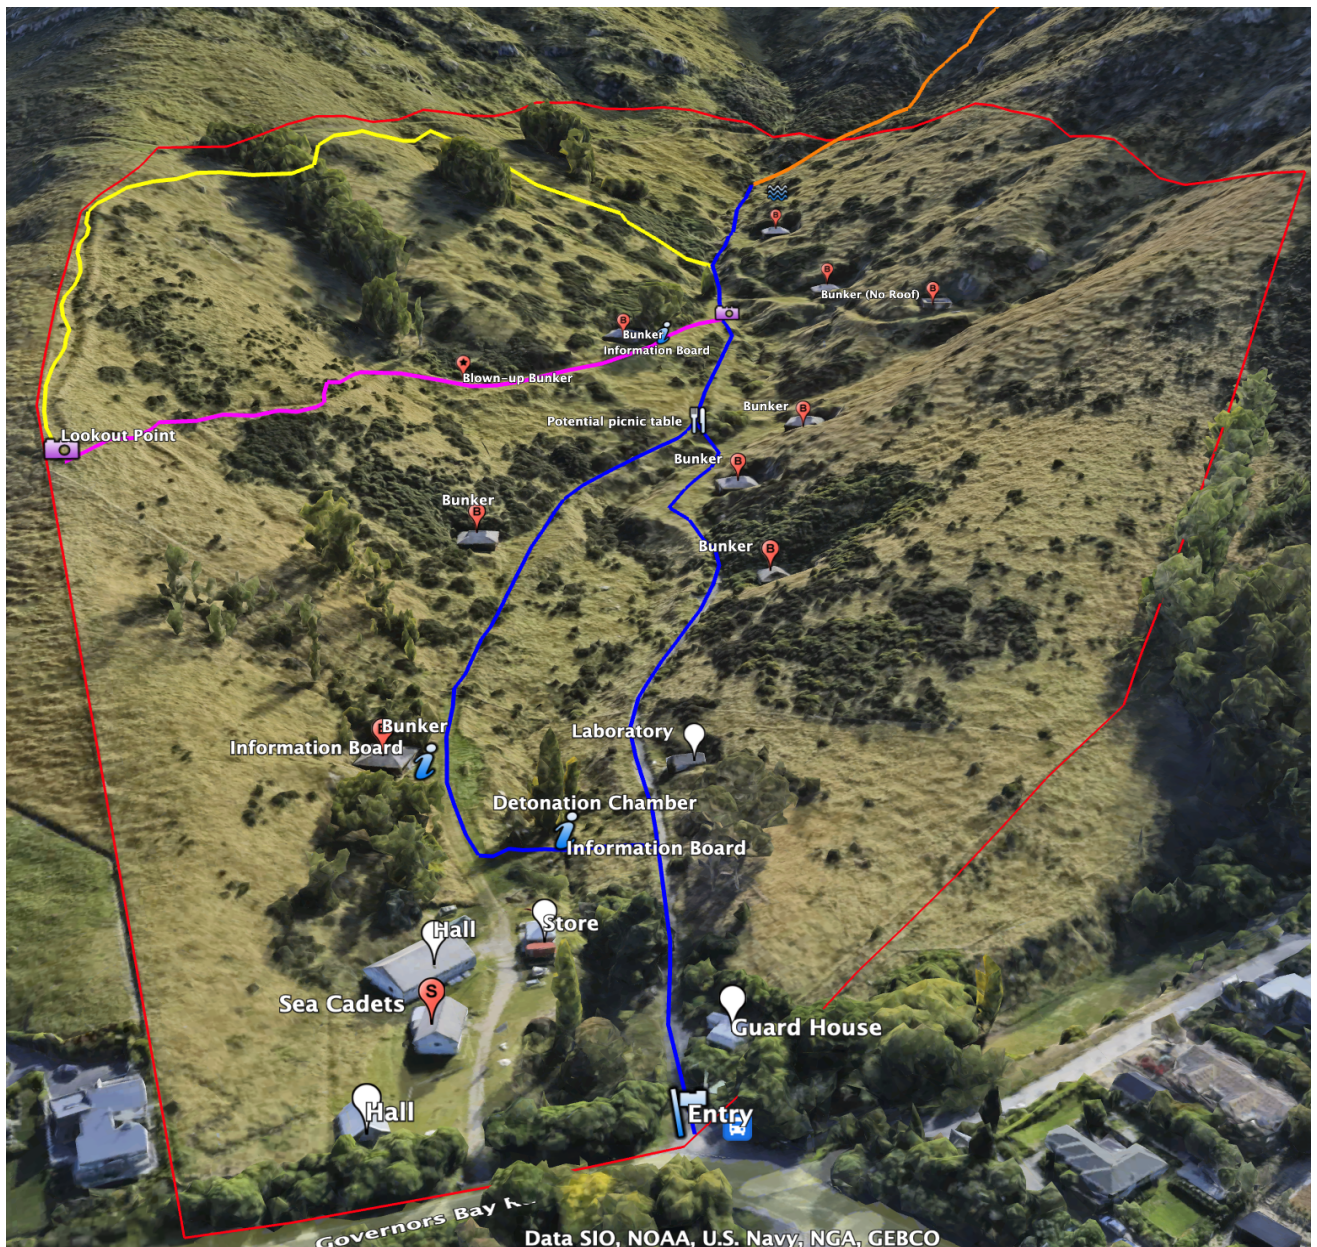
Figure 11. Google Earth visualisation of the area with proposed elements.

Figure 11 enables visualisation of what the holistic plan may look like if it were implemented. Not only is the modified walking track incorporated, but proposed lookout points, signage, and picnic tables. A version of this file is accessible and modifiable online to the public and is located [here](#).
