# More Than a Drain: Improving the health of St Albans Stream through riparian planting methods

A community research project partnering with the St Albans Residents Association and GEOG309 to enhance the quality of the much-loved Abberley Park

*20<sup>th</sup> October 2022*

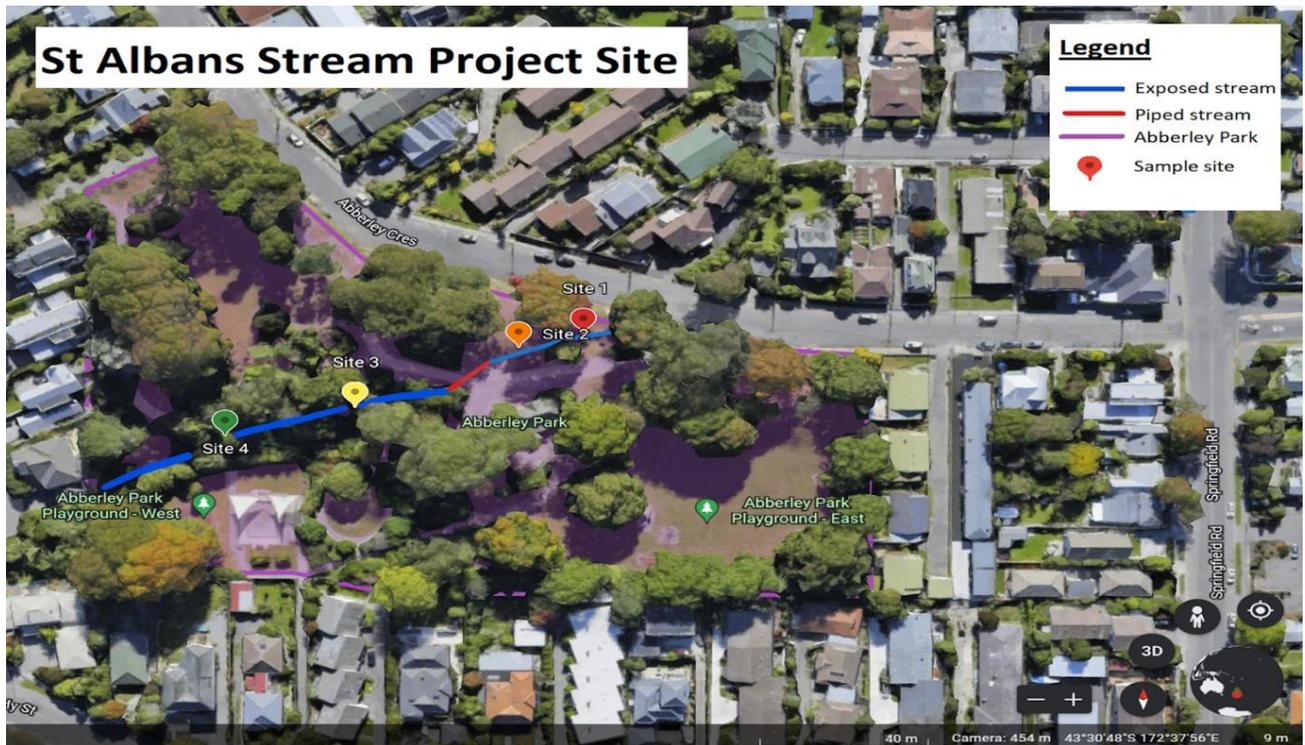
Figure 2. Map of Abberley Park and the four study sites along St Albans Stream assessed for water quality and habitat characteristics. The stream flows left to right.

We recorded Latitude and Longitude using an eTrex® 10 GPS receiver. Co-ordinates are displayed in WGS 84 format and mapped in Google Earth (Figure 2).

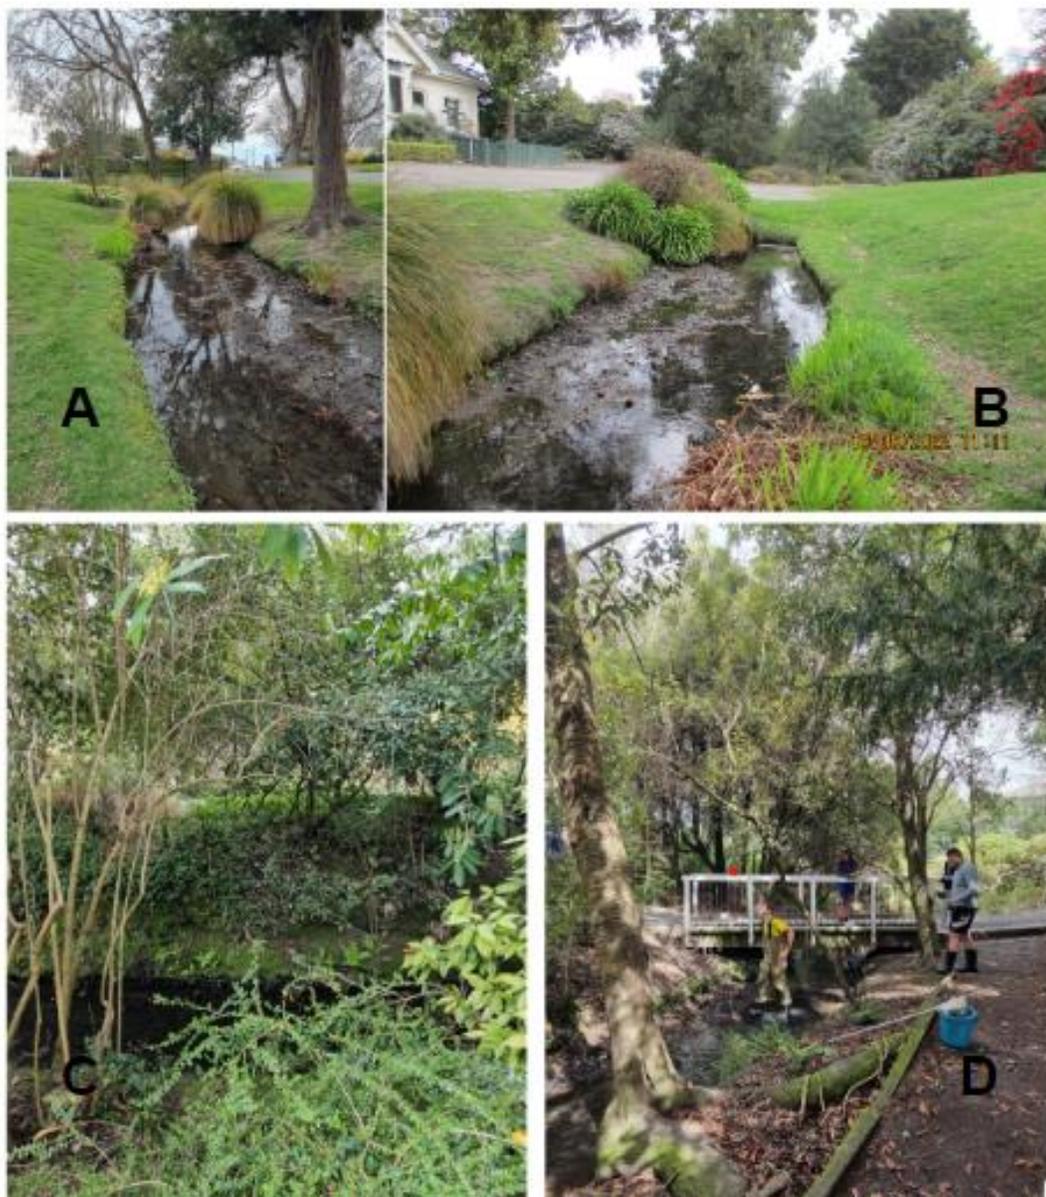
Site location, instream habitat, canopy and ground cover and species identification were observed in the habitat assessment. Results of the assessment are in Table 2 with supporting site images seen in figure 5.

Sites two and three had the muddiest substrate. Sites one and four had gravel substrates. Paths near these sites likely contributed to this. Site one was the only riffle habitat, all other sites were classified as runs.

Sites one and two have high groundcover but low canopy cover. This is because the wide riparian buffers are mostly grassed down to the water's edge, but few mature trees are present. Sites three and four have low groundcover, but high canopy cover. Understorey vegetation is low, particularly on the left tributary, but canopy cover is high, particularly at site three. Deciduous plants dominate the canopy at sites one and four, so canopy cover should increase in summer. Slopes are steep on the right side and gravel driveways limit riparian width.

Figure 5. Photos of stream sample sites in Abberley Park; a) Site one b) Site two c) Site three d) Site four

After examining the current riparian conditions of St Albans Stream, we recommend planting efforts focus on sites one and two. Comprehensive riparian planting across the three buffer zones is needed to remedy low vegetation cover. Sites three and four have established vegetation, meaning additional understory plants are recommended to reduce erosion and bank instability issues.

We recommend making the riparian buffer 5 m wide. Sites three and four already have wide enough buffer zone on both sides. However, the right tributary at sites one and two cannot have a 5m riparian buffer due to the gravel driveway. We recommend using as much space as possible to maximise effectiveness (Parkyn, 2004).
