Sumner Waterways: Opportunities for Restoration

**Final report for GEOG309: Research Methods in Geography
prepared for Habitat Sumner**

**UNIVERSITY OF CANTERBURY
Semester Two 2012**

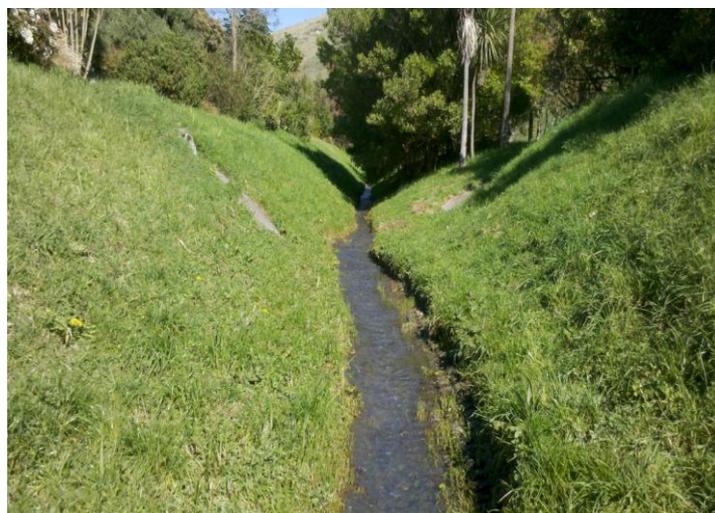
Figure 2: Sumner Stream at Cascade Place: Upper end of stream, gentle slope, grass banks.

1. Cascade Place Site, Sumner Stream

- Native riparian planting
- Replace concrete streambed with natural coarse substrate
- Proper fencing of stream to prevent livestock access

Planting native riparian vegetation is a standard starting point for each site along the streams and it is recommended that a variety of native plant types are used to create diverse habitats and encourage development of biological communities. Overhanging vegetation provides habitat, shade and a food source for aquatic species, while marginal vegetation provides food sources in the form of vegetation and also the insects that the vegetation attracts (CCC, 2003). Planting vegetation with deep roots is recommended along the stream banks to aid stabilisation and to act as a buffer zone to loose sediments washing into the stream. Furthermore plantings filter sediments and contaminants from stormwater, contributing to increased water quality. As indicated in *Table 1*, Cascade Place recorded the highest velocities of water flow; as a result vegetation planted within the channel itself must be able to withstand complete or partial inundation during

Restoration along this section of Sumner stream is less complicated compared to areas within the township, as it is a lower density residential area. There is a wider riparian zone, therefore channel reshaping is recommended to restore natural meanders and instream features. Meanders will eventually change the distribution of bed sediments as they cause variation in water velocity across the channel. They can also lead to the eventual undercutting of banks to allow shelter under ledges. Riffles, runs and pools are three important areas of a stream that provide different conditions for different species and are therefore valuable for stream restoration at this site. Riffles are shallow, swift flowing sections with broken water surface and larger substrate due to the high energy environments (CCC, 2003). The increased turbulence created by the water tumbling over larger substrate increases the exchange of dissolved gases, nutrients and organic material between the water flow and the substrate layers, and provides good habitat for EPT taxa. Runs are the main instream habitat for the majority of Christchurch's lowland streams (CCC, 2003) and are characterised by an undulating, but relatively unbroken water surface, with a bed of a mixture of small and large substrate. Pools are deeper, slow moving areas with a smooth water surface. They often have fine bed substrate and they act as important storage basins for organic detritus that can be slowly released into the stream (CCC, 2003).

Stage Two for Cascade Place also involves some improvements to current stormwater devices. Currently there are many stormwater pipes that extend out of the stream bank and contribute directly to the stream. These pipes should be replaced with gravel lined drains that catch litter and help to filter out sediment and contaminants before they enter the stream. While the extensive impervious surfaces within the Sumner stormwater catchment is considered a diffuse source of pollution to the stream and is harder to remedy, each individual stormwater drain into the stream can be managed as a point source pollution input. If feasible during earthquake damage repair, the extent of impervious surfaces should be reduced where possible. Stage Two involves the same ideas as stage one, and like stage one restoration is restricted to only short lengths of the stream, where there is enough space to accommodate it.

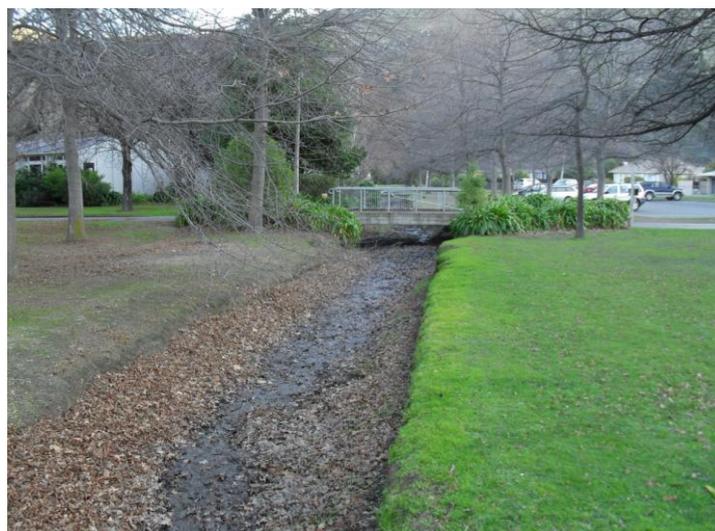
Figure 3: Sumner Stream at Van Asch School: Flat slope, lack of riparian zone.

2. Van Asch School Site, Sumner Stream

- Native riparian planting
- Placing natural coarse substrate in the streambed

As with Cascade place, increasing levels of natural vegetation is highly recommended, as is creating a bed consisting of natural coarse substrate. This will increase the visual character of the site which is highly

beneficial to the school that the stream runs through. As one side of the channel is buffered by a concrete wall, the removal of this will further add to the visual amenity and natural character the stream could provide.

Again, similar to Cascade Place it is recommended that meanders and natural stream features be added to the stream channel. Sumner Stream at Van Asch School is surrounded on both sides by flat grassed areas, so any reshaping of channel would have minimal impact on surrounding amenities. The channel here has a flatter profile, so it could potentially be narrowed to encourage higher water velocity, which would facilitate more gas and nutrient exchange and prevent stagnant flow. As with Cascade Place, redevelopment of stormwater drains into the stream is also an integral part of stage two for Van Asch School.

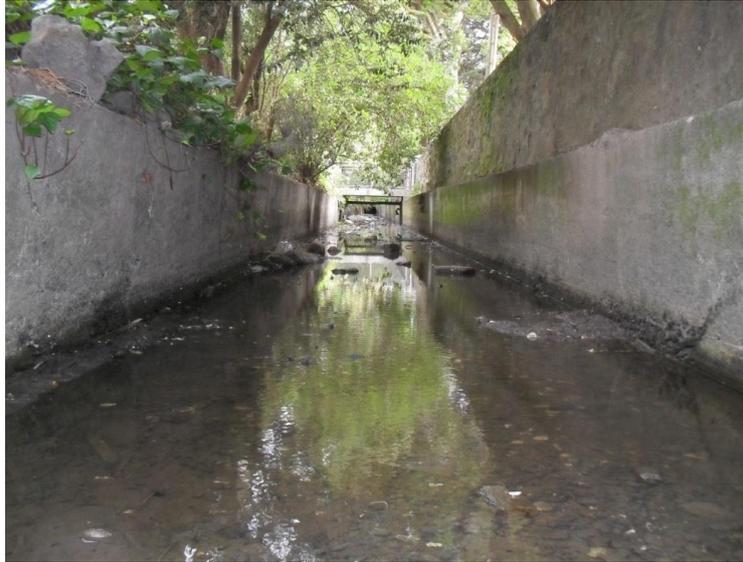
Figure 4: Sumner Stream at Scarborough Beach: Highly modified in box culvert.

The Scarborough Beach site, where the stream is contained within a box culvert, performed the most poorly on the riparian quality index as the stream has been completely modified. Box culverts are poor practice for streamflow management as "during low flow periods, box culverts do not concentrate flows to maintain water depth as circular culverts and natural stream beds and consequently result in a thin sheet of water covering the full width of the culvert" (Speirs & Ryan, 2006). This site exhibited the highest discharge of 0.9 m³/s which is attributed to the wide culvert. Contrary to expectations, the average suspended sediment concentration did not decrease further downstream, it would be expected to decrease as velocity decreases (*graph 1*) which should allow the sediment particles to settle out of the water column reducing turbidity and suspended sediment concentrations. This may not be the case because the Van Asche site was quite shallow, on average 5 cm deep, which could have contributed to the increased suspended sediment concentration as it was shallow muddy layer of reasonably still water (average velocity of 0.1m/s). The lack of riparian vegetation

3. Scarborough Beach Site, Sumner Stream

- Box culvert removed on park side
- Native riparian zone, instream vegetation
- Placing natural coarse substrate in the streambed

Redevelopment of the Scarborough beach site is complex due to the riparian zone being constricted, not only by the concrete culvert but by the road and toilet block located directly either side of the channel. As an initial low impact measure, it is recommended that the box culvert be removed on the park and toilet side and to create a natural sloping bank in its place. This will open the space up as a resource for the park rather than concealing it. Once again, native vegetation should be planted and natural substrate be added to the bed to increase the potential for habitat.

- Remove box culvert

Building on the partial removal of the channel in stage one, stage two involves complete removal of the box culvert from Scarborough Beach. As the stream is closely bounded by the road leading up to Scarborough Head, it is recommended that the stream channel be narrowed to create room for a natural bank and riparian area, which will also increase stream velocity. EOS Ecology (2012) has already indicated a promising result from the removal of a box culvert from a stream in Christchurch's northern suburbs. The redesign of the channel was aimed at providing a healthier habitat for the Bluegill Bullies within the stream and restore the freshwater environment.

Stage three for the Scarborough Beach site involves relocating the stream to the base of Scarborough Head to where properties are red zoned. This recommendation utilises the available land to create a natural park with walkways and seated areas, similar to the planned biodiversity corridor for red zoned area surrounding the Avon River. (CCC, 2012; Avon-Otakaro Network, 2012). The Avon-Otakaro River biodiversity corridor is aimed at creating a ecological and recreational reserve to restore the indigenous habitat natural to its historic ecology (Avon-Otakaro Network, 2012). The implementation of such an idea in Sumner would not only increase water quality, stream health and create a valuable resource for the community; it would also acknowledge the value of environmental health and serve as a space dedicated to the community following the impacts of the earthquakes as in the centre city.

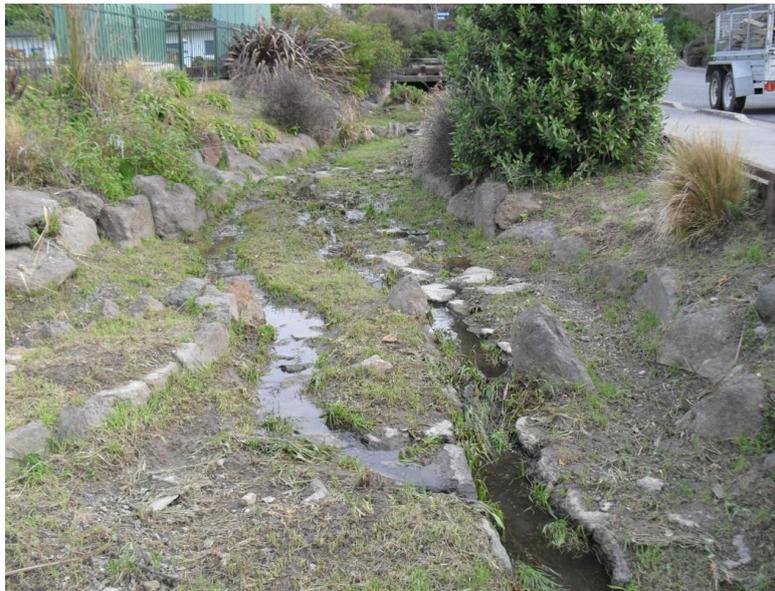
Figure 5: Richmond Hill Stream at restored site with daylighting. (Only one measurement site was identified on the Richmond Hill Stream due to the lack of access to the upper area. This site will provide a useful comparison as to its effectiveness).

In comparison to the highly modified Sumner Stream, the restored site on the Richmond Hill stream adjacent to the bowling club presented well. Overall, as indicated in *Tables 1 and 2*, Richmond Hill Stream had lower sediment concentration, high turbidity and high dissolved oxygen. These findings are attributed to the stream being piped underground which reduces the amount of sediment suspended within the water load. Furthermore the restored area is narrow channels with a wide floodplain relative to the stream's size; this allows water velocity and discharge to increase, increasing dissolved oxygen while allowing flood events to be contained effectively. Significantly, the results from this site are similar to those measured at Cascade Place, which indicates the ability of restoration methods such as daylighting and channel alteration in returning the stream to a condition similar to a natural site.

4. Daylighted Section, Richmond Hill Stream

- Improving native riparian zone

Richmond Hill site indicated positive impacts from previous restoration measures of daylighting, channel landscaping to narrow flows, while providing a flooding area within the channel and limited riparian planting. This site exhibited increased dissolved oxygen and lower sediment concentrations than highly degraded sites on the Sumner Stream. The stage one recommendations for this site therefore aim at improving the current

measures. Increasing vegetation around the stream would create more shaded areas within the stream. There is little impact that a Stage Two method would have on the Richmond Hill site, therefore Stage Three method would follow on from stage one method. This is discussed below.

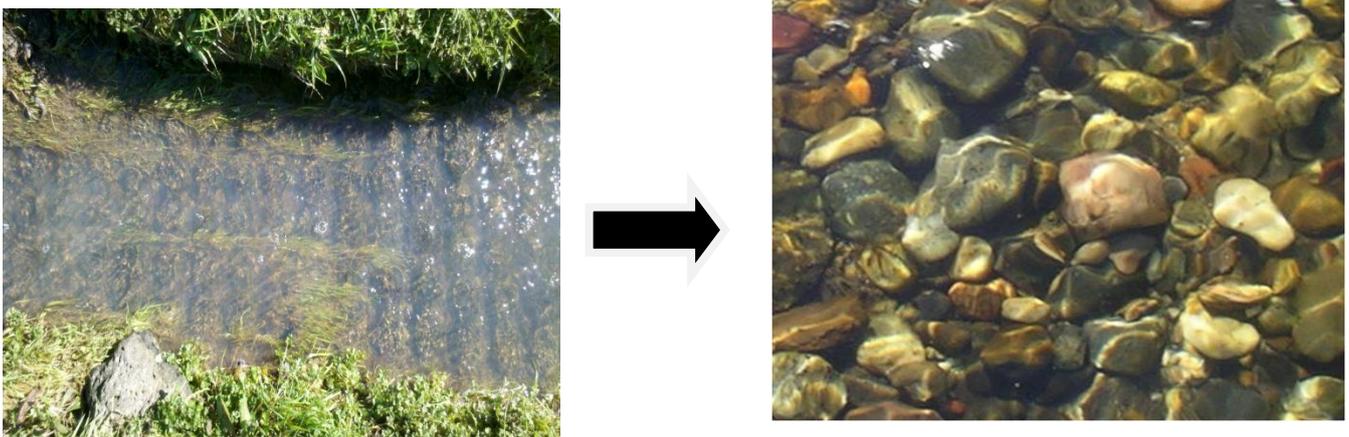
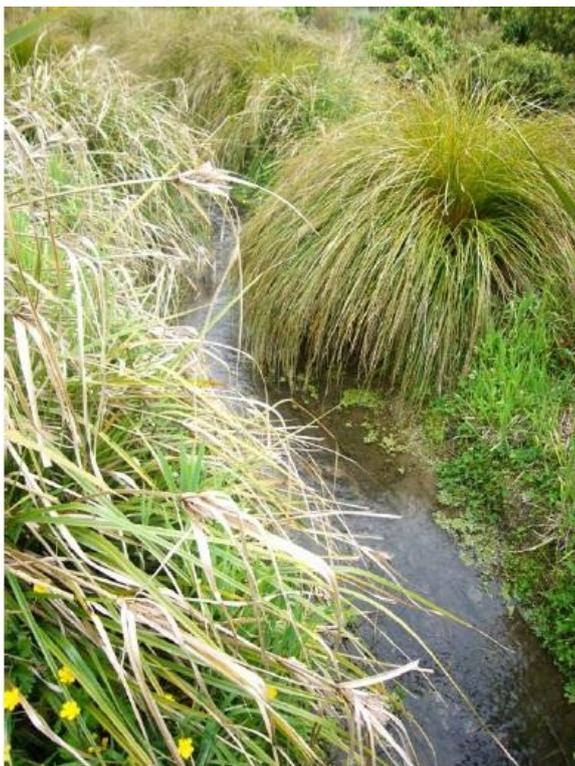
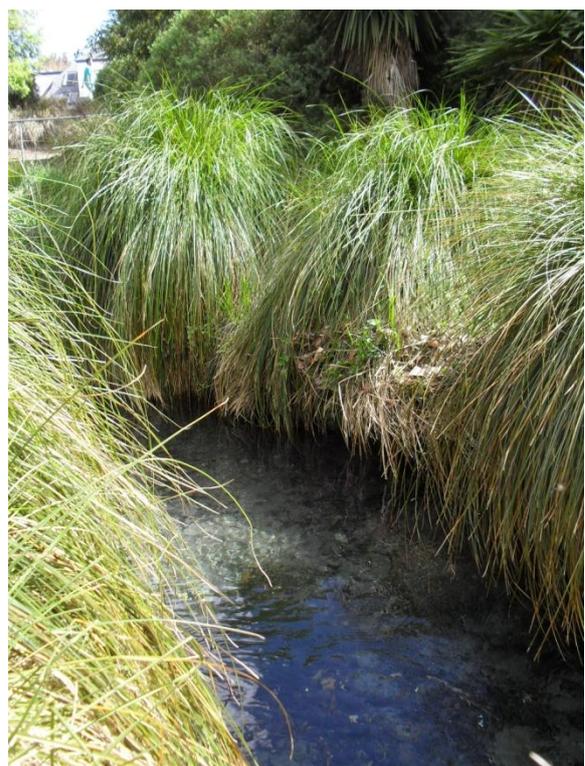
Figures 6 & 7 show an impression of converting the bed from concrete to cobbles. Figures 8 & 9 show what native grass plantings may look like.

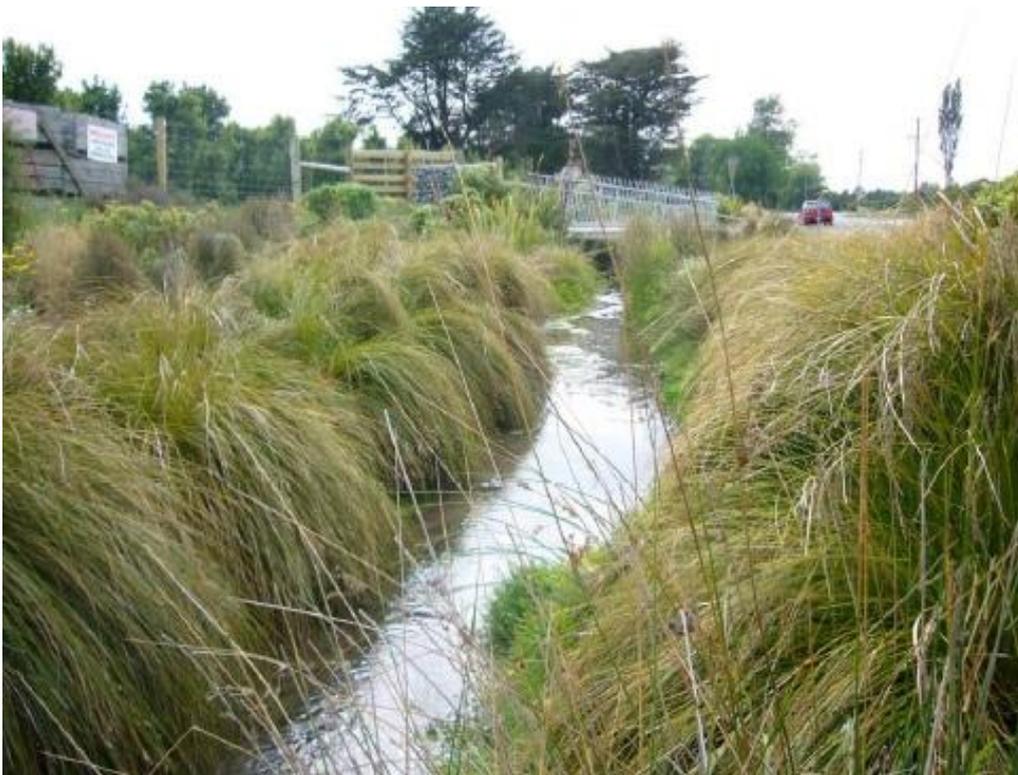
Figure 10: Example of restored stream (Radcliffe Road Drain, Christchurch)

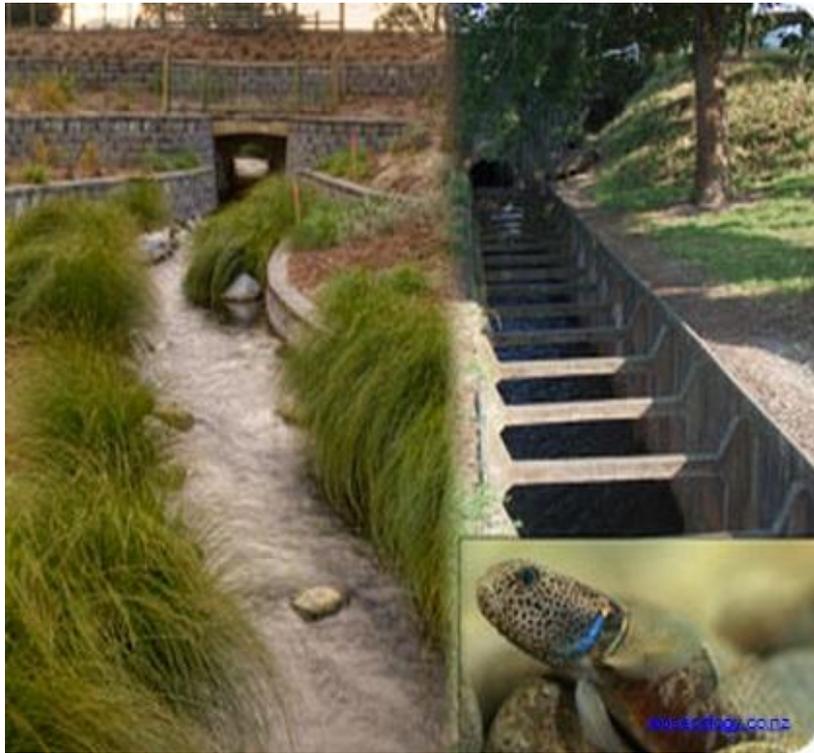
Figure 9: This figure shows the restoration method taken place on a bow culvert located in a Northern suburb of Christchurch.
