**An Assessment of Freshwater Quality
in Cass Bay:
Building a Comprehensive Baseline of
Stream Data.**

University of Canterbury, 2023

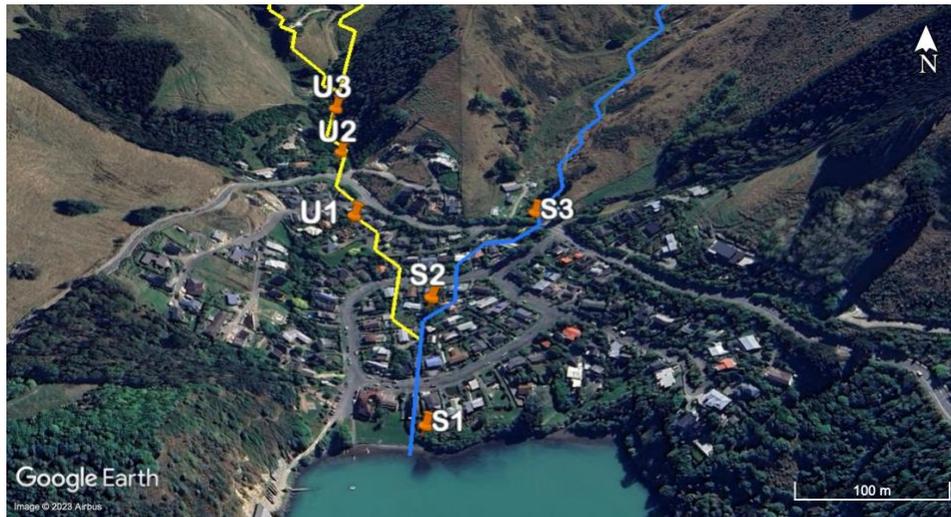
Figure 2.

Sampling site locations for Steadfast stream (S) and the second unnamed stream (U) in the lower and mid Cass Bay Catchment.

Primary data was collected at six individual locations across the two streams within the study area (Figure 2). Sites S1-S3 and U1 covered the urban reaches of the two streams, while sites U2 and U3 examined the middle reaches of the second unnamed stream before it entered the residential zone. Both streams converge downstream of site S2 in the central part of the residential area. Sampling began at site S1 and moved progressively upstream to not interfere with the composition of downstream communities before we had the opportunity to sample them.

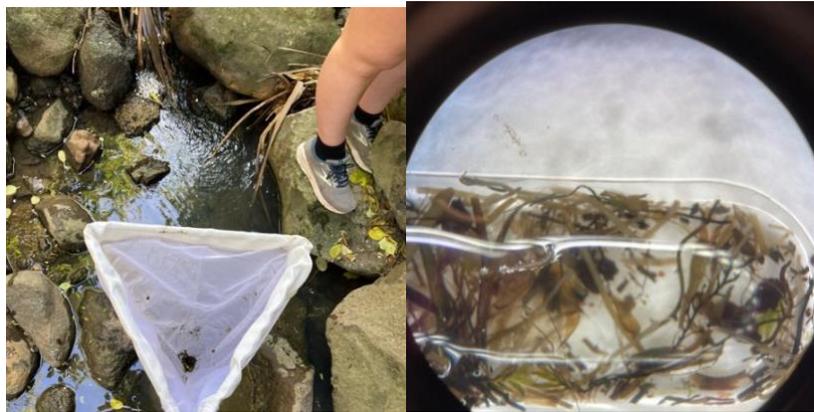
Kick-net used to gather macroinvertebrate samples (left). A macroinvertebrate sample is shown in a Bogorov tray under a microscope (right).

Every known species of macroinvertebrate in New Zealand is assigned a value, indicating the species' tolerance to pollutants. This is known as the macroinvertebrate community index. The MCI is commonly used as a proxy for indicating stream health, where the presence or absence of certain indicator species provides insight into the level of pollution within the aquatic environment (Stark & Maxted, 2007). Kick-net sampling was undertaken following the method proposed by Stark et al. (2001), as shown in Figure 3. Sites were tested starting from the bottom and moving to the top of the catchment to not interfere with the composition of downstream communities before they were sampled. Various habitat types were sampled including riffles, pools, and runs to accurately represent the entire site.
