# **GEOG309-23S2**

**Final Report**

**Erosion Susceptibility at Mt Vernon Park**

**Group 12**

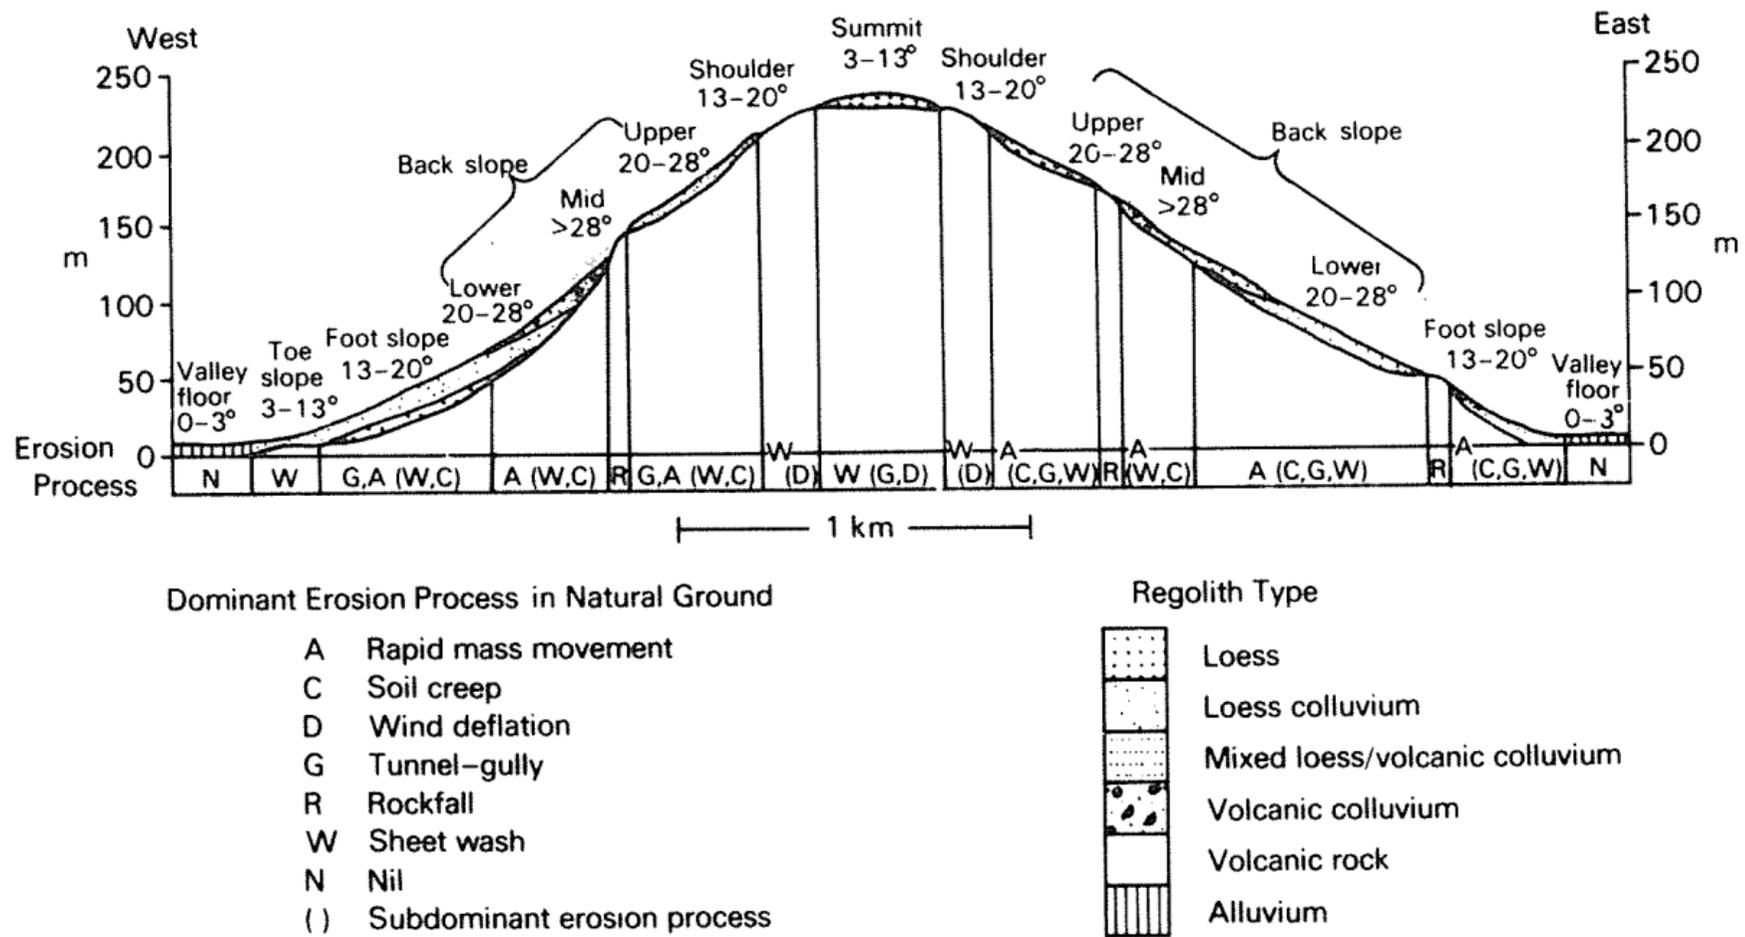
Figure 2: Generalised Ridge Cross-Section Showing Relationships Between Landforms, Slope, Regolith Types and Erosion in The Sumner Region. Sourced from Trangmar & Cutler (1983).

Trangmar and Culter (1983) identified the erosion types occurring within slope ranges (Figure 2). Using GIS, the slope values at Mt Vernon could be extracted to identify different slope zones and therefore be related to erosion processes. To perform this analysis a 1m Lidar-based Digital Elevation Model (DEM) was used, sourced from LINZ (Land Information New Zealand, 2021). Using ArcGIS Pro the slope tool was used to analyse slope angles from the DEM. Slope angles were then classified into different ranges, guided by the relationships of Trangmar and Culter (1983).

The GIS analysis has provided meaningful results that help understand erosion at the Park. Figure 2 by Trangmar and Culter (1983) shows the dominant and subdominant erosion process and is useful in understanding the erosion process that will be present at the Park. Figure 7 shows different slope angles within the Park area. These slope angles have been classified into eight different ranges based on the findings of Trangmar and Culter (1983). By classifying the slope angles into different ranges, the dominant erosion process in natural ground can be identified. The Figure 7 shows that the land on the main spur has low erosion susceptibility, as shown by the yellow and pink colours. Figure 7 shows that the Northwest corner of the park and the valley slope facing Northeast in the Northeastern area of the park have high susceptibility. The green colours indicate the dominant erosion processes present in tunnel gullies and rapid mass movement.

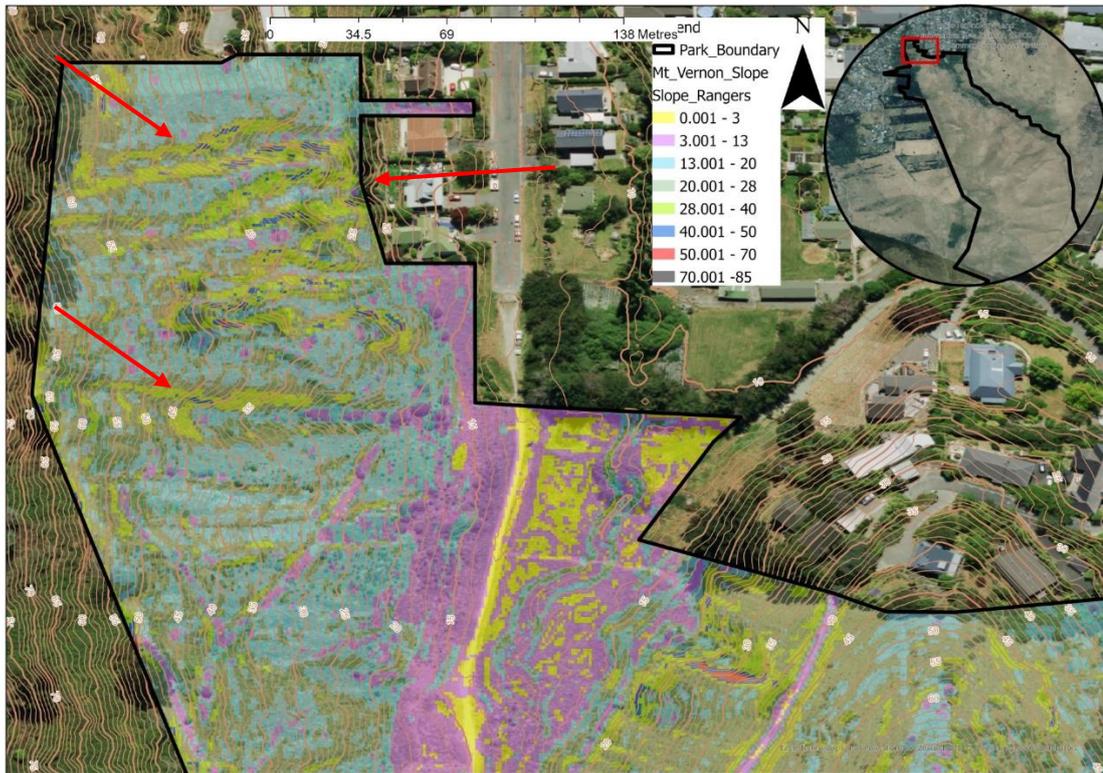
Figure 3: Northern End of the Map with the Red Arrows Highlighting the Tunnel Gully Erosion on the Slope Angle GIS Layer.

The methodology involved utilising slope angle data, satellite imagery, and topographic contour lines to identify the various geomorphic features. Tunnel gully erosion was pinpointed by simultaneously using the slope angle GIS layer and topographical contour lines, as tunnel gullies were found to generally run perpendicular to these contours (Figure 3). Satellite imagery proved less effective for identifying small-scale tunnel gullies due to typically being covered in vegetation cover, or not clearly expressed at the surface.

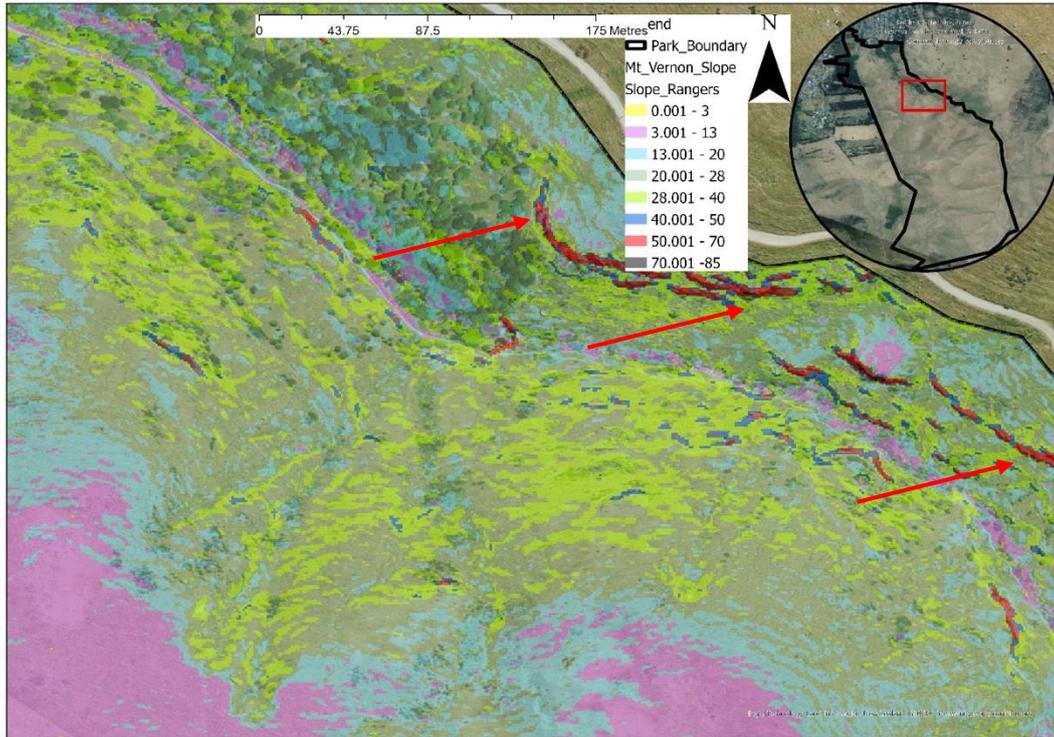
Figure 4: North-Eastern Side of the Map with the Red Lines Highlighting Exposed Bedrock on the Slope Angle GIS Layer.

Exposed bedrock, with its pronounced relief in the landscape, was identified using the slope angle layer (Figure 4). Mass movement, primarily slips, were mapped using a combination of the slope angle layer, contour lines, and satellite imagery (Figure 5). These movements were identified by either a head scarp without debris or a head scarp with hummocky block movement beneath.

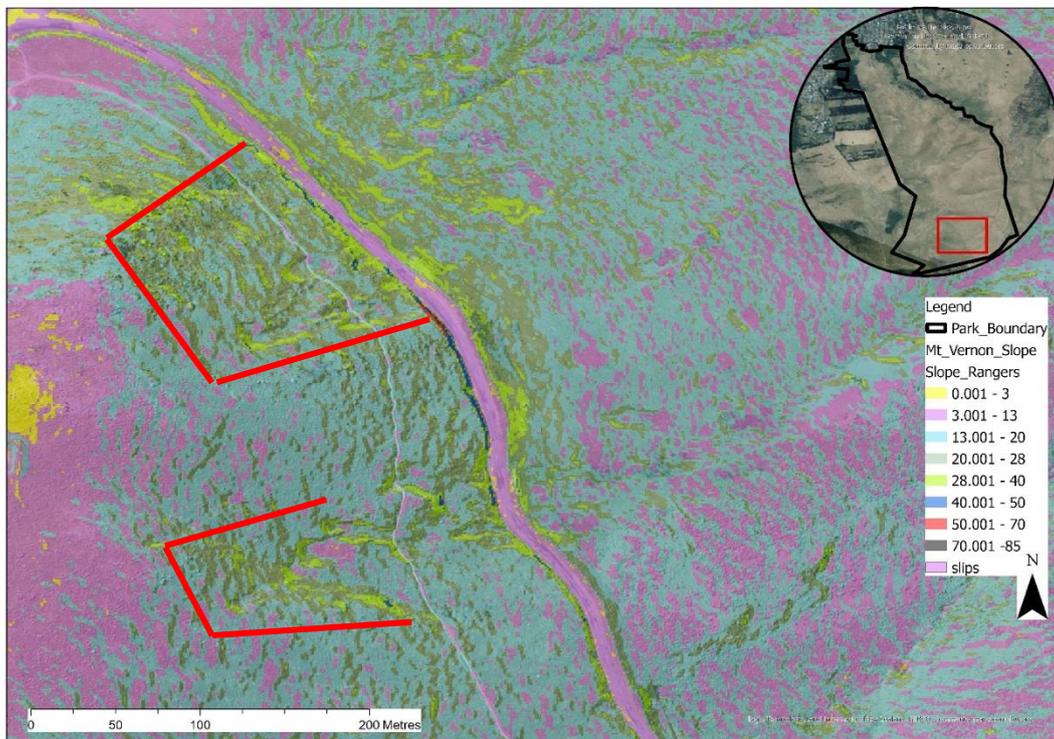
Figure 5: South Side of the Map with the Red Lines Highlighting Mass Movements on the Slope Angle GIS Layer.

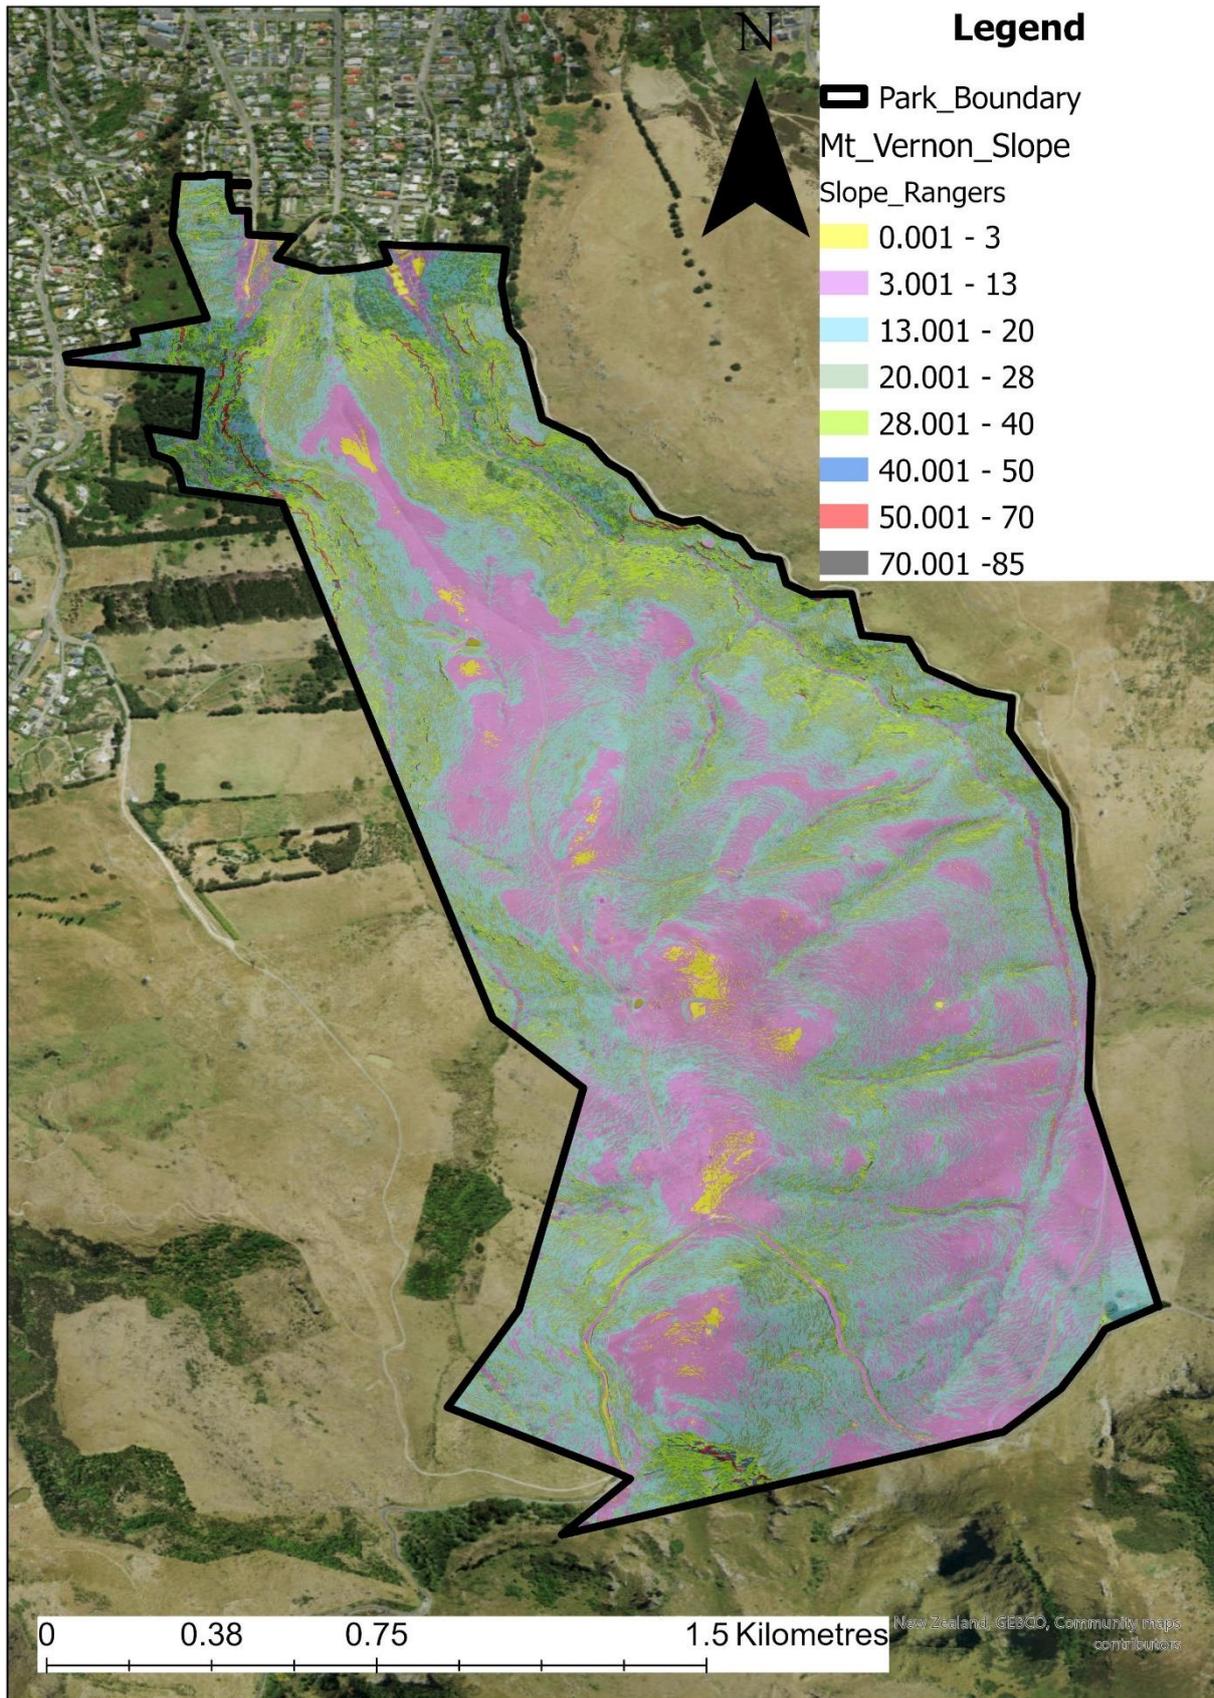
Figure 7: Map showing the slope angles classified into eight ranges based off the findings of Trangmar and Culter within the Mt Vernon Park.

Understanding erosion susceptibility is important for effective land management in the Park. Slope analysis reveals steeper slopes (28-40 degrees), are most vulnerable to erosion (See Figure 7). Soil erosion is most common on slopes steeper than 25 degrees (NZ Landcare Trust, 2019). The highest levels of tunnel gulying are observed in valleys on either side of the main ridge, particularly in the lower park section (See Figure 7). High erosion is evident in the northeast valley near the lower farm track. The lower half of the park, around the southwest valley, also experiences heightened tunnel gully erosion (See Figure 7). The top block on Mount Vernon's summit holds cultural significance as it maintains a relationship with Te Hapu o Ngāti Wheke between the Port Hills Trust. This area

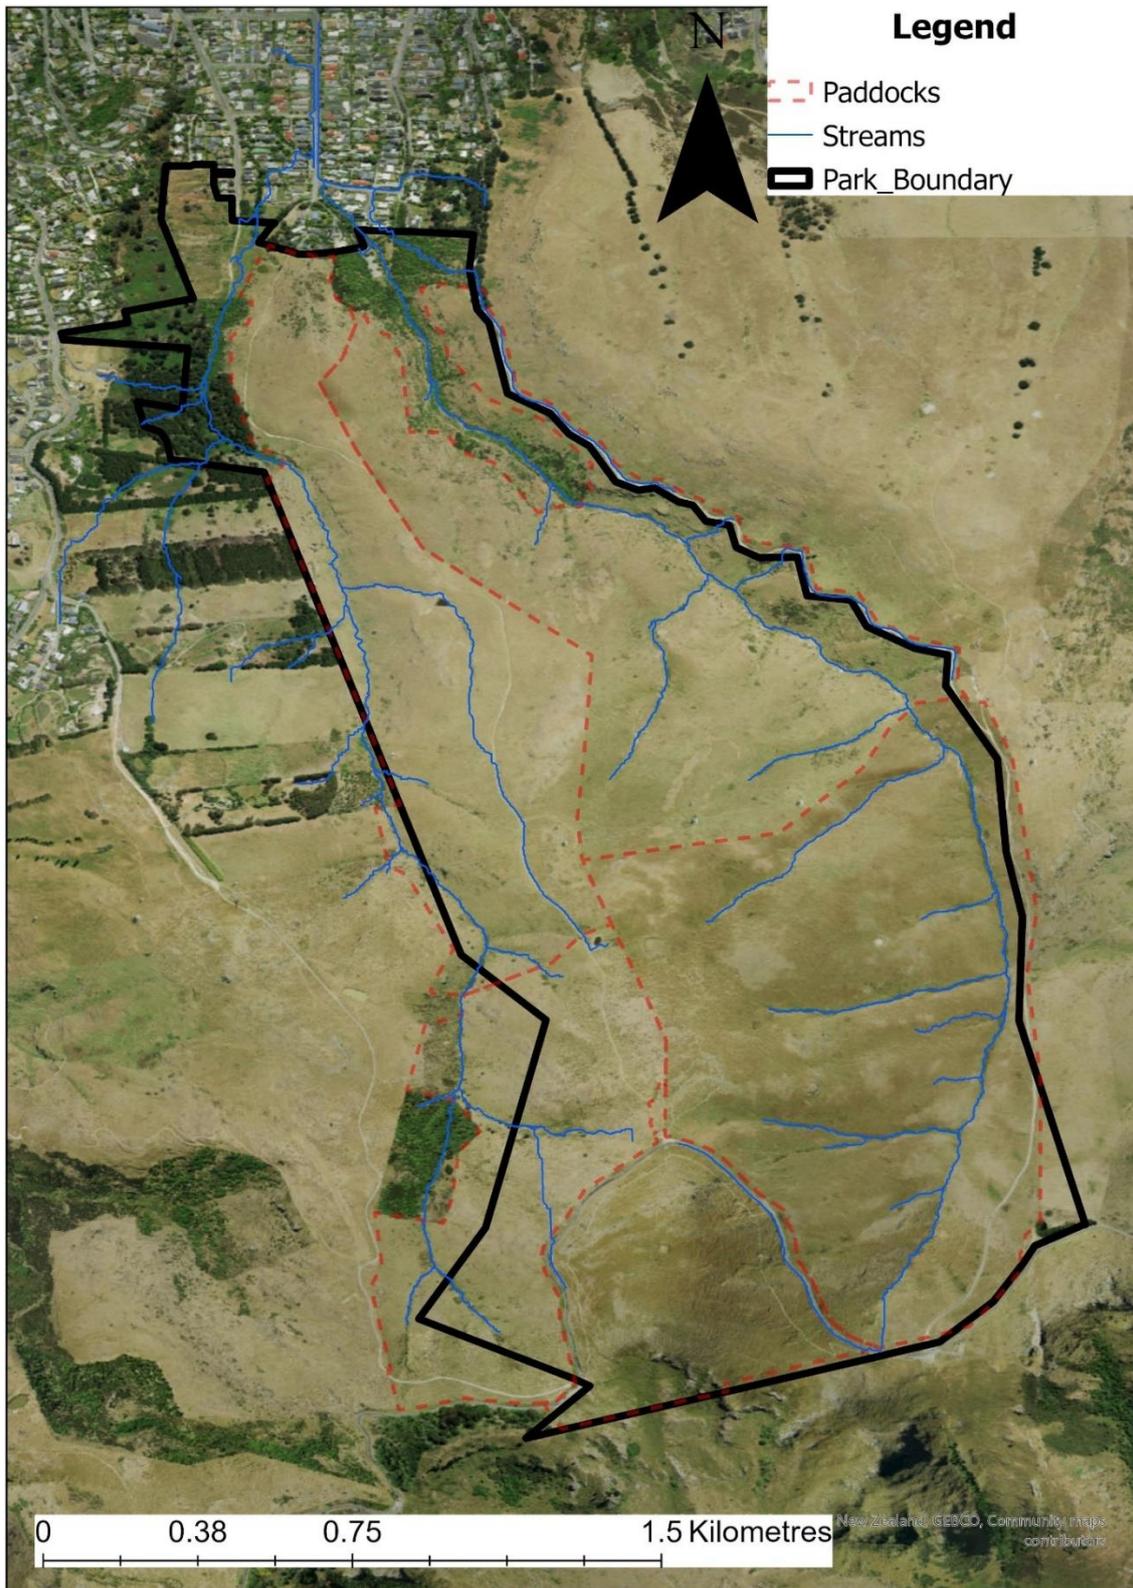
Figure 8: Map showing the stream network extracted from DEM data within the Park, current farm fence lines have been mapped to show farm blocks.

Figure 8 shows the stream network within the Park which was derived from the DEM. Showing the key drainage points within the park, the fence lines have also been plotted to show that these fences do not exclude stock from anyway of the waterways identified.

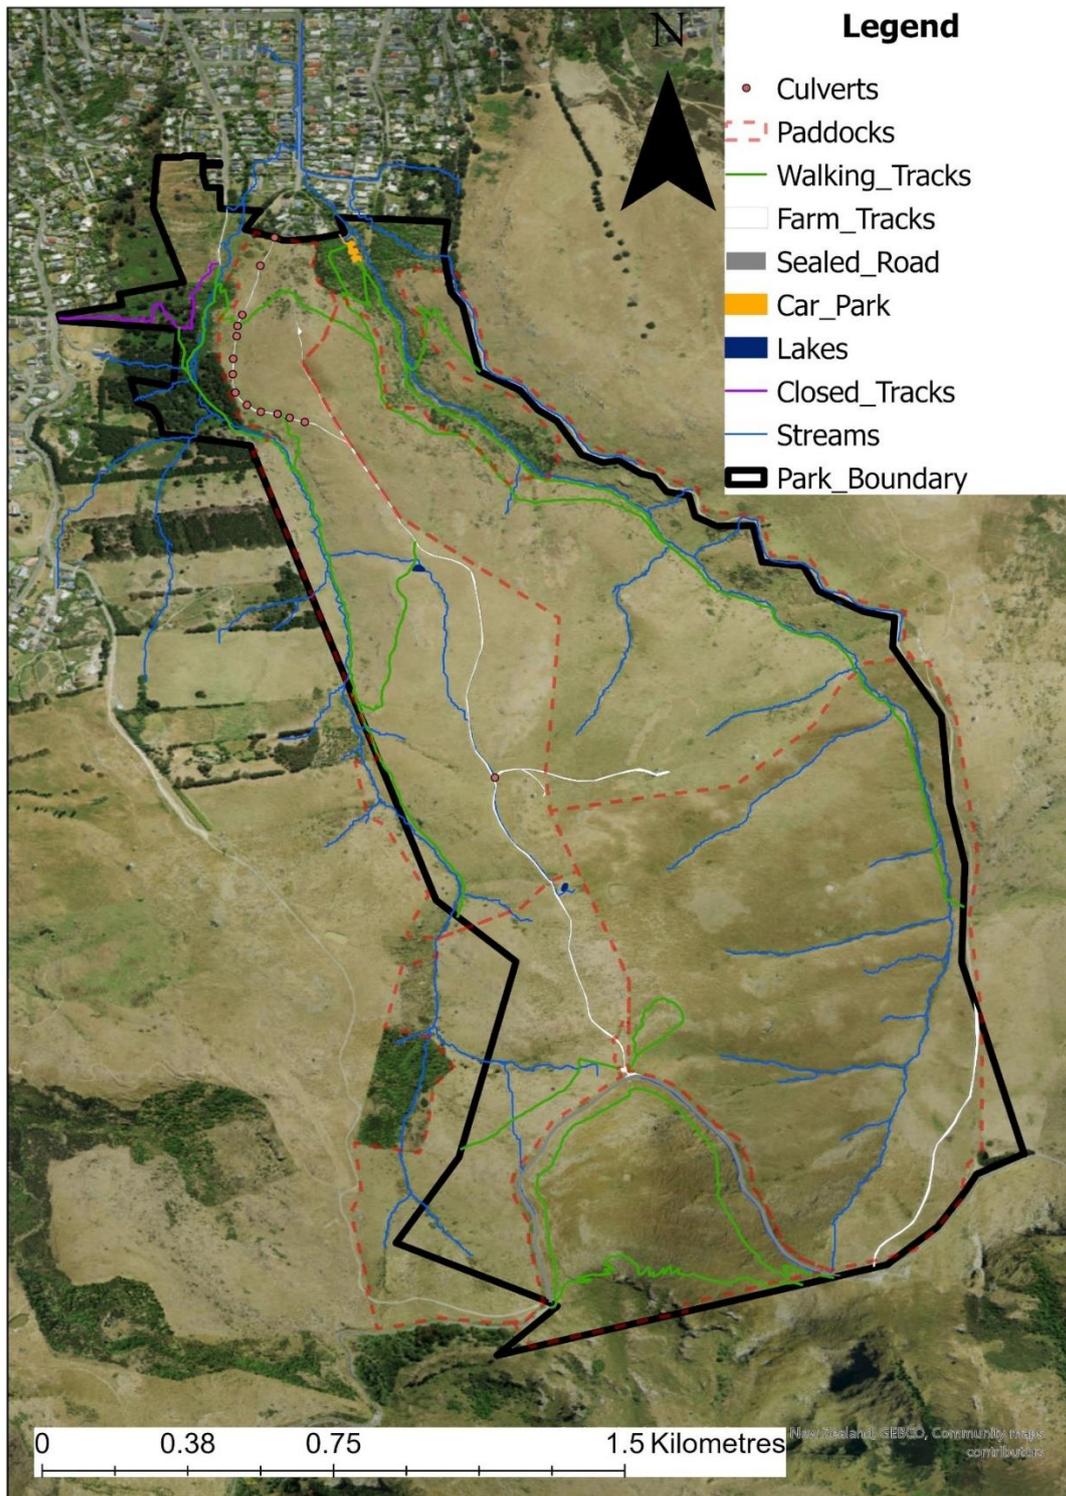
Figure 9: Map presenting natural and man-made features within the park that influence erosion susceptibility and park management.

The features extracted and digitised within the park on GIS can be seen in Figure 9. These features help in understanding natural and human activities that are influencing erosion susceptibility at the Park. The culverts in Figure 9 show the current management infrastructure in place to reduce erosion. The different tracks show the main routes that are used by different groups such as the public, farm workers and stock.

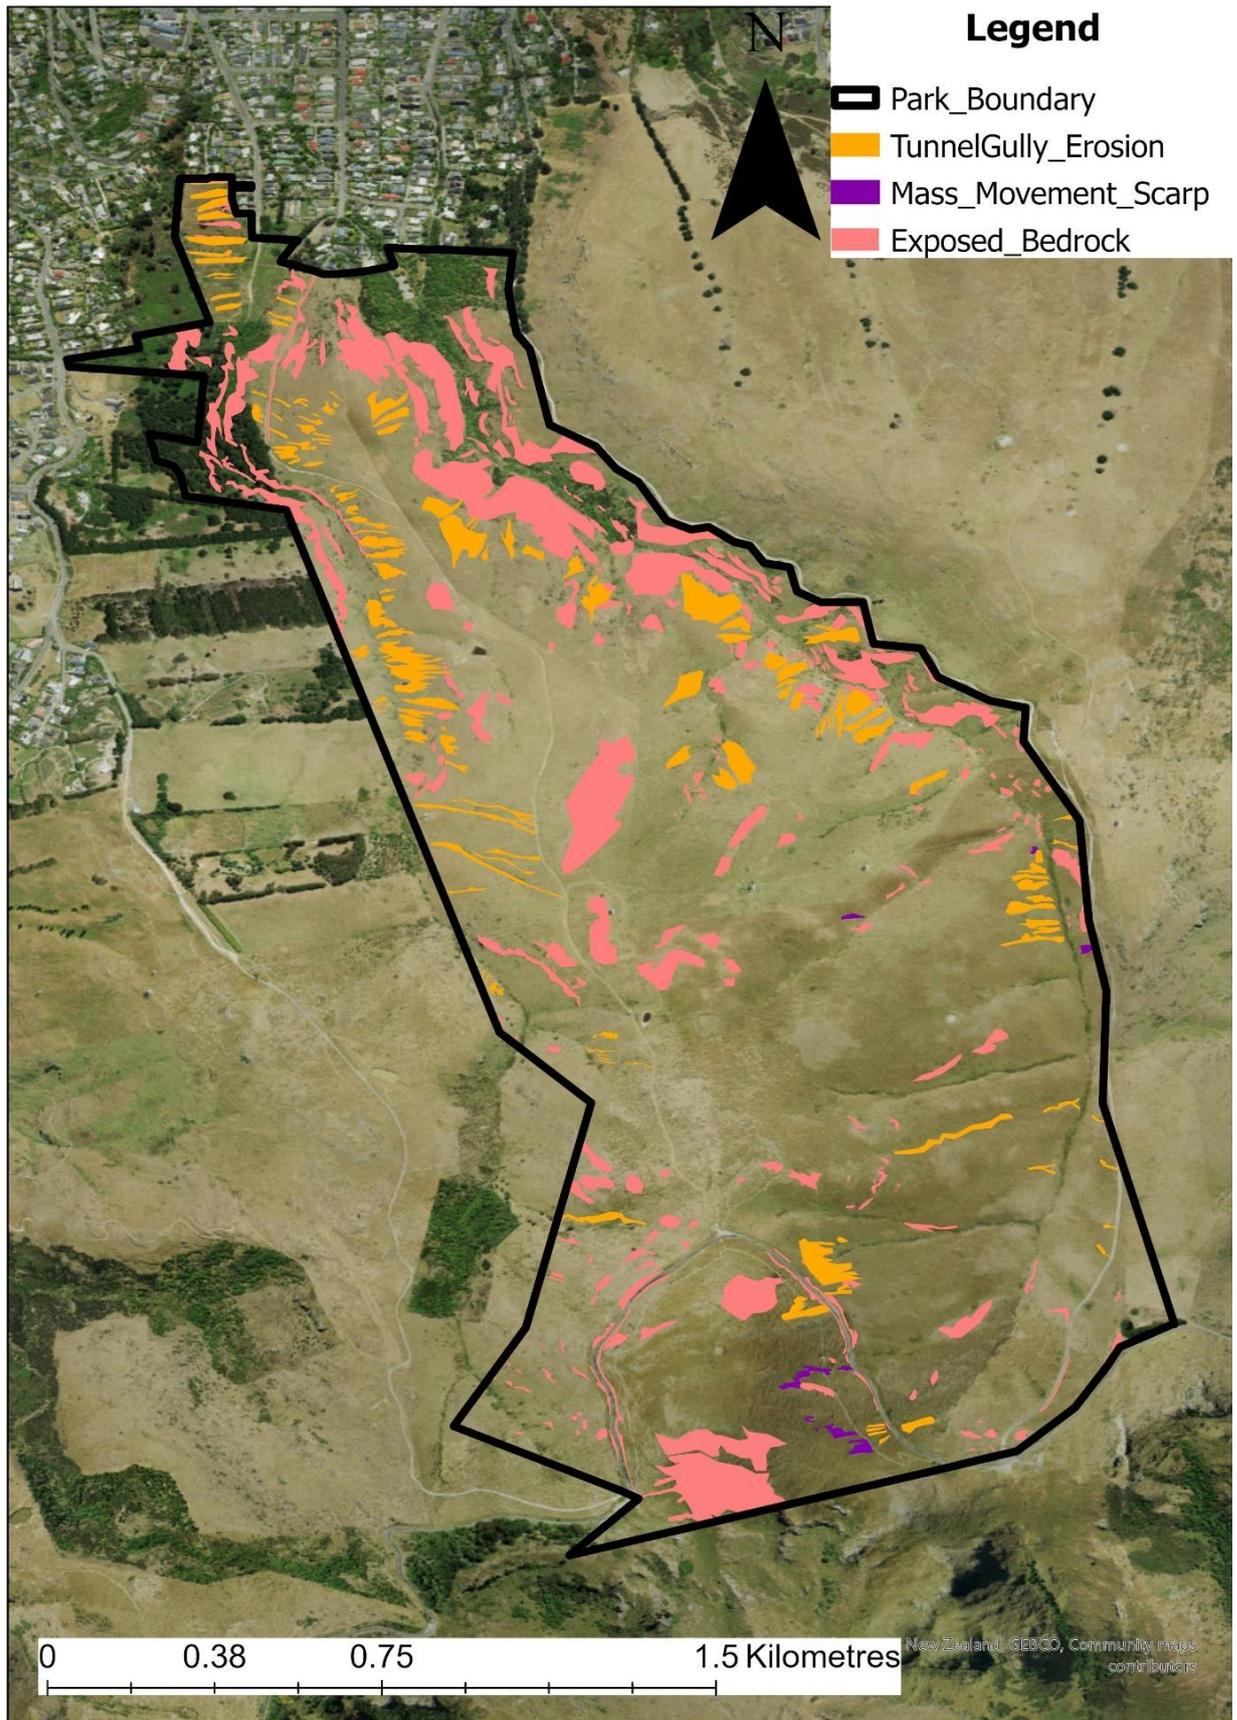
Figure 10: Geomorphic Map, erosion features have been determined from the Slope Map (Figure 7) and the use of satellite imagery.

Utilising the GIS-geomorphology method for mapping allows for a valuable comparison with data from the Trangmar and Cutler (1983) study. Tunnel gully erosion was mapped throughout the entire back slope region at Mt. Vernon, aligning with the findings of the study by Trangmar and Cutler (1983). The geomorphic map has identified a total of 10.1 hectares of the park affected by tunnel gully erosion (Figure 10).

Exposed bedrock within the park was mapped across all slope regions, though not all of it is susceptible to erosional processes such as rockfall (Figure 10). The exposed bedrock most prone to erosional threats was primarily concentrated in the mid-back slope regions, where the slope gradient exceeds 50 degrees. However, a limitation of the mapping process arises from including all exposed bedrock, rather than just the portions susceptible to rockfall. Consequently, it becomes challenging to determine the specific area of highly susceptible rockfall terrain.

The mapped mass movements varied in size and type, predominantly concentrated in the lower and upper back slope regions, consistent with the study by Trangmar and Cutler (1983). These mass movements covered an area of 0.4 hectares within the park (Figure 10).

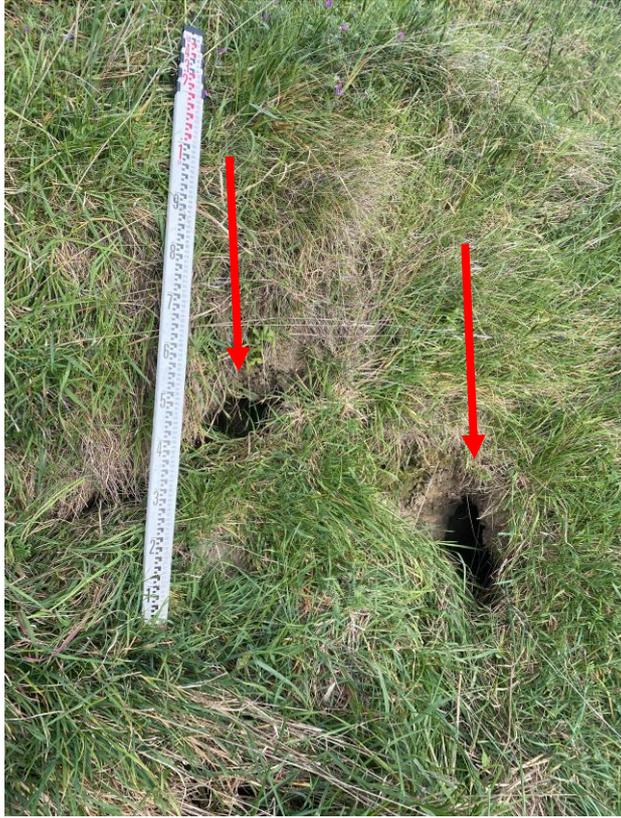
Figure 11: Tunnel Gully Holes at Mt. Vernon, Indicated by the Red Arrows. The Measuring Staff is 1 m for Reference.

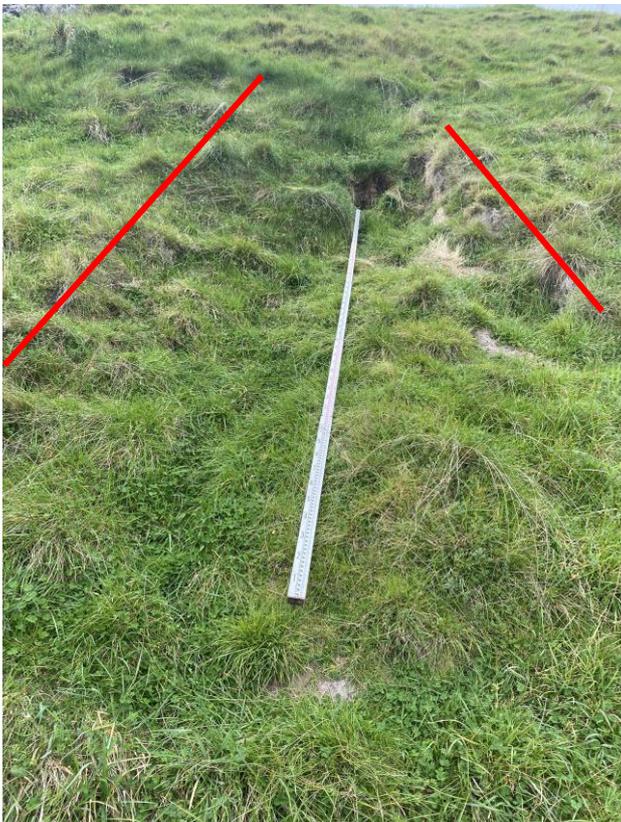
Figure 12: Collapsed Tunnel Gully Erosion at Mt. Vernon Park, Indicated by the Red Lines. The Measuring Staff is 5 m for Reference.

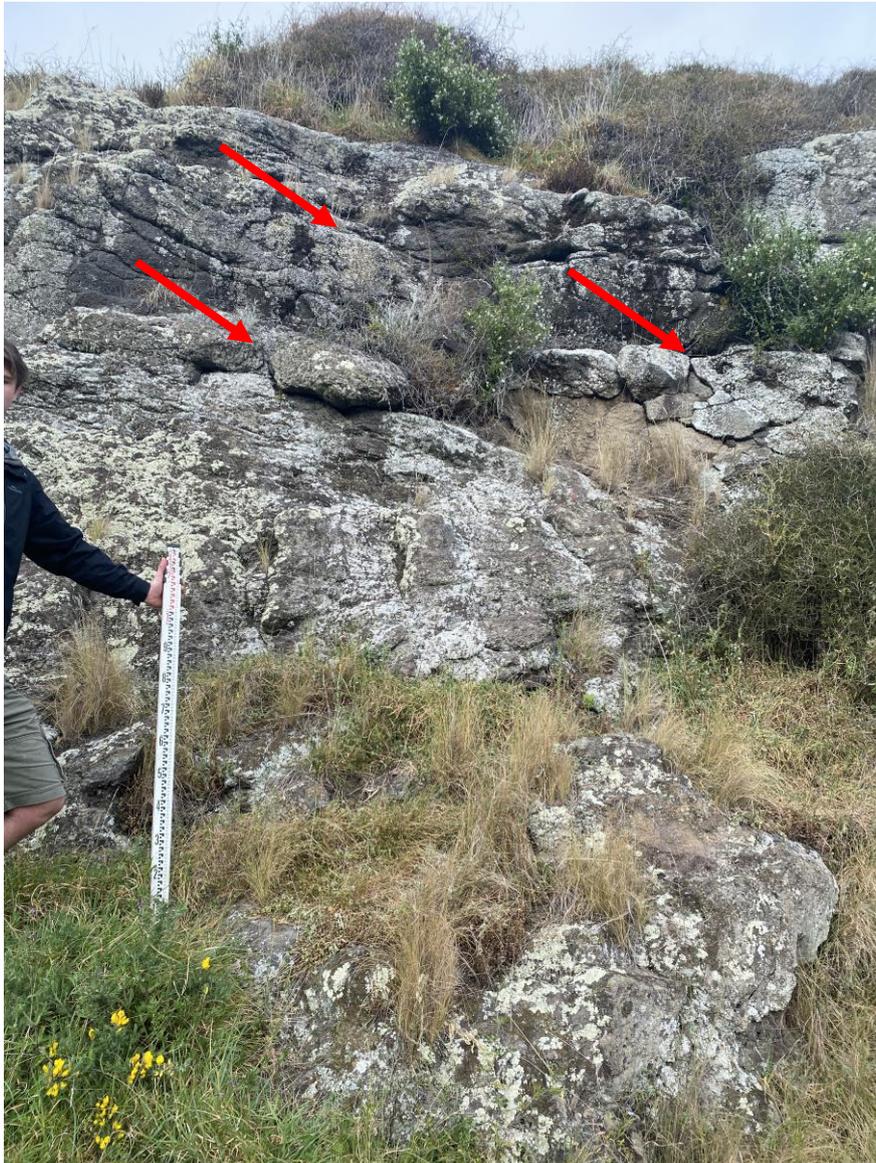
Figure 13: Exposed Lava Flow Outcrop at Mt. Vernon, Platy Fabric, Joints and Fracturing Indicated by the Red Arrows. The Measuring Staff is 1 m for Reference.

During the visit, volcanic bedrock, comprised of stratified lava flow sequences in the form of outcrops, ranging in height from 1 to 10 meters, was observed. These outcrops exhibited various platy fabrics, joint sets, and fracturing (Figure 13). Furthermore, scattered throughout the summit and shoulder slope regions were boulders of rock. Significantly, the exposed bedrock identified in the field closely matched what had been previously mapped using the GIS-geomorphology method.

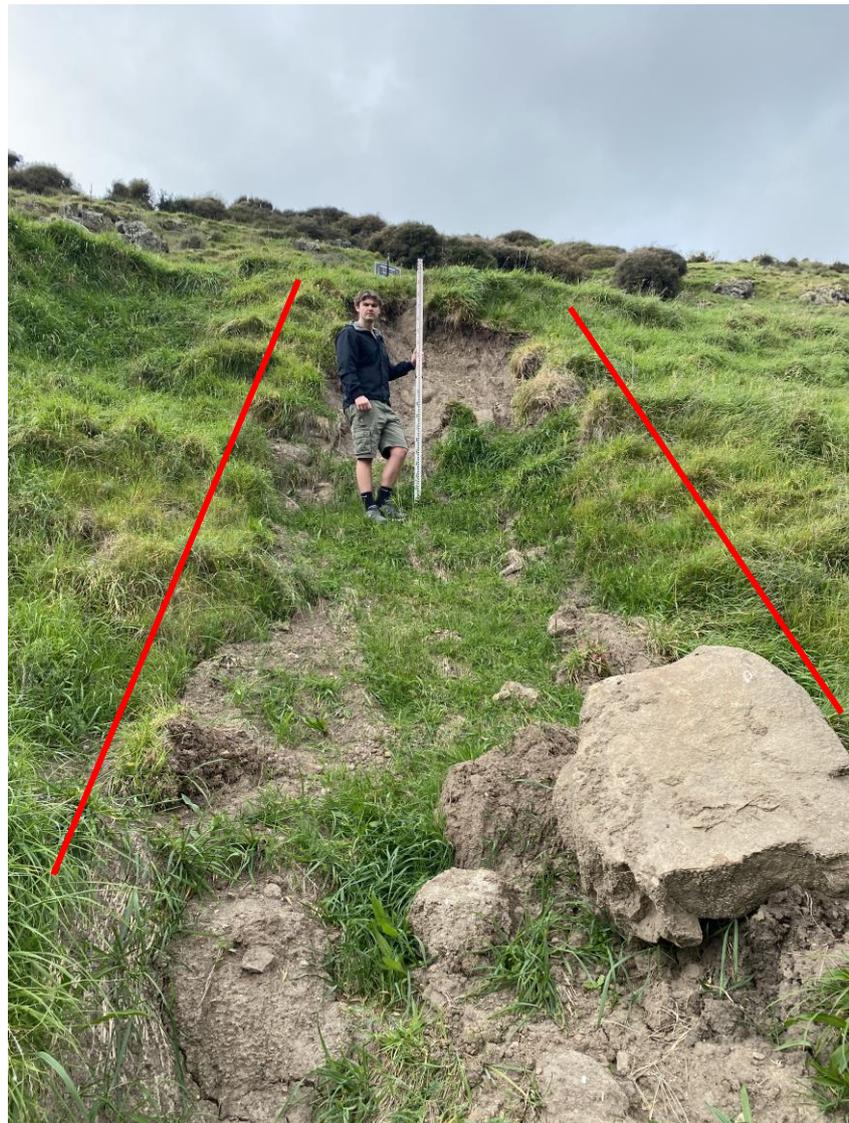
Figure 14: Mass Movement at Mt. Vernon, Indicated by the Red Lines. The Measuring Staff is 2 m for Reference.

The specific area under examination within the park revealed no previously mapped mass movements on the geomorphic map. However, during the visit, a small mass movement was identified downslope from the farm track (Figure 14). This particular event appeared to be an

earth flow and is recent (Winter of 2023 has been relatively wet), which accounts for its absence in satellite imagery.

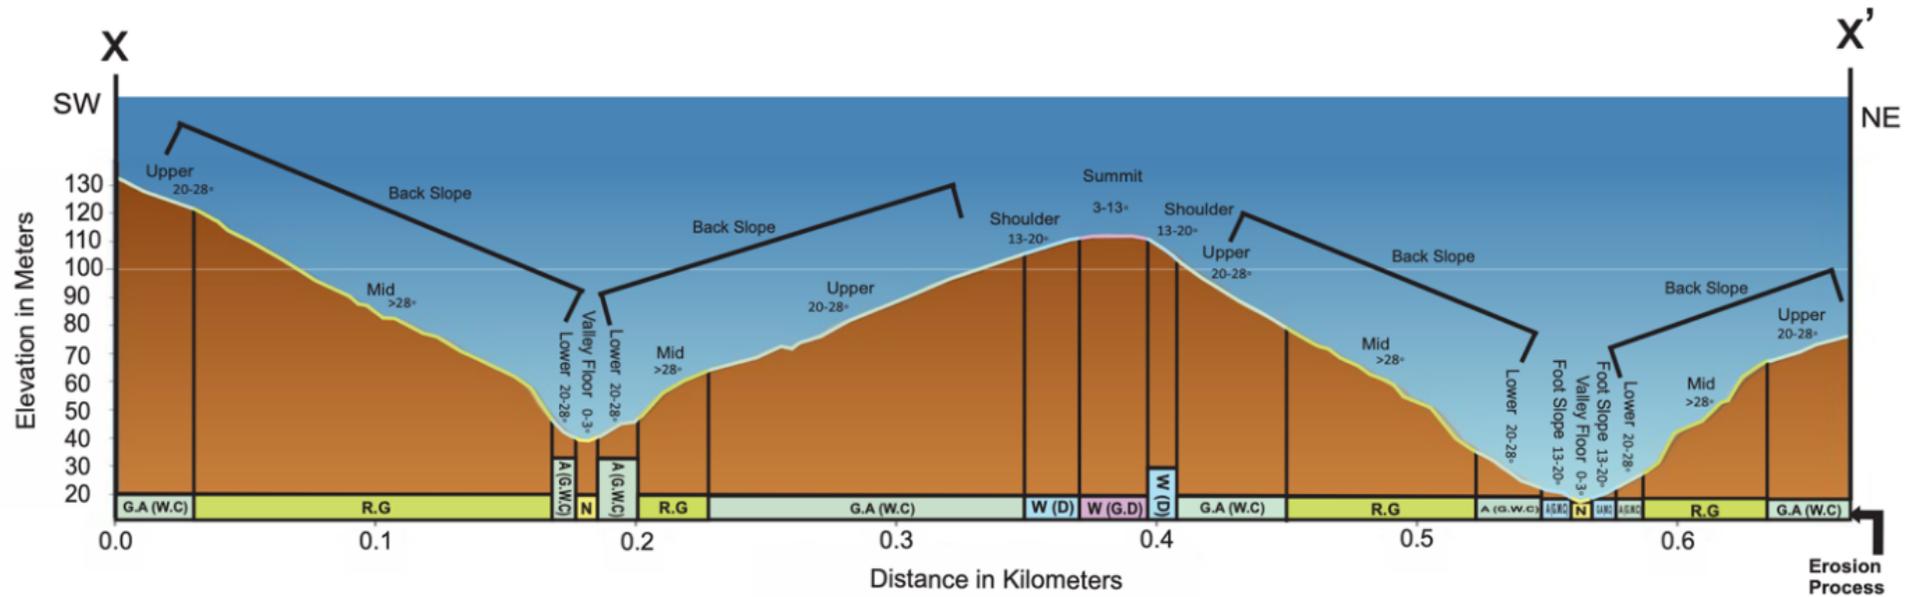
# Mt Vernon Park - Lower Park Cross Section

Figure 15: Lower Park Cross-Section Showing Relationships Between Landforms, Slope, And Erosion at Mt. Vernon Park.

The cross-sections (Figures 15 & 16) developed in the analysis provided an opportunity to infer what the subsurface geology is doing. The geology at Mt Vernon is comprised of multiple layers of igneous strata (Timm et al., 2009; Hampton and Cole 2009).

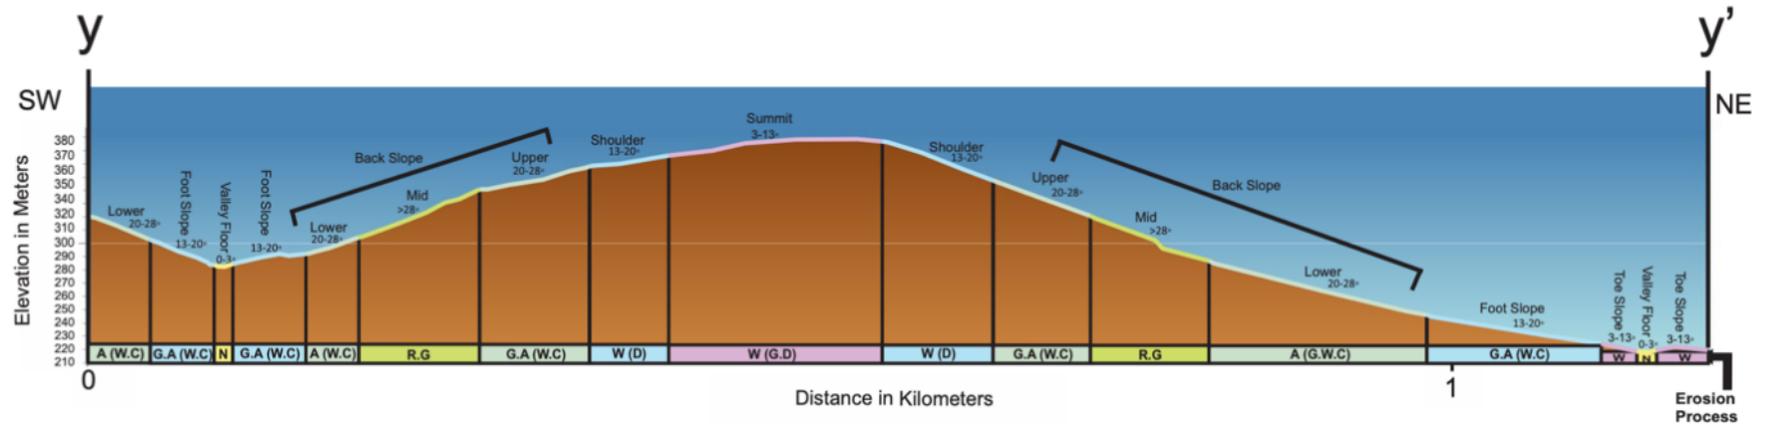
# Mt Vernon Park - Upper Park Cross Section

Figure 16: Upper Park Cross-Section Showing Relationships Between Landforms, Slope, And Erosion at Mt. Vernon Park.

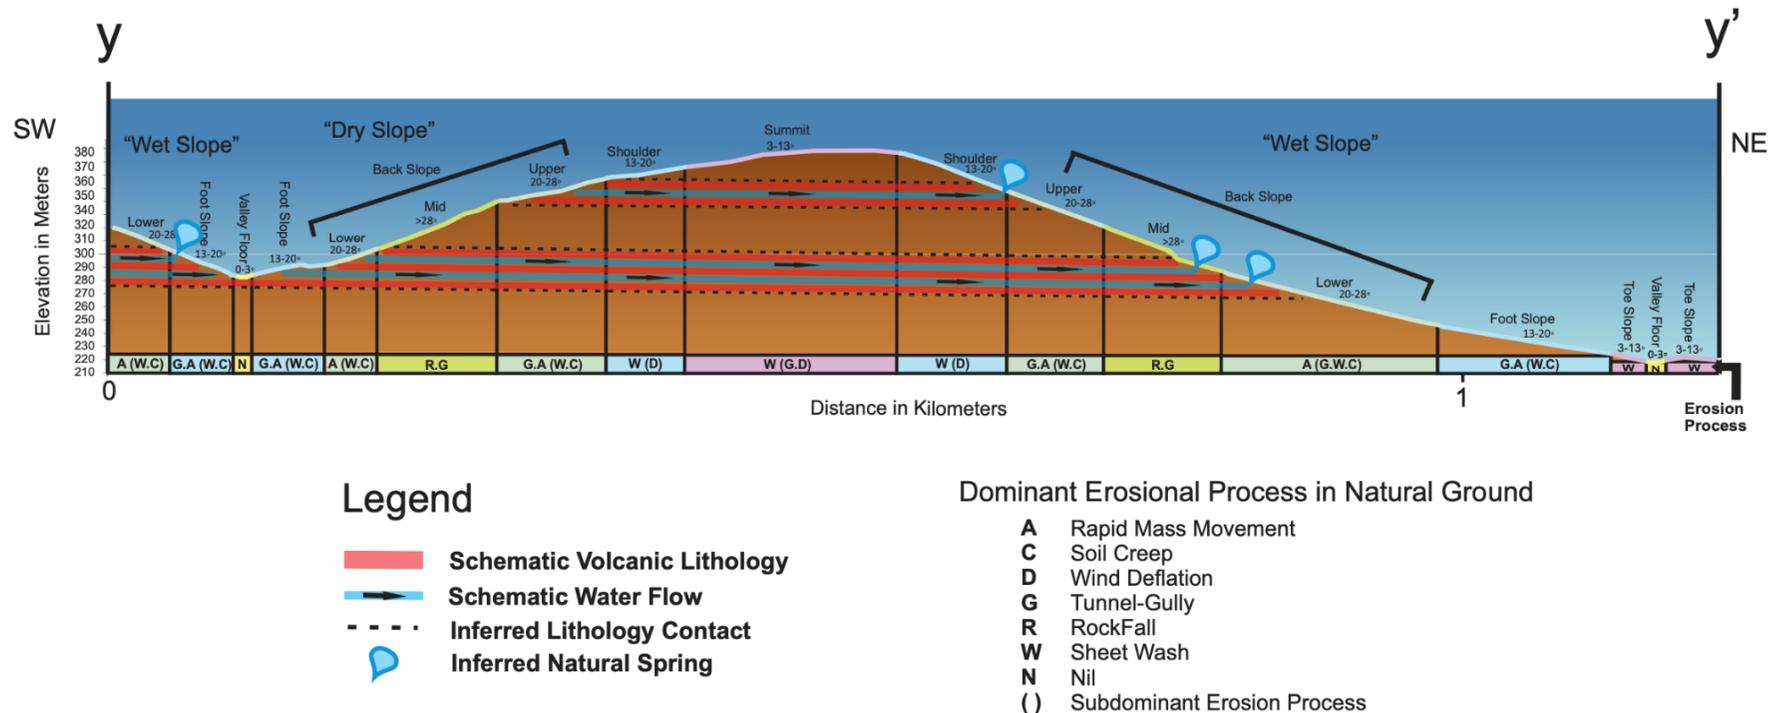
# Mt Vernon Park - Upper Park Cross Section - Interpretations

Figure 18: Upper Park Cross-Section Showing Relationships Between Landforms, Slope, And Erosion, with the Inferred Red Lines Serving as Indicators of Ancient Lava Flows at Mt. Vernon Park. The Rock Layers Exhibit a Slight Dip Toward the Northeast Direction (Hampton and Cole, 2009).

Discussions with volcanologist Dr Sam Hampton, have enabled inferred strike and dips to be projected within interpreted cross-sections (Figures 17 & 18). Stratified lava flow sequences are permeable, which enables water to traverse through pore spaces and joints within the strata (Qin et al., 2023). Additionally, the rock layers exhibit a slight dip toward the northeast direction (GNS Science, n.d.). Consequently, water infiltrating the southwestern slopes gradually channels towards the north-eastern slopes, indicating the flow direction. This insight allows for the classification of slopes on either side of the spur as either "Dry Slopes" or "Wet Slopes." The "Wet Slopes" classification implies there is a higher chance of natural springs forming as the water resurfaces (Hampton et al., 2018). It is very important to maintain monitoring of these springs to prevent any further slope saturation.

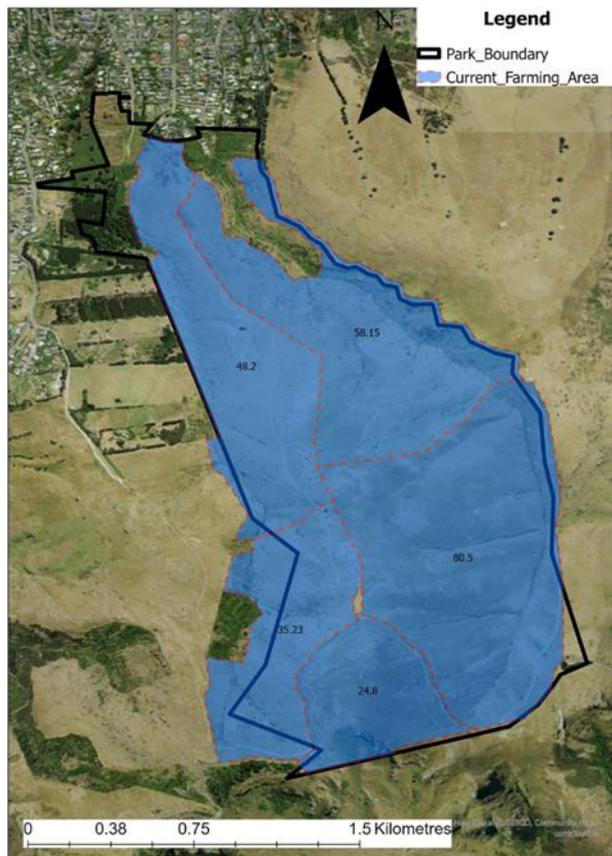
Figure 19: Farm Map showing the current farming blocks within Mt Vernon Park and their respective area size in hectares.

Mt. Vernon Park serves recreational and agricultural purposes with a network of trails, including a central farm track providing access to Summit Road, and walking tracks that extend along the northeast and southwest valleys to Mt. Vernon's summit (See Figure 9). The park's existing fence lines divide it into five large blocks where sheep graze freely throughout, with two areas in the park's lower reaches retired from farming (Figure 19).

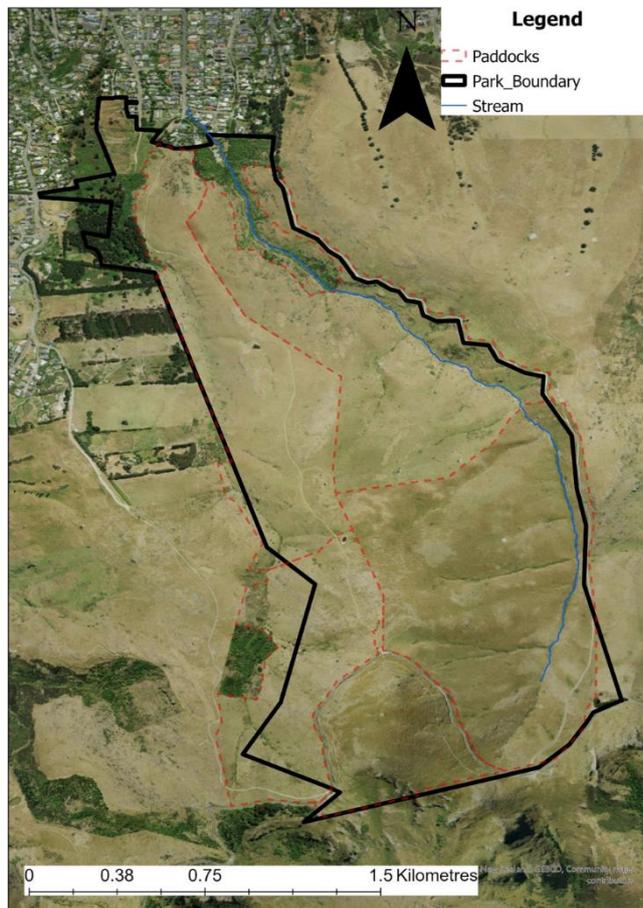
Figure 20: This map highlights the main outlet stream for water within the Mt Vernon Park Area.
