# **GEOG309-23S2**

**Final Report**

**Erosion Susceptibility at Mt Vernon Park**

**Group 12**

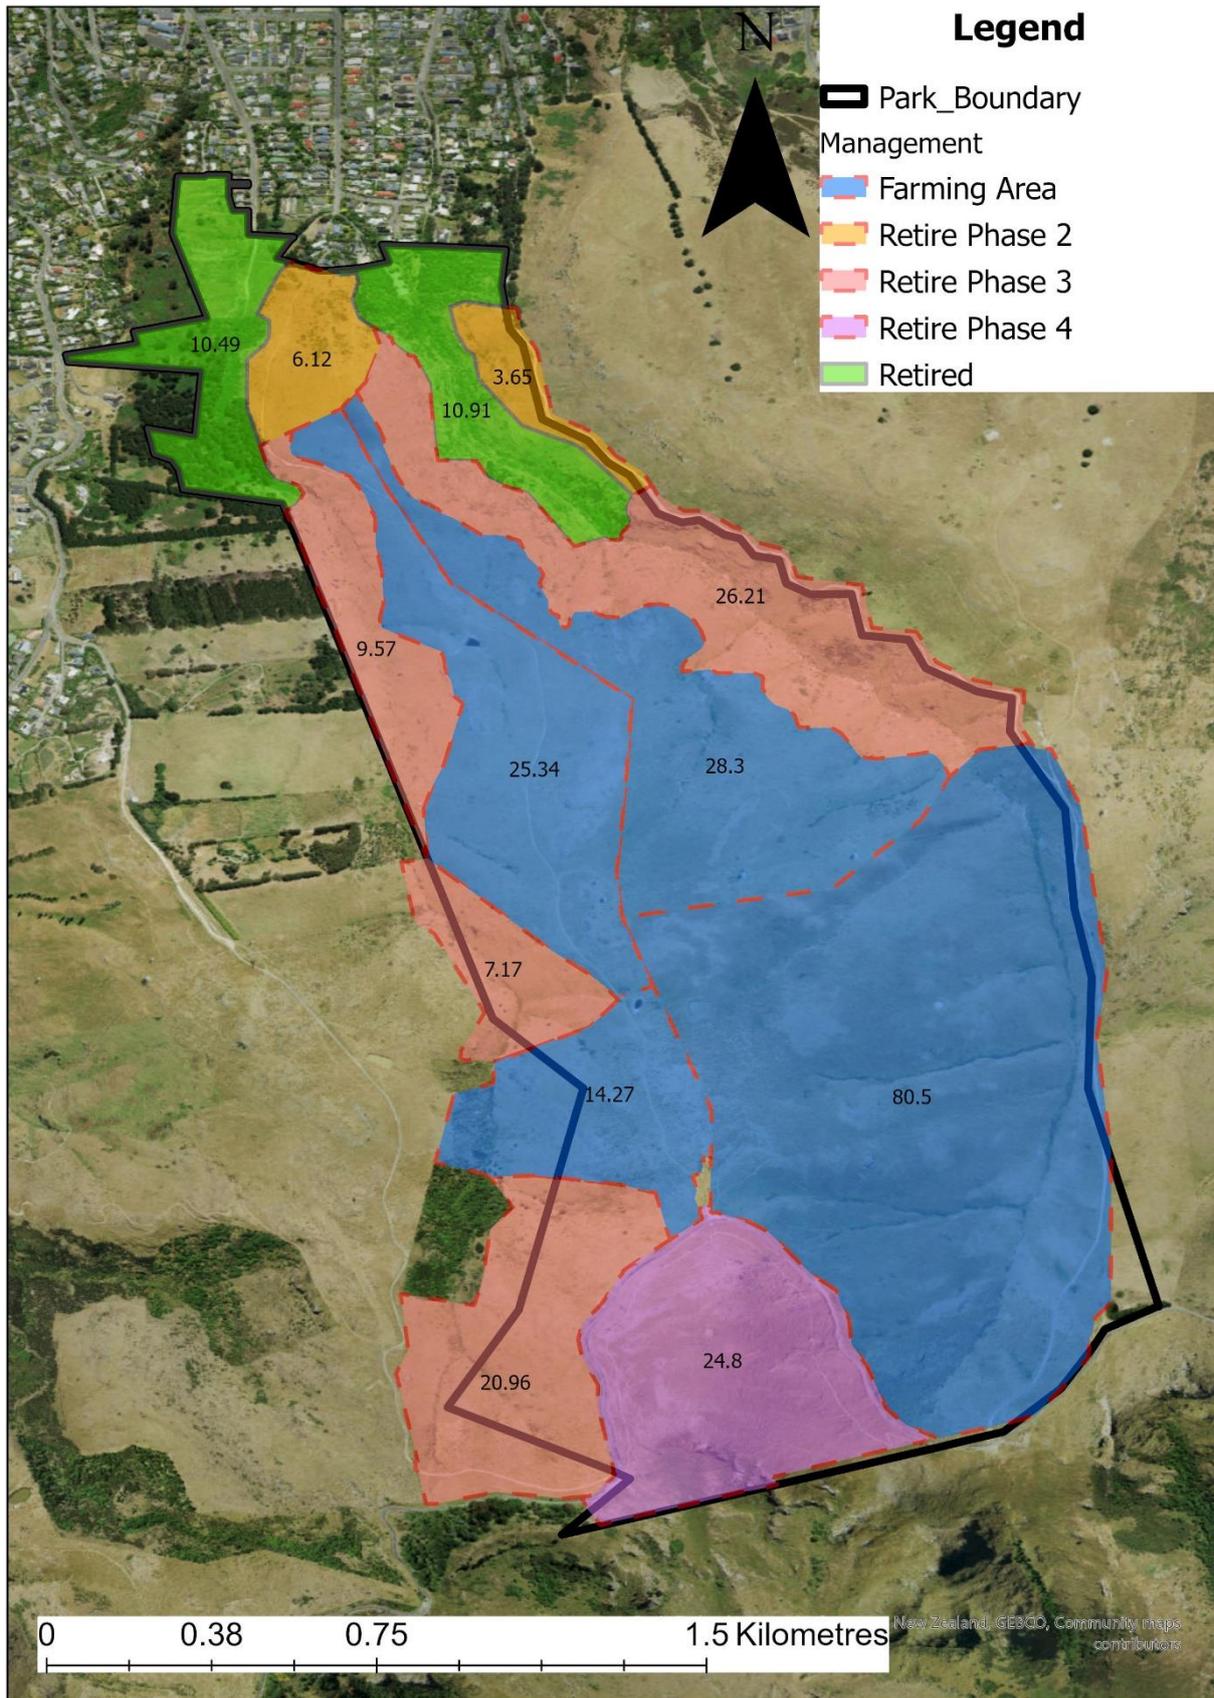
Figure 21: Proposed management blocks for future park management, providing suggestions on areas to retire. Each block's area is presented on the map in hectares.

The paddocks highlighted in blue are the most suitable grazing zones, where stock should be kept to reduce erosion after all other blocks are retired (Figure 21). These new grazing blocks create a farming area of approximately 148 ha.

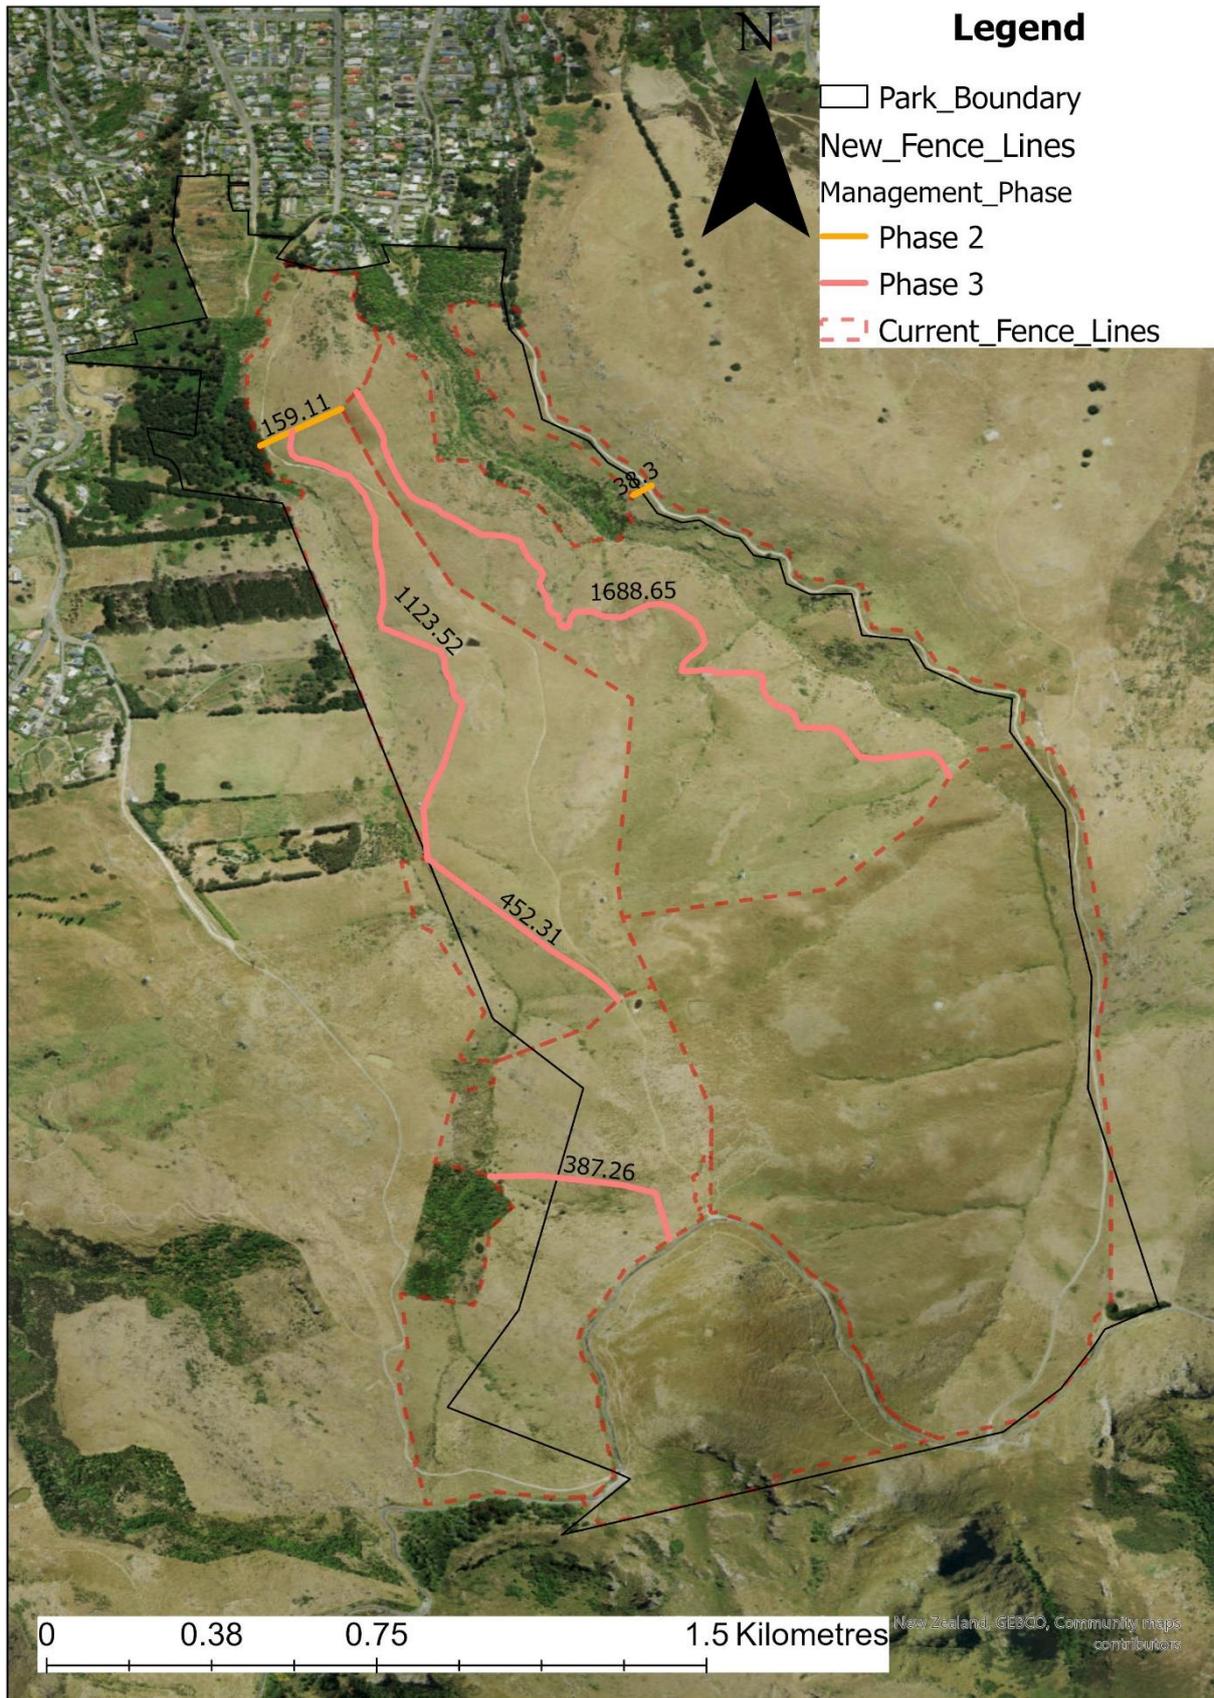
Figure 22: Map showing the new fence lines required for retirement of susceptible land. The length required for each fence line is shown on the map in metres.

Long term recommendations begin with stage 2 for implementing new fence lines (Figure 22). Stage 2 involves fencing off the steep northeast and southwest slopes, marked in red, which

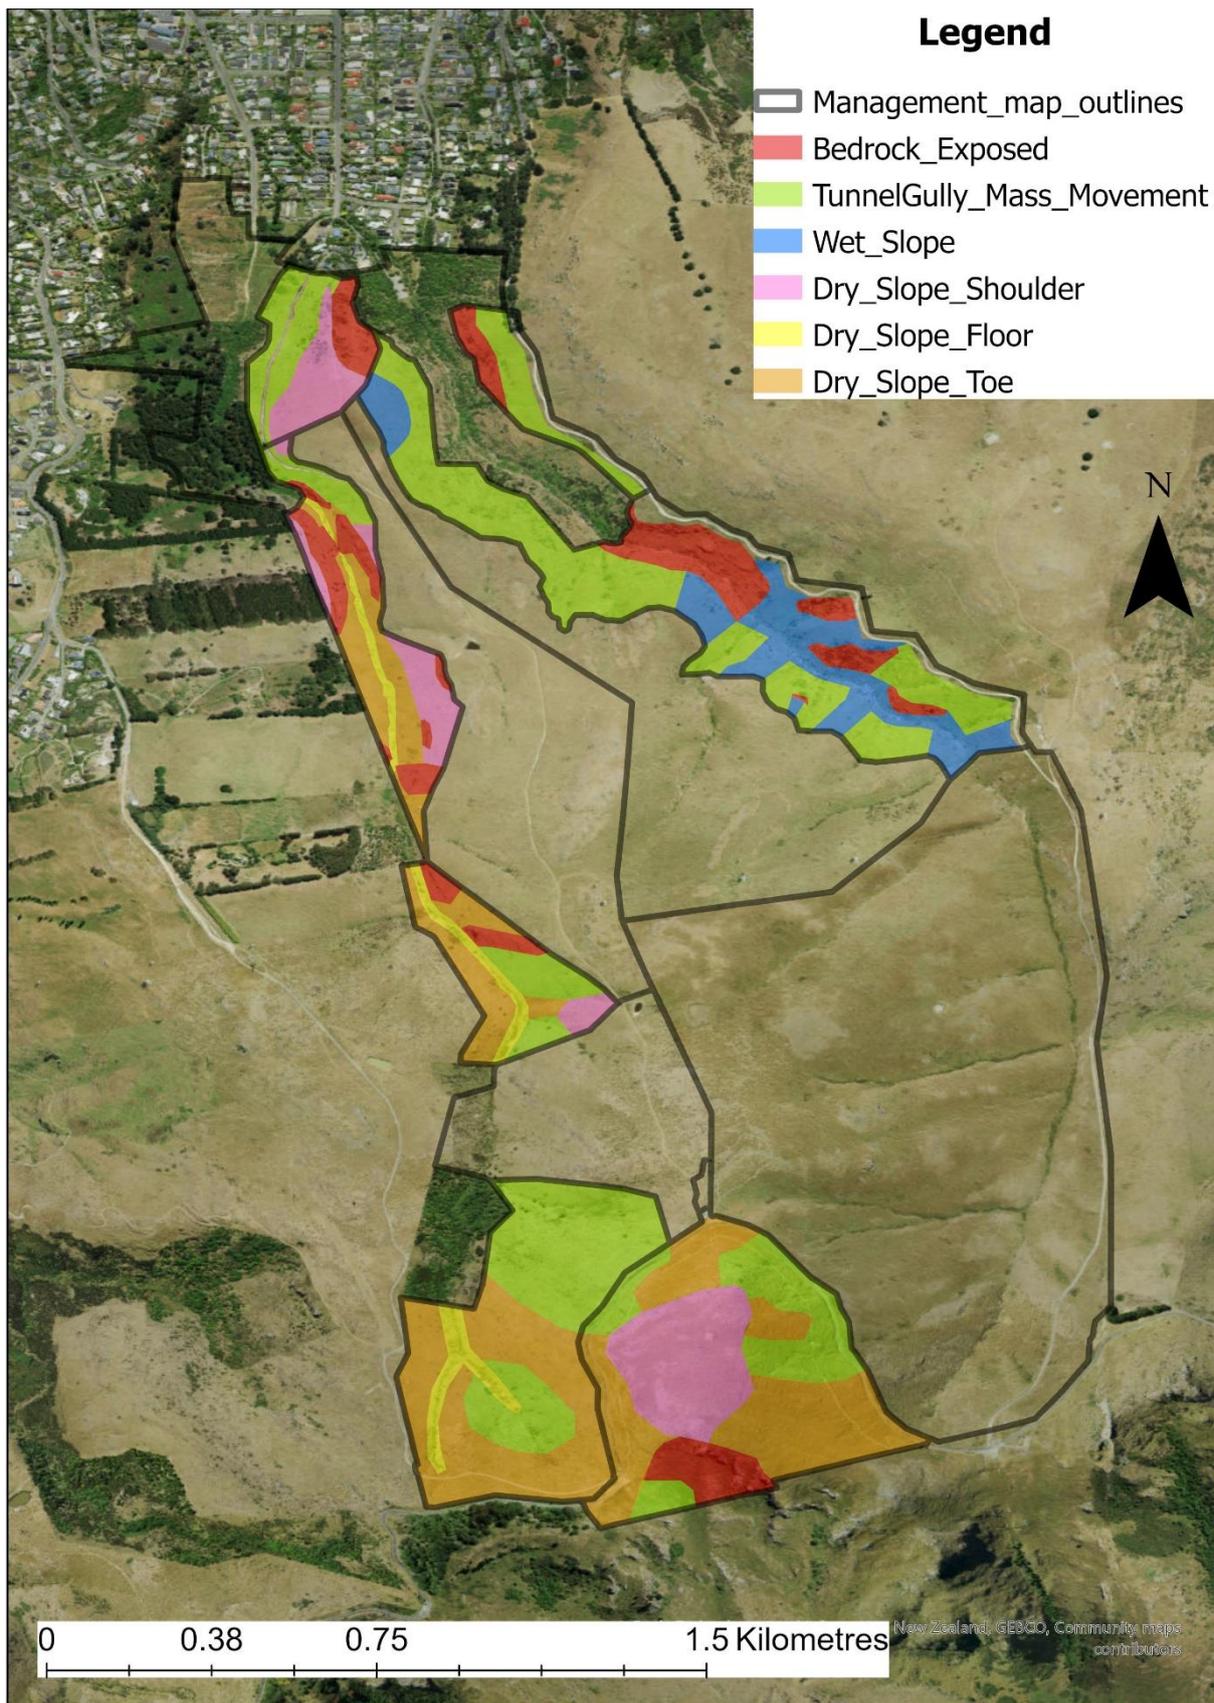
Figure 22: Planting area guide for future retirement blocks within the Park, based on erosional processes.

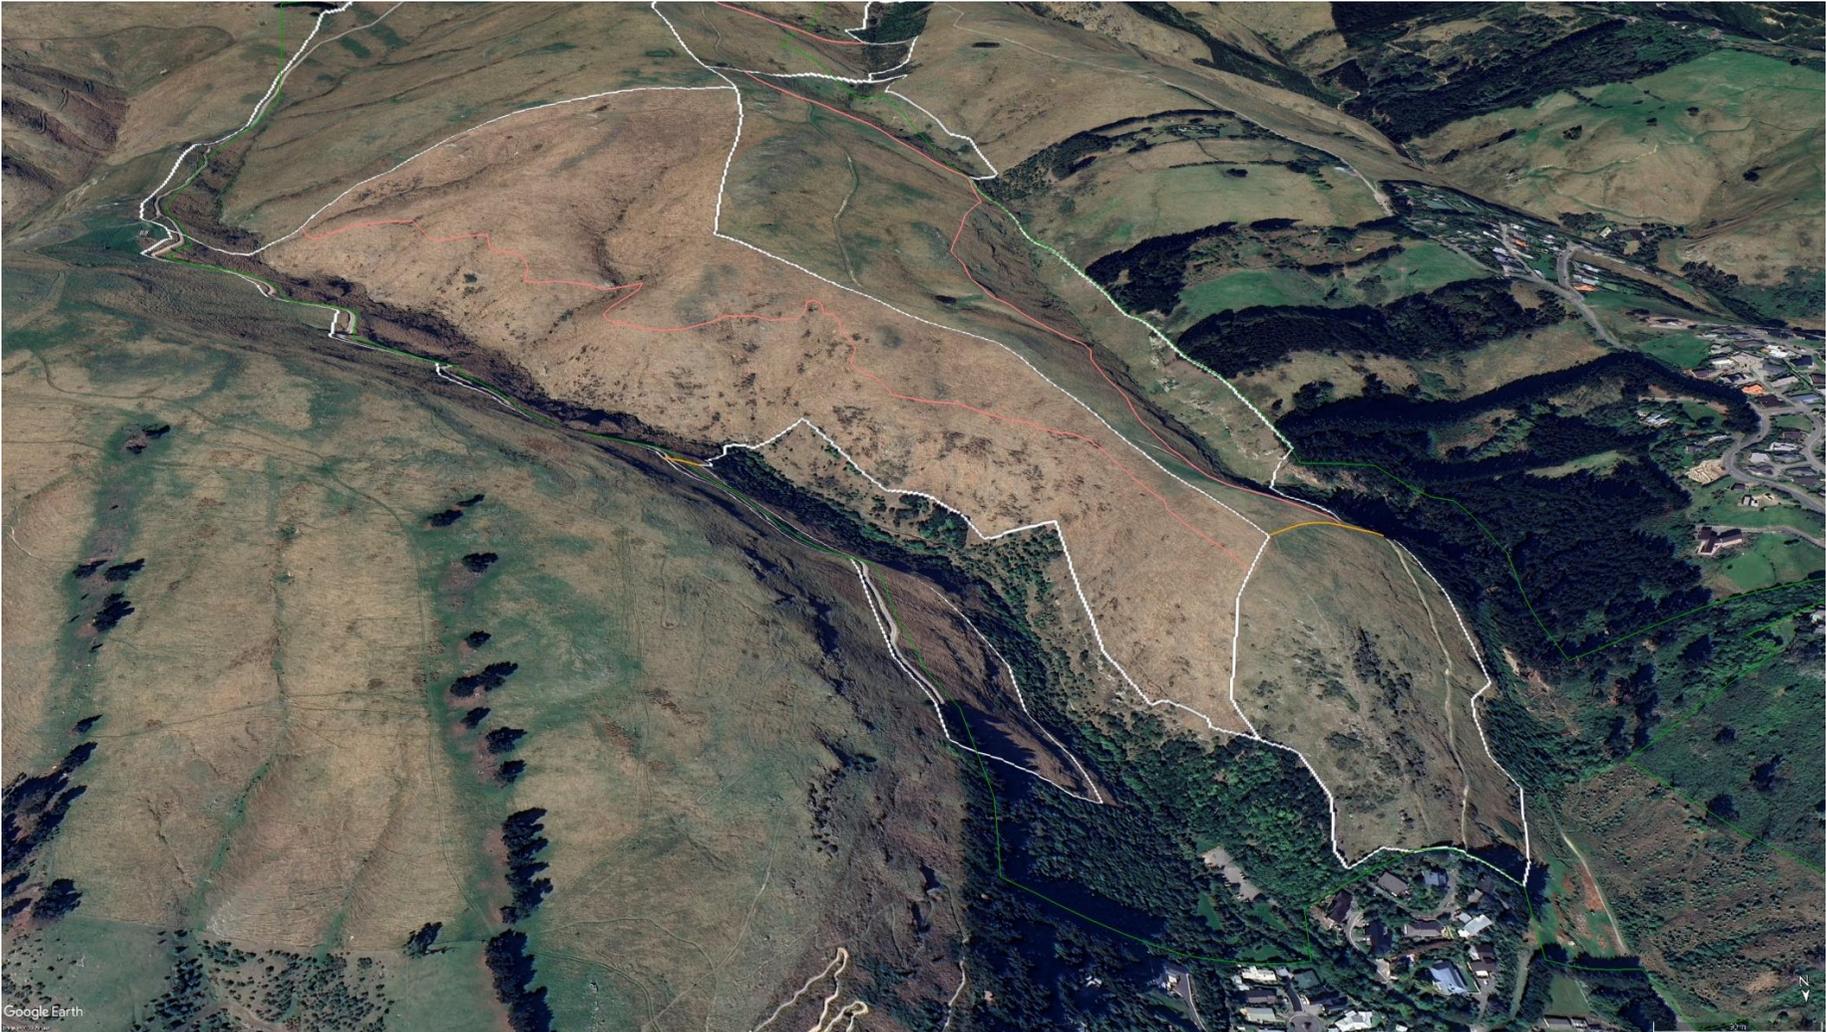
Appendix A: Google earth image of Mt Vernon Park showing existing fence lines (white), phase 2 fence lines (orange), and phase 3 fence lines (red).

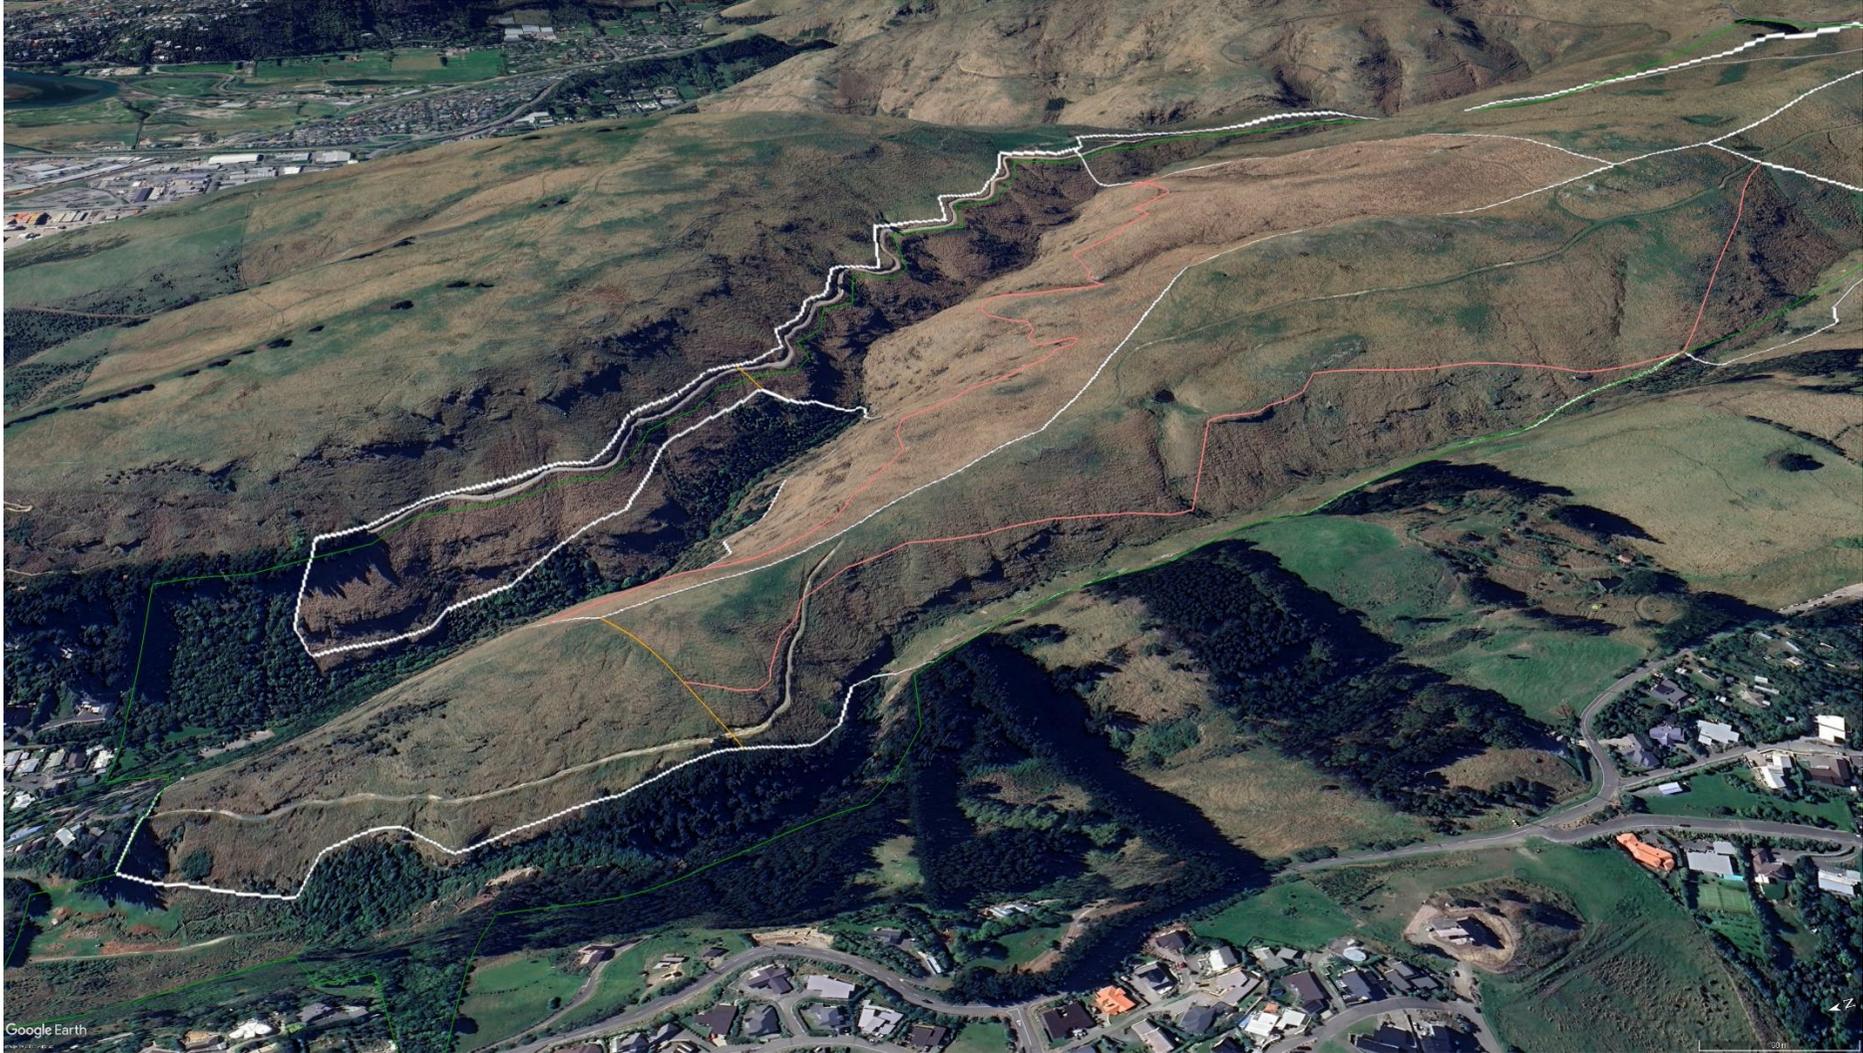
Appendix B: Google earth image of Mt Vernon Park showing existing fence lines (white), phase 2 fence lines (orange), and phase 3 fence lines (red).
