# Quick Pass Dune Vulnerability Assessment

In association with Christchurch City Council and  
Environment Canterbury

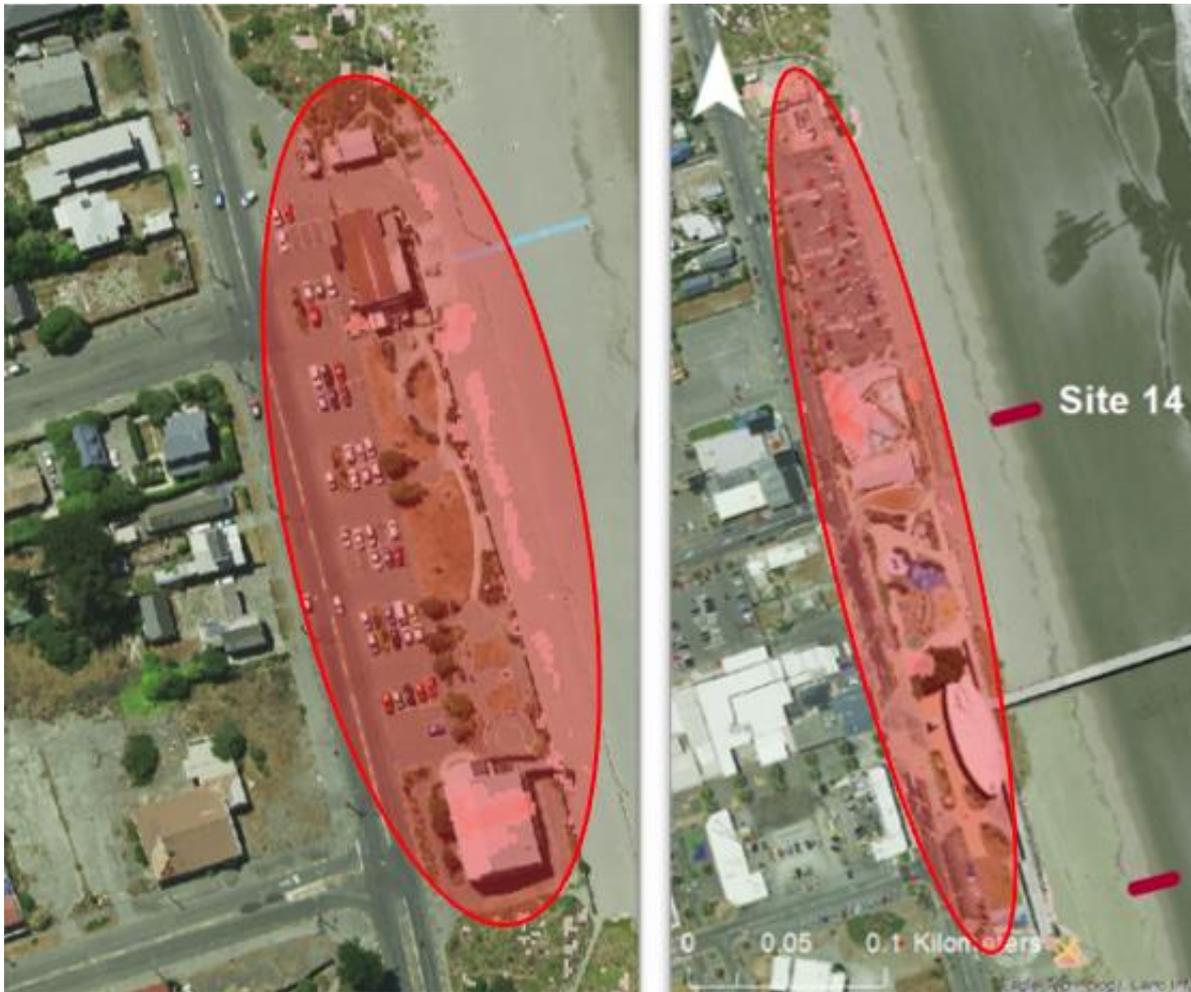
**Figure 19**

*Sites Showing a Lack of Vegetation in Front of Heavy Foot Traffic Areas.*

*Note.* Sites 9 and 10 have a lack of vegetation coverage due to the amenities behind the beach. This leads to the public frequently accessing the beach through these areas, hindering vegetation growth. These public amenities are essentially located on top of the sand dunes and reside within the red ovals present in the image.

As a result of high-density infrastructure, SLR and frequent storm events, a lack of vegetation has been seen across segments of the study area (figure 19). Plants are essential to coastal ecosystems as they trap dune sediment in their roots which reduces erosion, weakens wave energy, and helps to trap sediment blown by wind. All of these factors contribute to dune growth (Sigren et al., 2014). The limited available space for dune growth and high wave energy in this site has made it difficult for dune plants to establish in these vulnerable areas and as a result the dunes have been unable to build up. Areas along the dune with increased rates of erosion also show little vegetation cover.

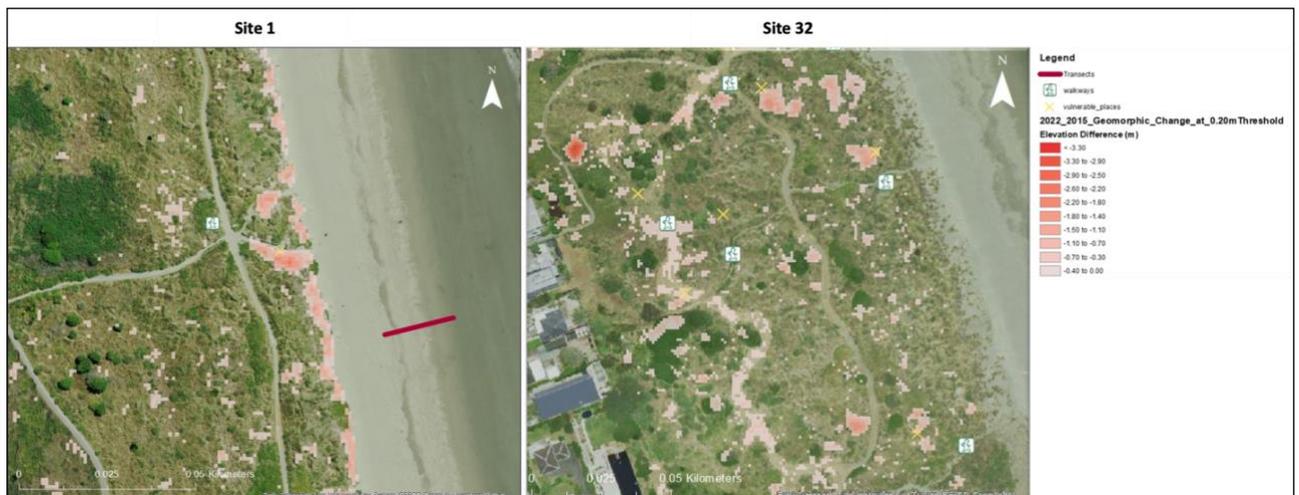
**Figure 20**  
*Points of Erosion Caused by Human Activity Around Walkways in Sites 1 and 32*

The results showed a significant effect of beach access paths on areas of erosion, with the GCD tool significantly highlighting areas like seen in Figure 20 below. Beaches like New Brighton and North Beach are popular for recreational activities such as swimming, surfing, the hot pools and fishing. Recreational beach use can lead to trampling of dune vegetation by humans, which decreases vegetation and increases erosion (Purvis et al., 2015). There are many established walkways along the beach to limit the areas of erosion, with them being constructed from bare sand or wood steps, with some paths having rails. The paths vary in distance from each other and width, influencing the degree of erosion on each path. Purvis et al. (2015) revealed that vegetation is typically reduced around pathways and species richness is reduced in areas where pathways are near each other. Erosion on these paths is an issue however individuals often make their own paths through establishing sand dunes, which poses more of a risk. This reduces dune height which hinders dune stabilisation/accretion, causing dune habitats to shrink and become fragmented (Purvis et al., 2015). Patches of natural habitat within urban areas is important for global diversity. The biodiversity

Human activity massively disrupts dune processes as people trample through the dunes off the walkways (Steven-Newman, n.d.). Getting people to acknowledge issues and understand that they need to make changes is also an issue. CCC rangers alerted us to this as they have struggled with this issue for years. Humans as species are resistant to change (Jost, 2015). The management of the dunes in the New Brighton and North Beach area will cause changes in people’s day-to-day lives resulting in resistance to dune management practices. There has been minimal change in the dune systems in these areas, hence the public’s strong backlash. Resistance to change has been occurring the most from the residents as they bought their homes in these areas because of the recreational activities and views the beach provides. However, dune management practices are needed to ensure future use of the beach can continue.
