Is there any spatial variability of soil types, plant species & terrain characteristics within Riccarton Bush, and is it linked to the inefficiencies of the current irrigation system?

Finn Seeds, Anton Verheul, Aimee Kennedy, James St Clair, & Emily Bowler

School of Earth and Environment, University of Canterbury

GEOG309: Research for Resilient Environments and Communities

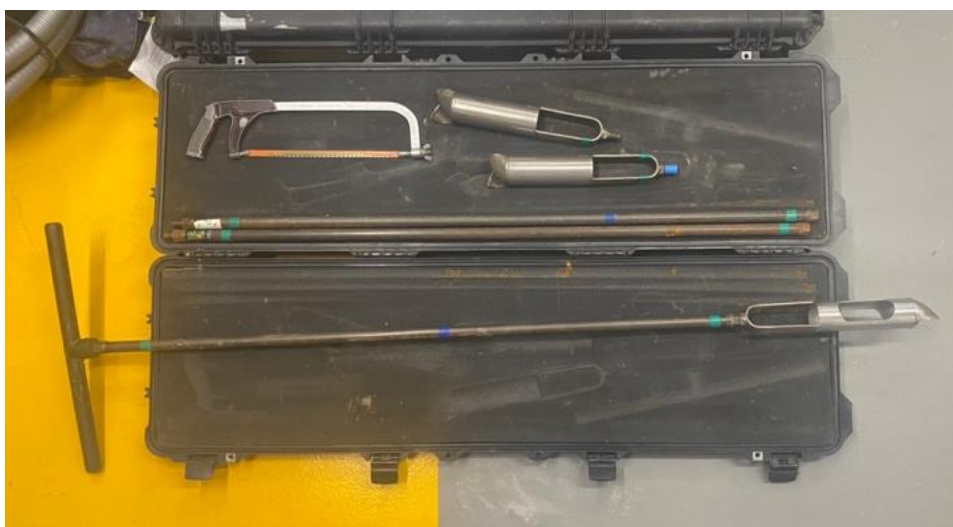
Figure 4. Hand Auger used in second phase of sampling.

Regrettably, during the collection of core 4, the AMS corers' hammer attachment snapped and rendered it unusable. In response to this unexpected setback and considering time constraints, the decision was made to revise the core collection target from 16 to 10 cores and transition was made to the auger method for the remaining seven randomly selected sites to ensure the study's continuity (Figure 4).

Like the core methodology, the auger was positioned perpendicularly to the ground. A controlled rotation initiated the auger's penetration into the soil, achieving a depth of approximately 15 centimetres each time. Extracted soil was carefully removed using a specialised tool and deposited into designated plastic bags. The depth of each sample was recorded directly on the bag using a permanent marker, ensuring precise documentation. This procedure was systematically repeated until a maximum depth of 90 centimetres was reached.

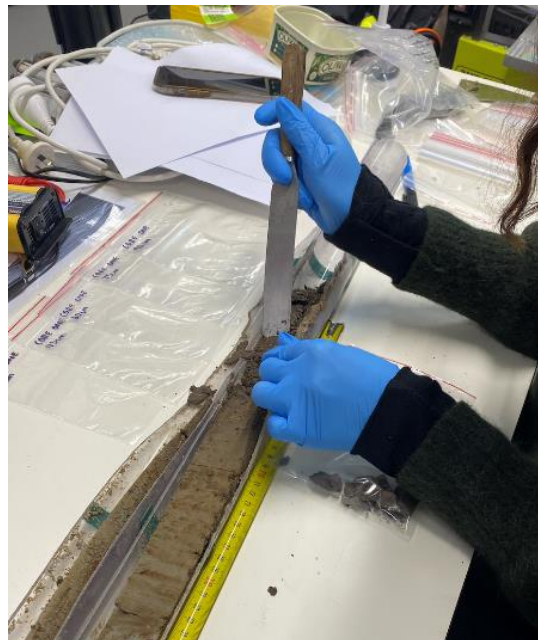
Figure 5. Sub-Sampling at 15 increments

Following the collection of the primary field data from Riccarton Bush, the samples were broken into increments of 15 cm to a depth of 90 cm to conduct analysis. This incrementation allowed for a good representation for the entire core profile. Munsell's colour chart 7.5 YR (Appendix B) was used to record the colour of all samples as it is a universal indicator for colour these were recorded in excel (Appendix C). The samples at each 15 cm increment were taken with an uncertainty of ± 5 cm (Figure 5). Samples were suspended in distilled water to prepare each sample for analysis (Figure 6).

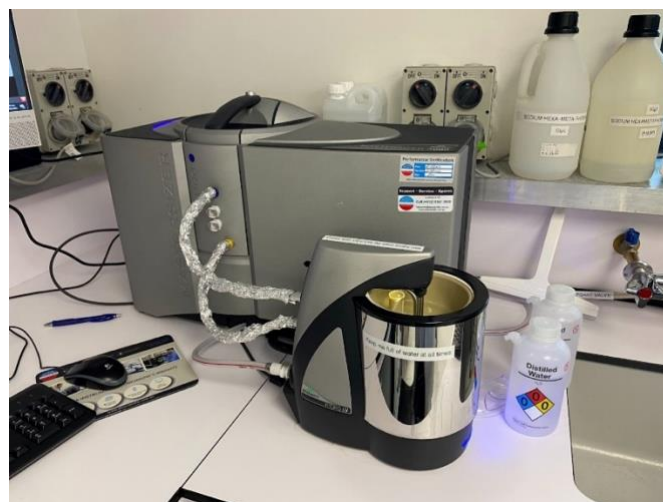
Figure 7. Mastersizer Hydro LV 3000 that was used.

The other method utilises a Particle Size Analyser (PSA), a digital-based method centred around the distribution of particle sizes for a given sample. The PSA machine used was the Mastersizer Hydro LV 3000 (MSLV) in the University of Canterbury's civil engineering soil lab (Figure 7). The MSLV utilises Mie's theory of laser diffraction (Malvern Panalytical, 2021) to determine the distribution of particle sizes in each sample - this was the method chosen.

The samples were suspended in distilled water and mixed on a magnetic stirrer (MSL 8 Magnetic stirrer) for ~2 minutes to ensure homogeneity of the samples. Following this, each sample was pipetted into the MSLV with particular attention given to the obscuration percentage to maintain the 8-12% threshold. The MSLV carried out three readings in its Malvern software for each sample tested, and then an averaged result was produced, minimising the influence of anomalies in the results.

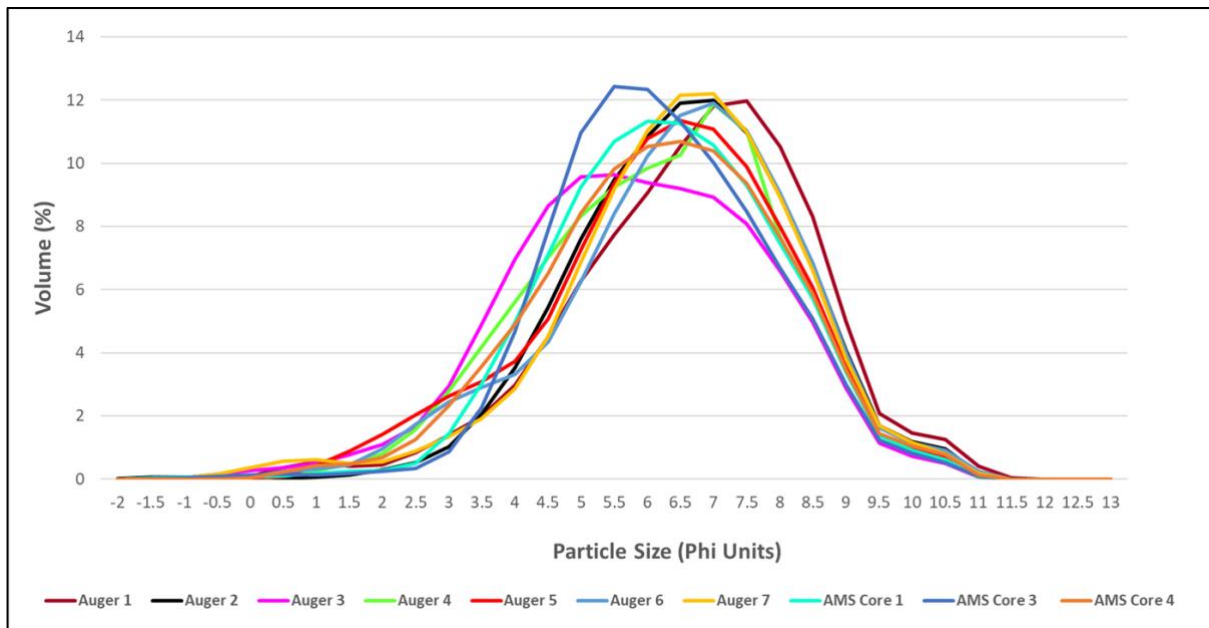
Figure 8. Average Particle size vs % Volume of each sample, is the average volume of each particle size across all increments.

Figure 8 shows the average sediment particle size against their relative abundance (%) in each of the 10 samples taken from Riccarton Bush. The average distribution curves were generated in excel via MasterSizer data processing and sorting of the volumes of each particle size at each incremental sample and calculating the average for the entire sample.

The curves observable in Figure 8 indicates that the particle size distribution of all the core samples is uniform. Eight of the ten core samples display a mean particle size value of 6.5-7.5 Phi. The AMS Core 3 and Auger 3 samples display lower mean values of approximately 5-5.5 Phi. The lower displayed mean value of these samples indicates a greater quantity of coarser sediment particles present in the two sample sites. The standard deviations associated with each of the 10 samples (Appendix D) returned values of greater than 1 for all. Values greater than 1, relate to and correspond with poor sorting characteristics of a medium.
