Lake Kate Sheppard:

An exemplar mahingā kai site?

GEO 402
Urban Development
Ada Zhang
Steve Carrick
June 2014

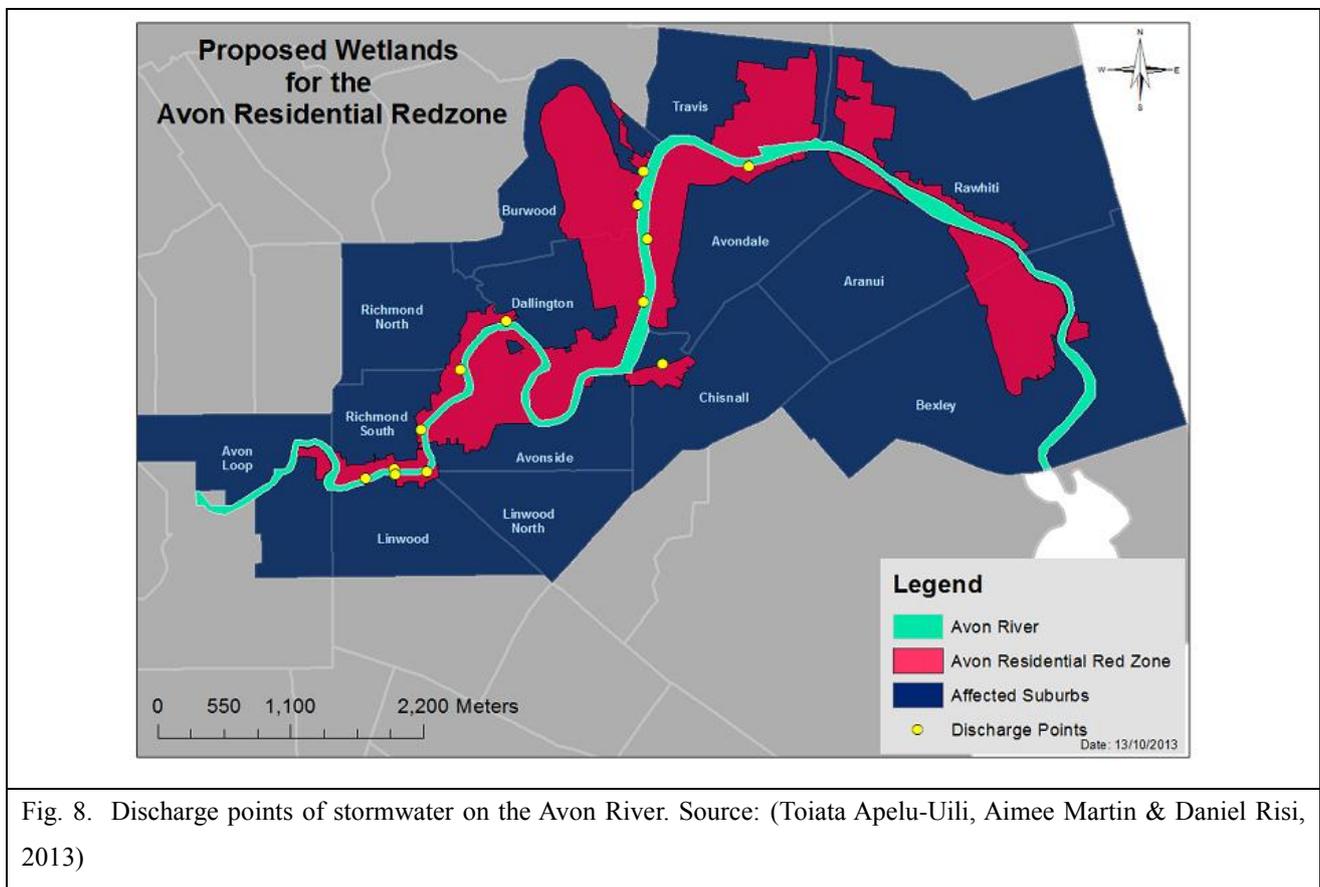
Fig. 8. Discharge points of stormwater on the Avon River. Source: (Toiata Apelu-Uili, Aimee Martin & Daniel Risi, 2013)

In addition, since the earthquake in 2011, the local drainage network has suffered a decline in capacity during peak river levels due to ground drop (MAYORAL FLOOD TASKFORCE, 2014). This enhances the risk of flooding during a heavy rain. The discharge points of stormwater in the upstream of the Avon River are shown in Figure 8. It means that part pollutants will enter our streams, rivers and lakes due to rainfall. It also illustrates that there will be a massive flow rate merged into the Avon River. This further increases the risk of flooding due to the water level rise.
